SH 82 Over Castle Creek Bridge Feasibility Study
Document No: 240207140925_5d9775bf
Version: Draft

City of Aspen
Structure No. H-09-B

Castle Creek Bridge

Prepared by: Beth Tosti, Structures Lead

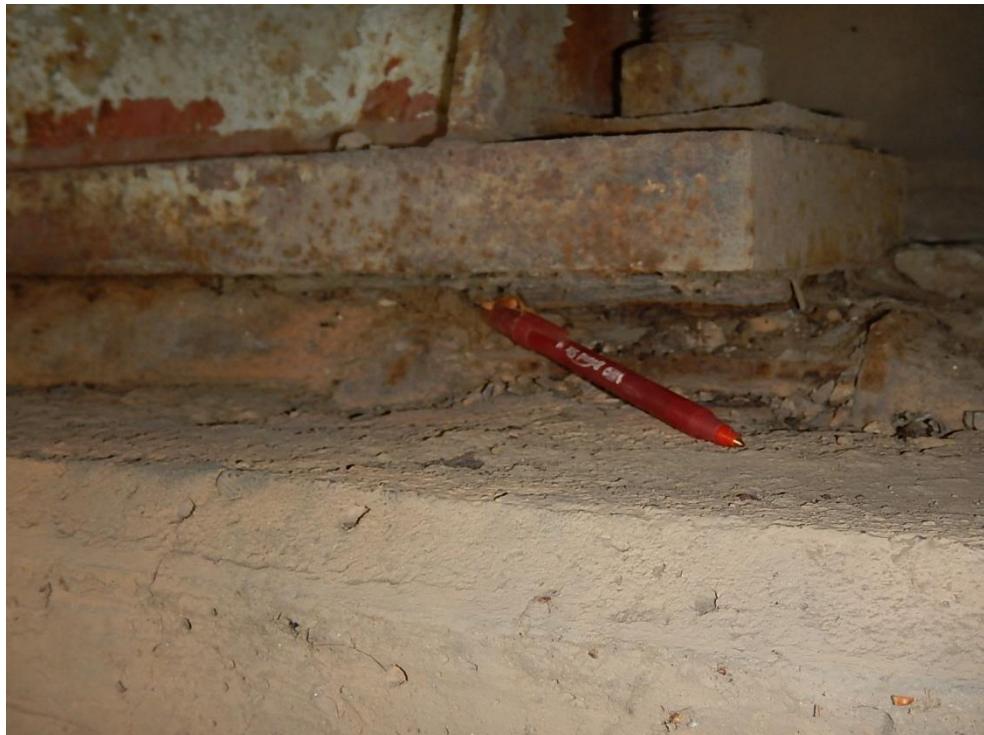
R3 - R4 Corrosion of Girder 5F near Abutment 6

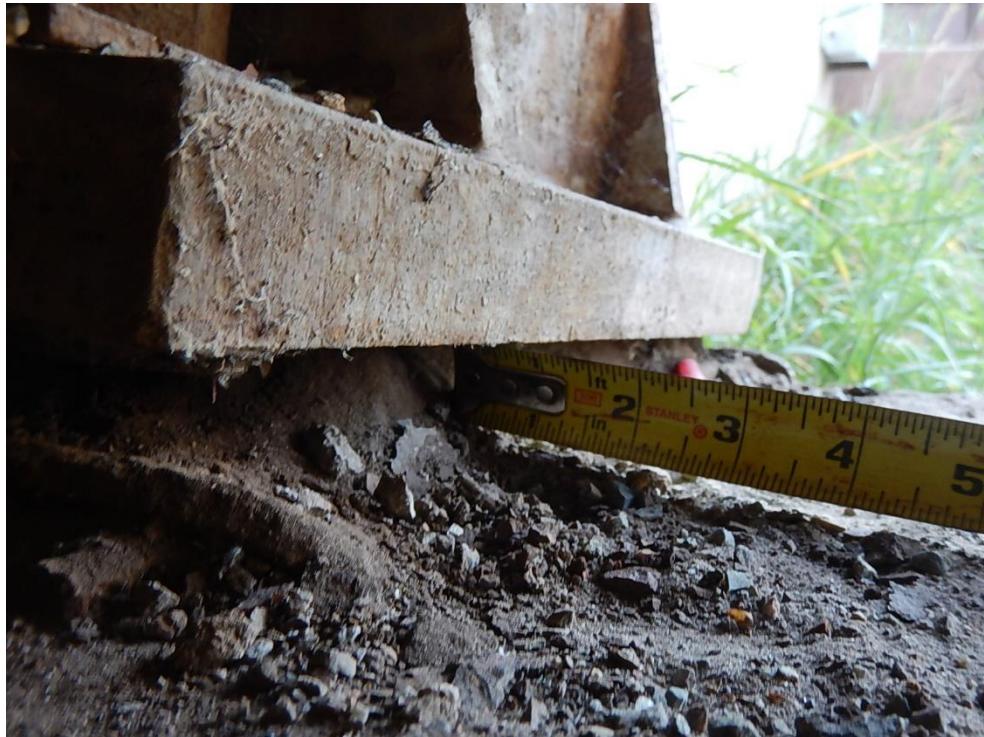
Bearing Loss Due to Missing Grout Pad Under Bearing 6B

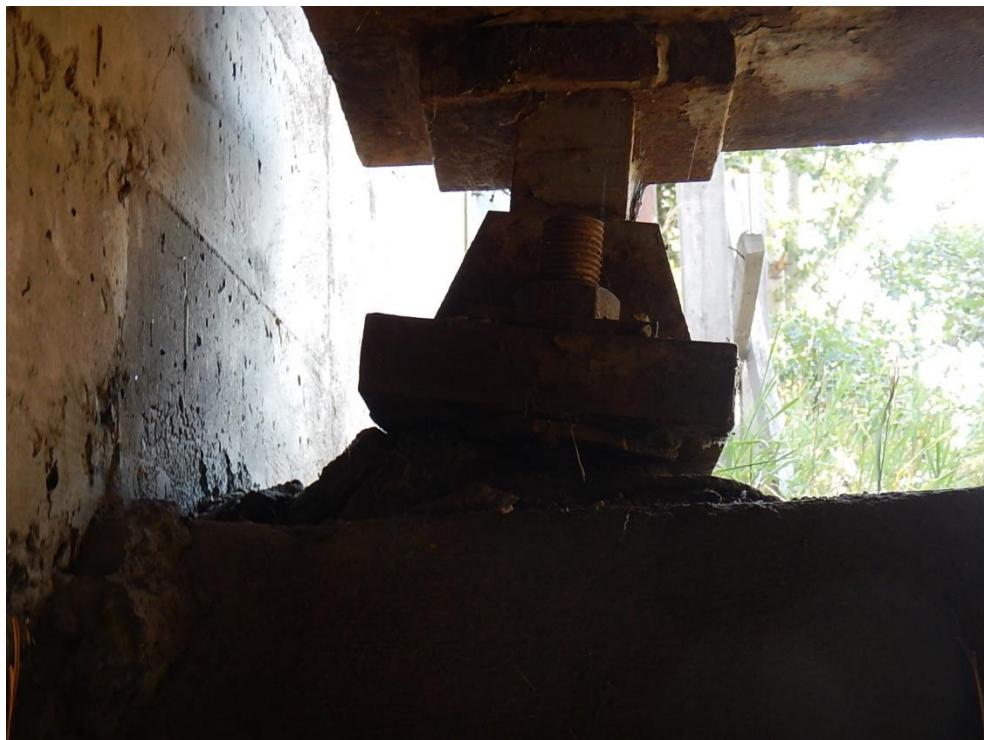
Broken Bearing Pad under Bearing F at Abutment 6 15
Percent Bearing Loss

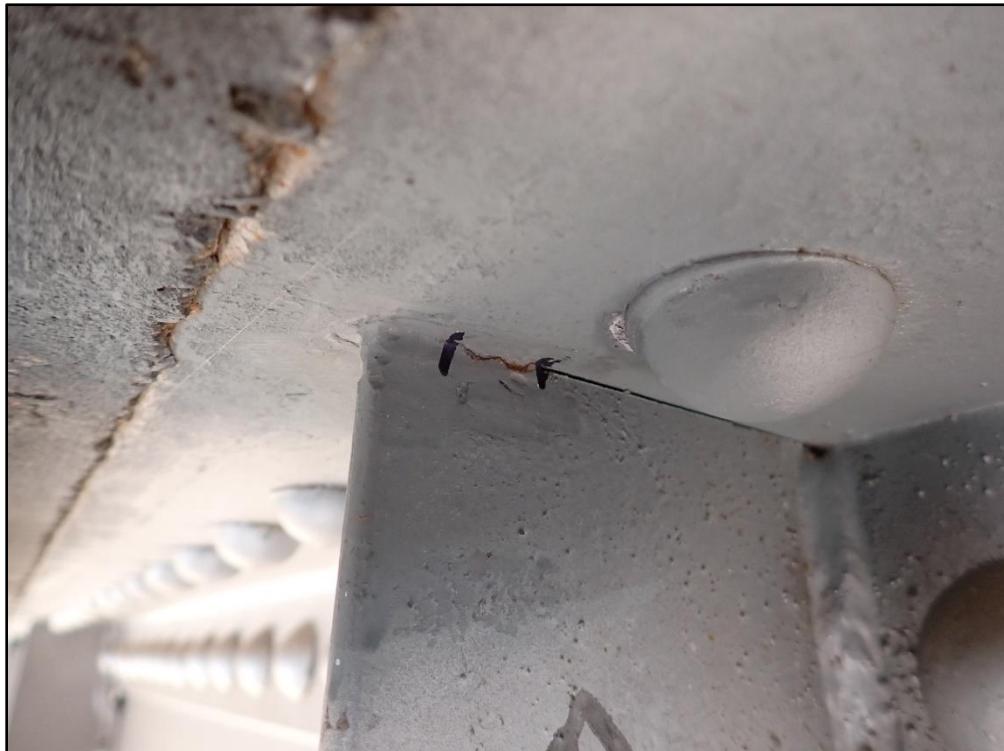
Figure 9 :Typical Stiffener Tack Weld Configuration with Crack Code Call-Outs

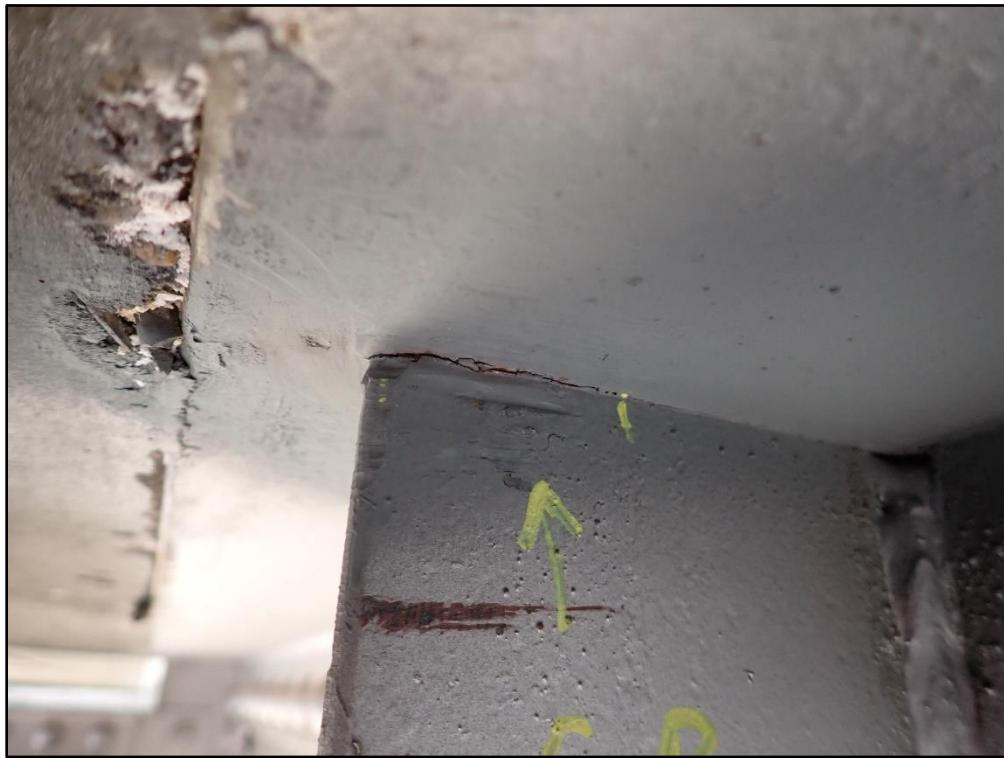
Figure 10: NSA Cracked Tack Weld – Girder B South Face – Stiffener 19 to Horizontal Leg of Top Flange Angle

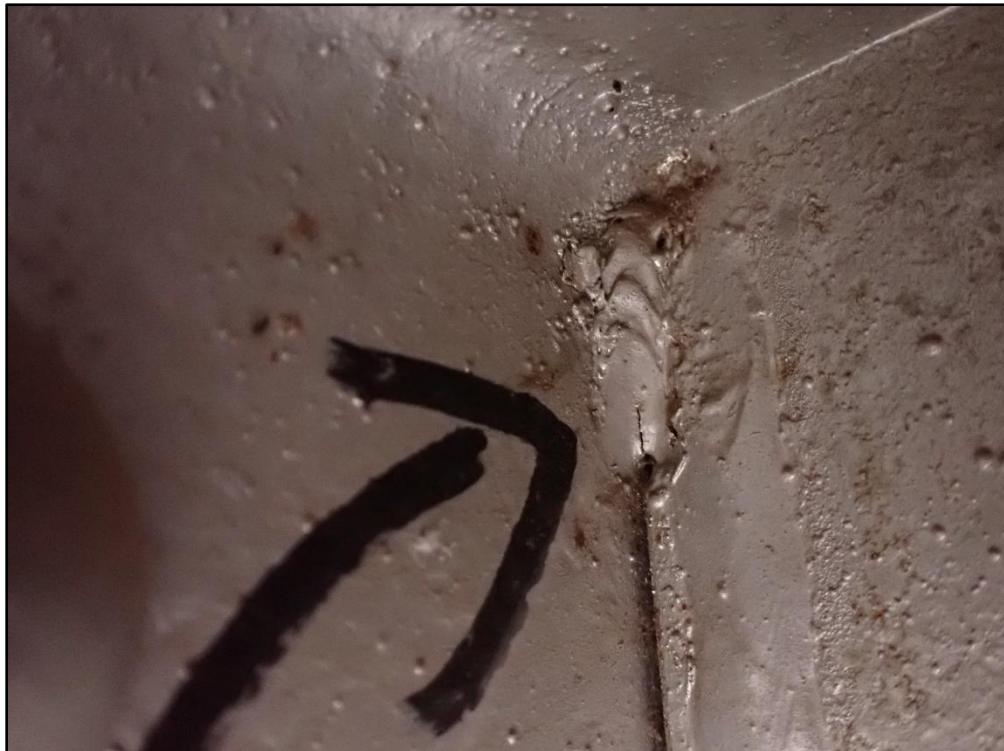
Figure 11: SA Cracked Tack Weld – Girder B South Face – Stiffener 17 to Horizontal Leg of Top Flange Angle

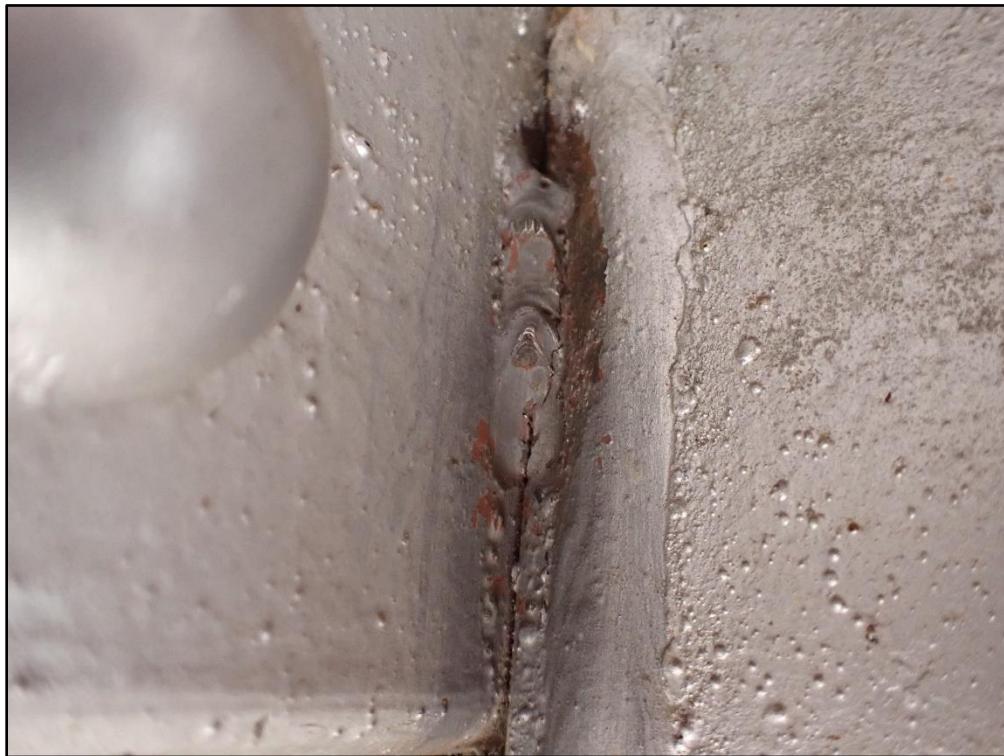
Figure 12: NSA Cracked Tack Weld – Girder C North Face – Stiffener 105 to Vertical Leg of Top Flange Angle

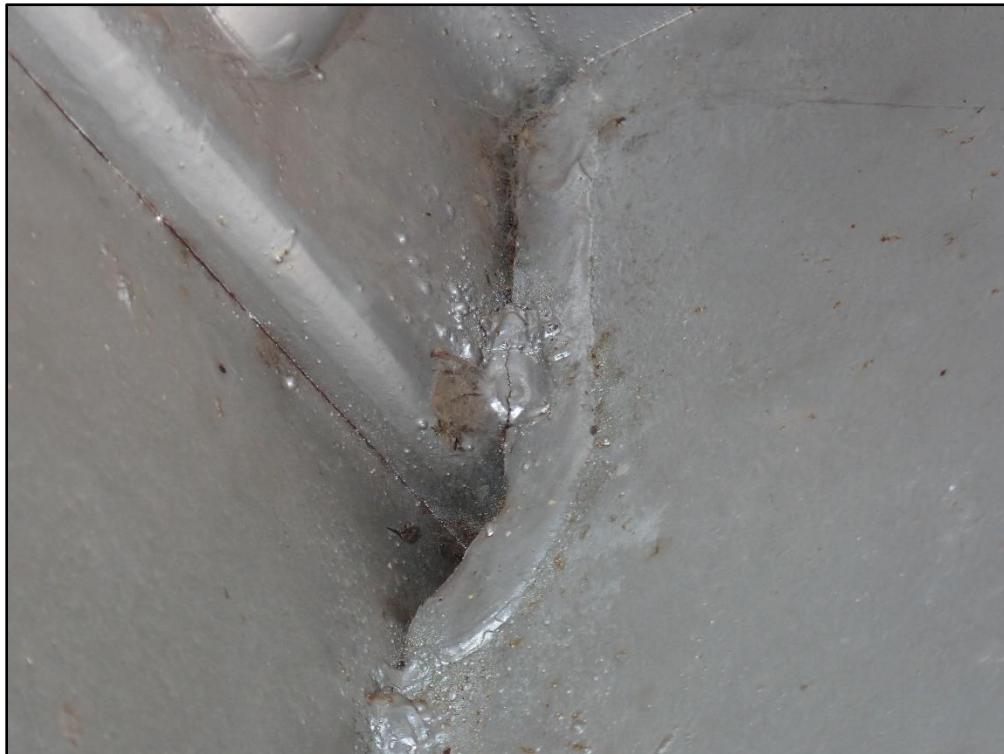
Figure 13: NSA Cracked Tack Weld – Girder D North Face – Stiffener 97 to Vertical Leg of Top Flange Angle

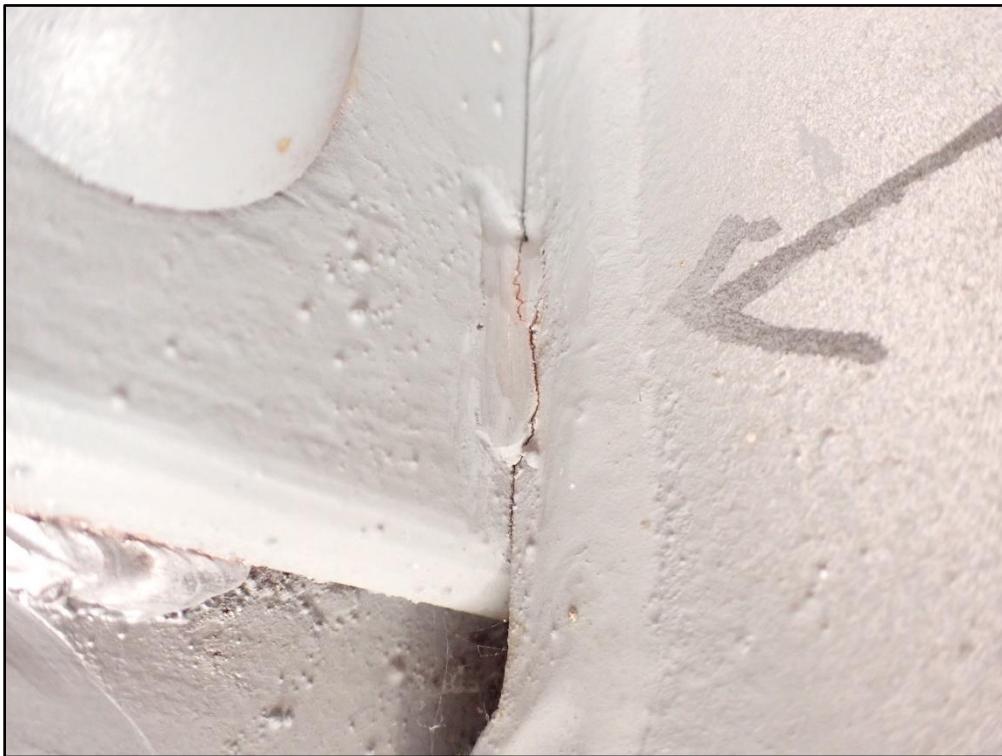
Figure 14: NSA Cracked Tack Weld – Girder E North Face – Stiffener 107 to Vertical Leg of Top Flange Angle

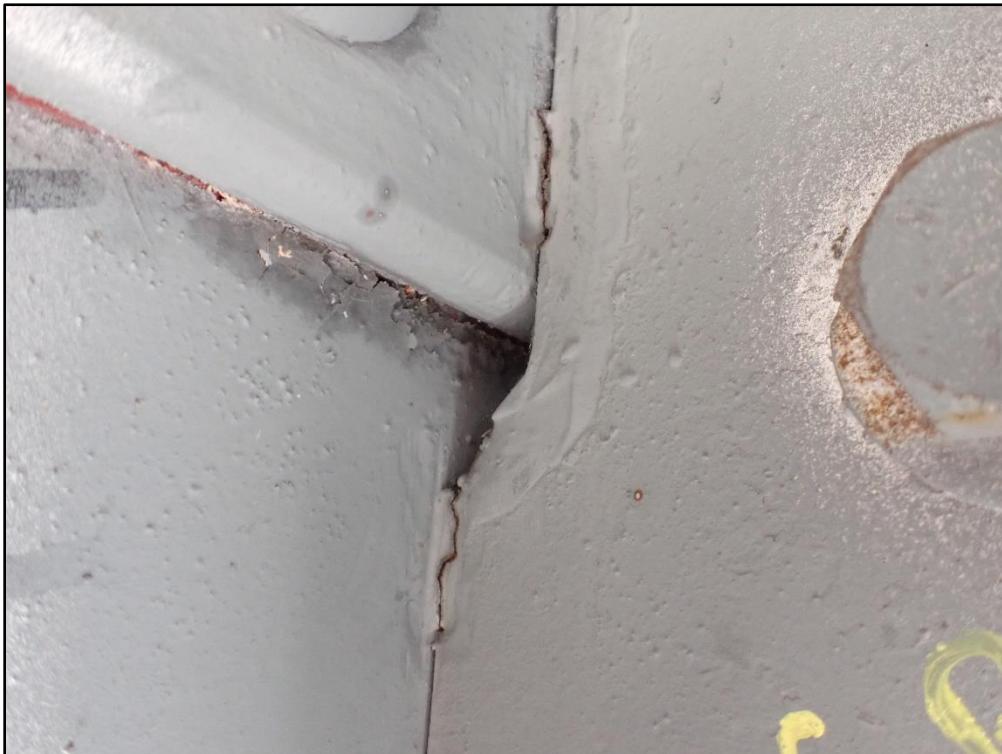
Figure 15: SA Cracked Tack Weld – Girder C South Face – Stiffener 16 to Vertical Leg of Top Flange Angle

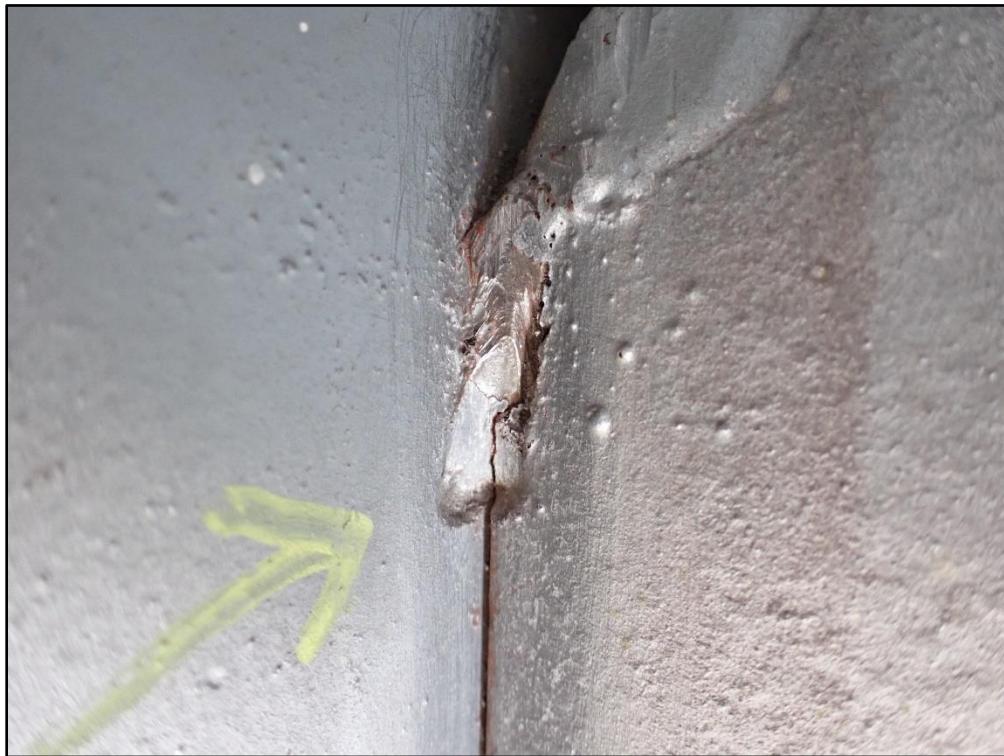
Figure 16: SA Cracked Tack Welds – Girder B South Face – Stiffener 41 to Vertical Leg of TF Angle and Web

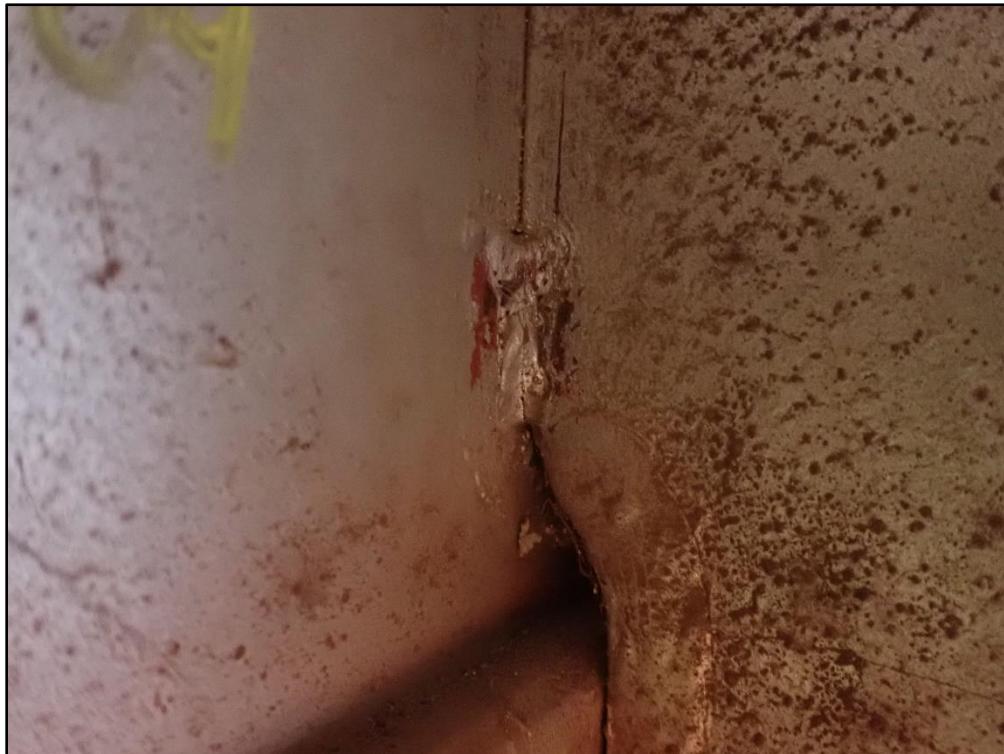
Figure 17: NSA Cracked Tack Weld – Girder E South Face – Stiffener 55 to Web

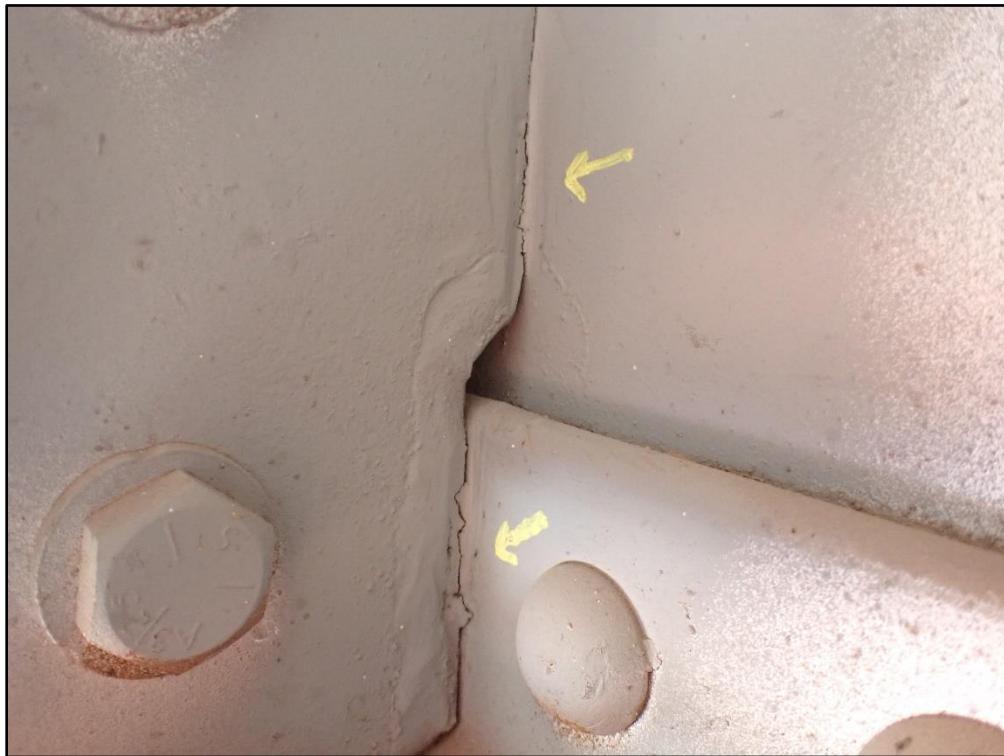
Figure 18: NSA Cracked Tack Weld – Girder C North Face – Stiffener 109 to Web

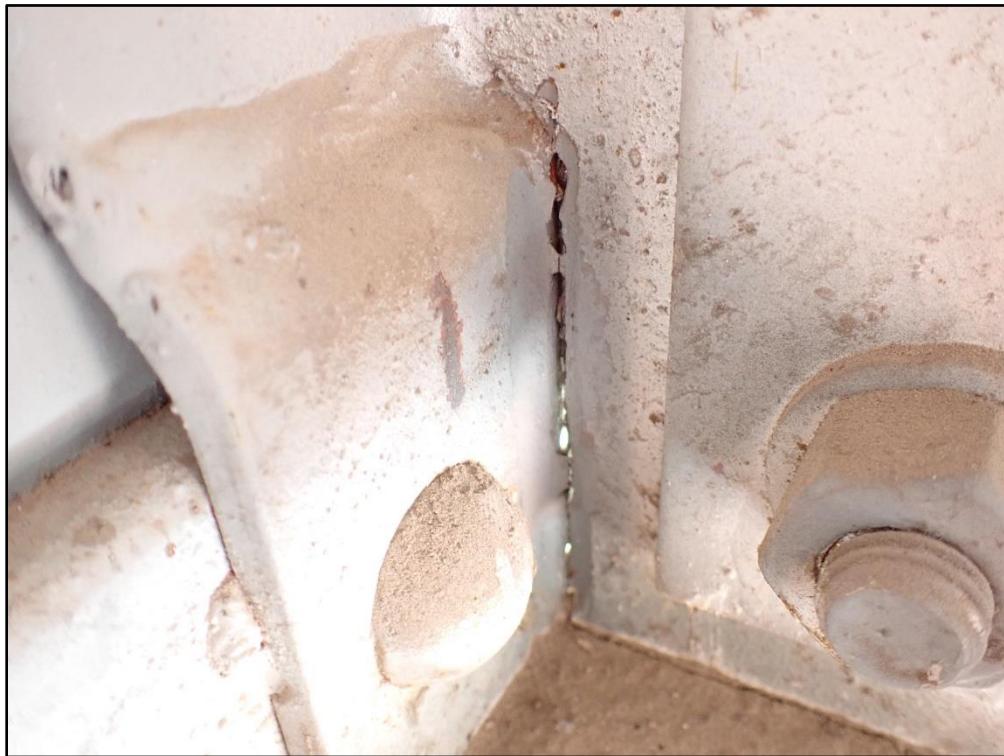
Figure 20: Partially Ground Out Tack Weld – Girder C South Face – Girder Top Flange to Web At Stiffener 16

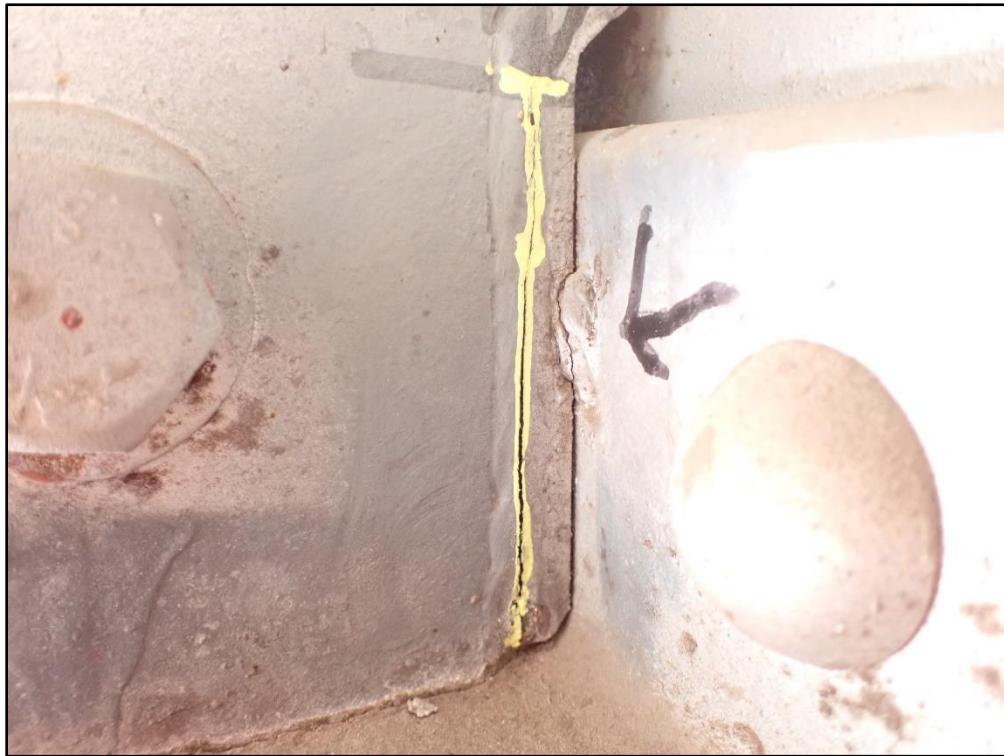
Figure 21: Fractured Stiffener 16 Weld – Girder C North Face at Bottom - Left

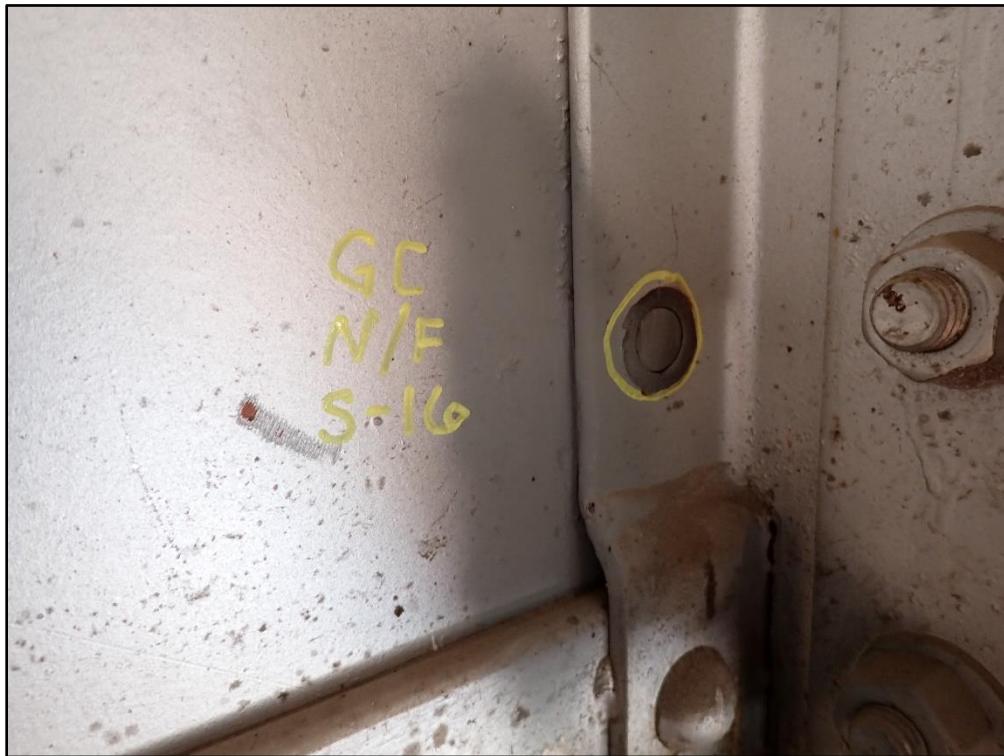
Figure 22: Fractured Stiffener 16 Weld – Girder C North Face at Bottom – Right

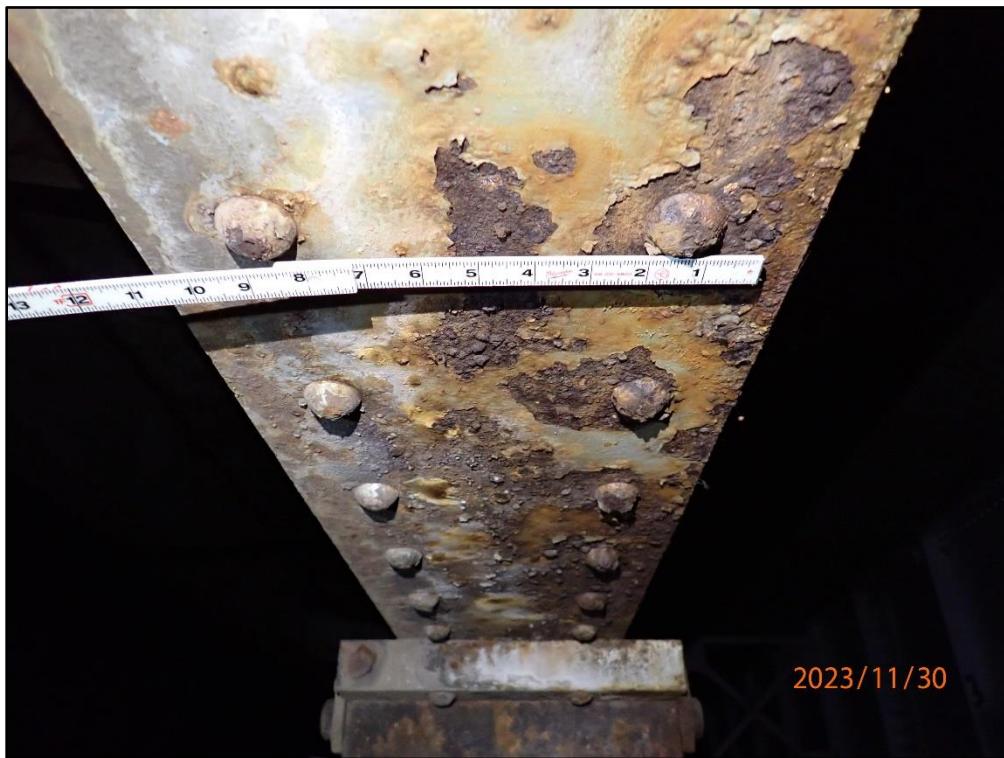
Figure 24: Typical Surface Corrosion of Interior Girder at Pier – Girder E South Face at Pier 4

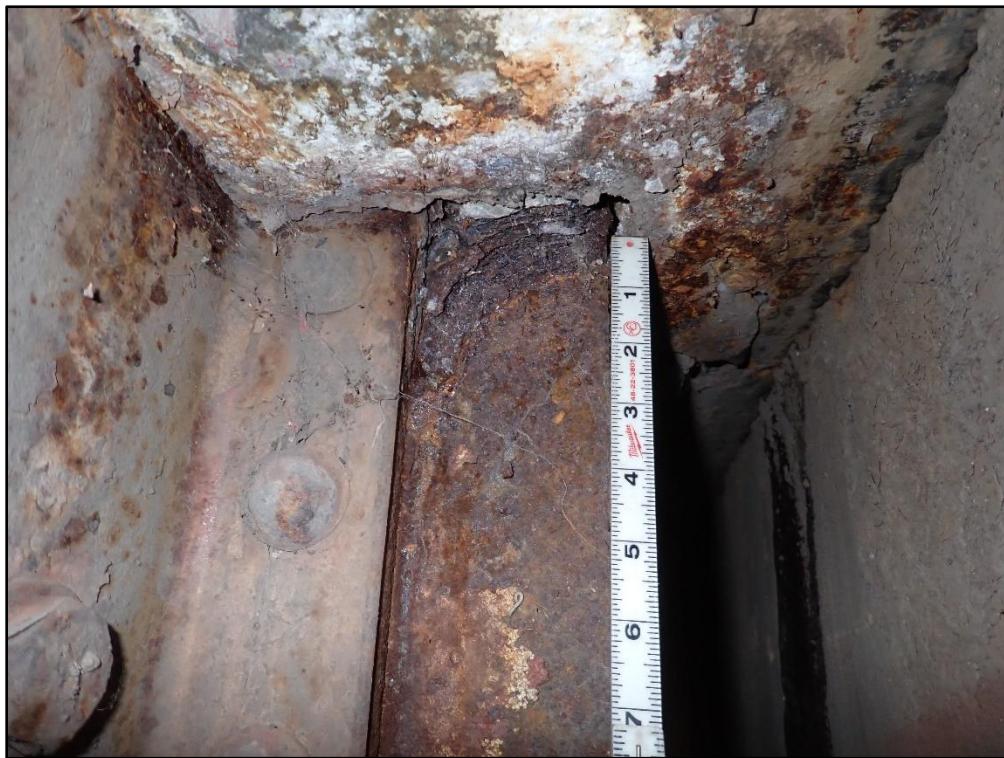
Figure 25: Surface Corrosion and Minor Pitting in Bottom of Bottom Flange of Girder E at Pier 4

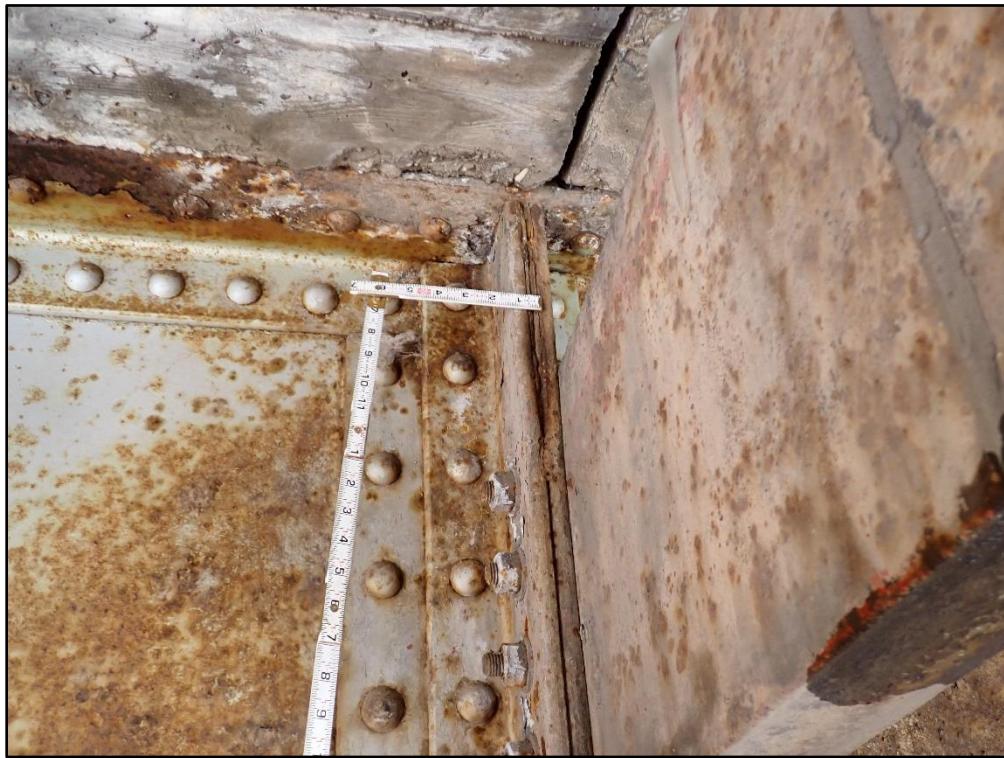
Figure 26: Laminar Corrosion of Girder E End at Abutment 6

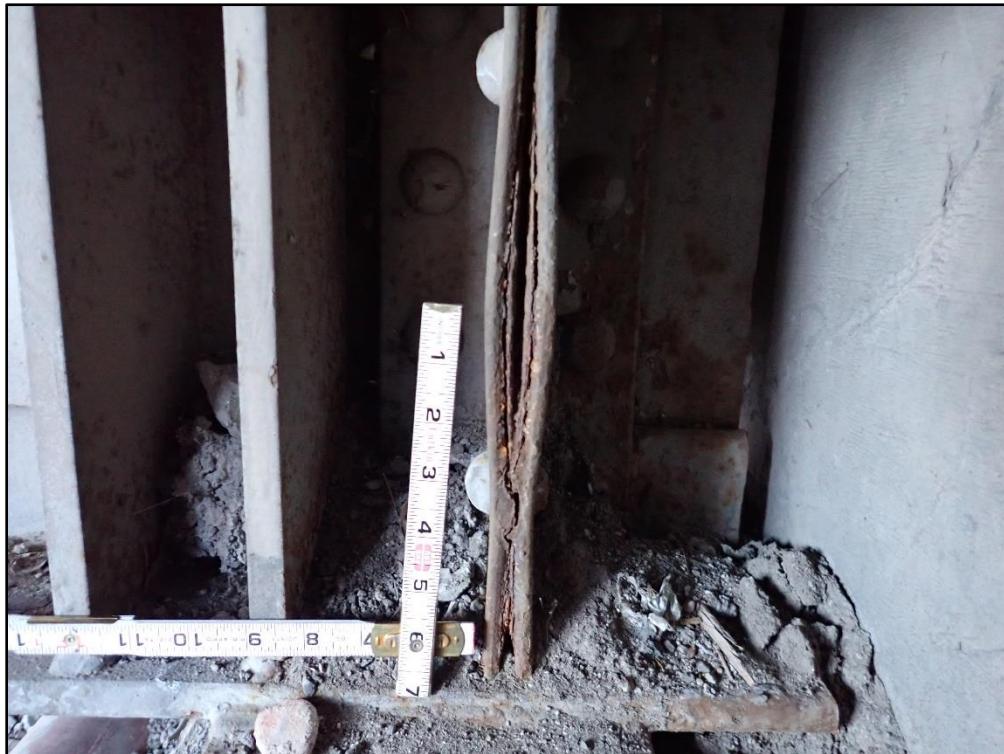
Figure 27: Typ. Pack Rust between Bearing Stiffeners of Int. Girders at Pier – Girder E S. Face at P4 – Stiffener 69

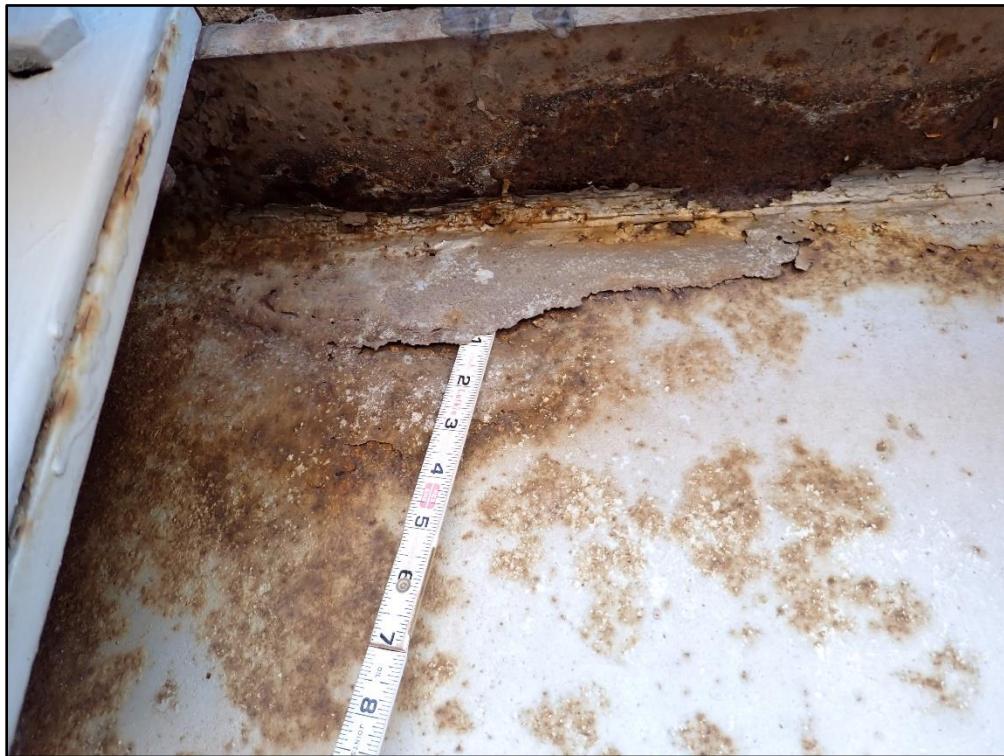
Figure 30: Laminar Corrosion in Web and Top of Bottom Flange of North Exterior Girder A

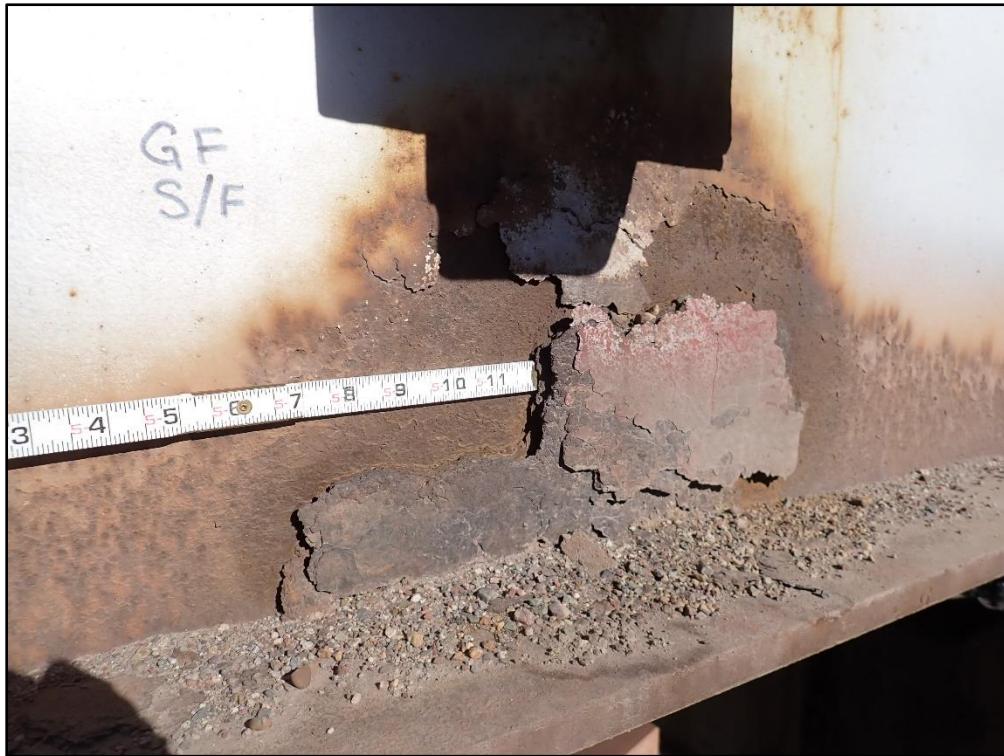
Figure 31: Laminar Corrosion in Top of Web of North Exterior Girder A

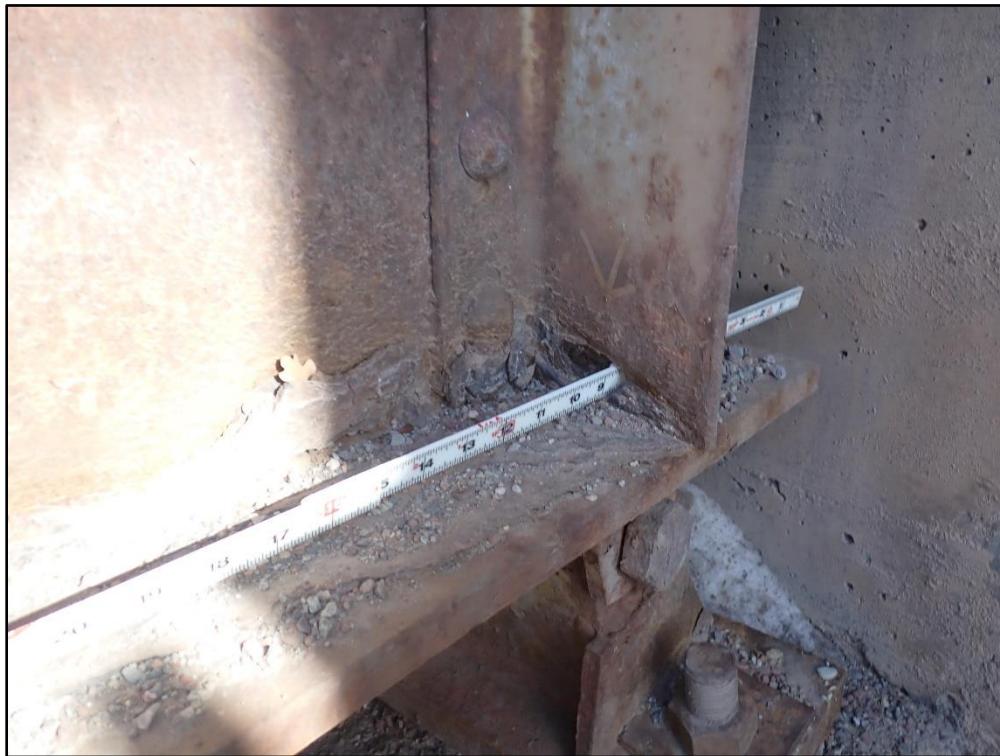
Figure 32: Laminar Corrosion in Web of South Exterior Girder F

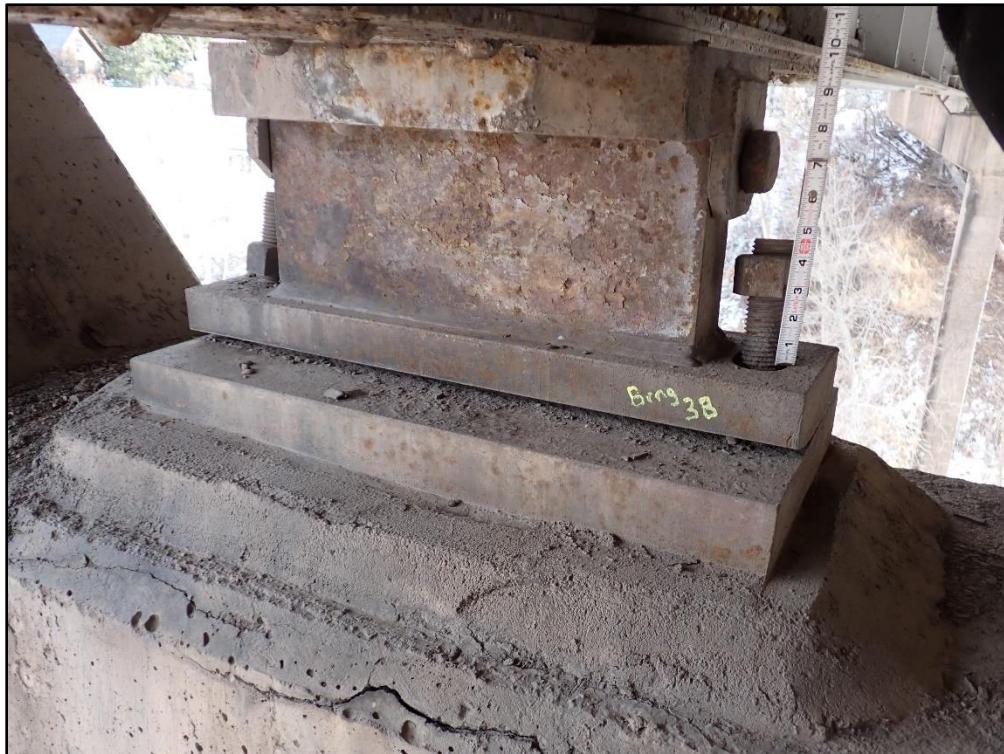
Figure 35: Typical Surface Corrosion of Bearing at Pier – Girder B at Pier 1

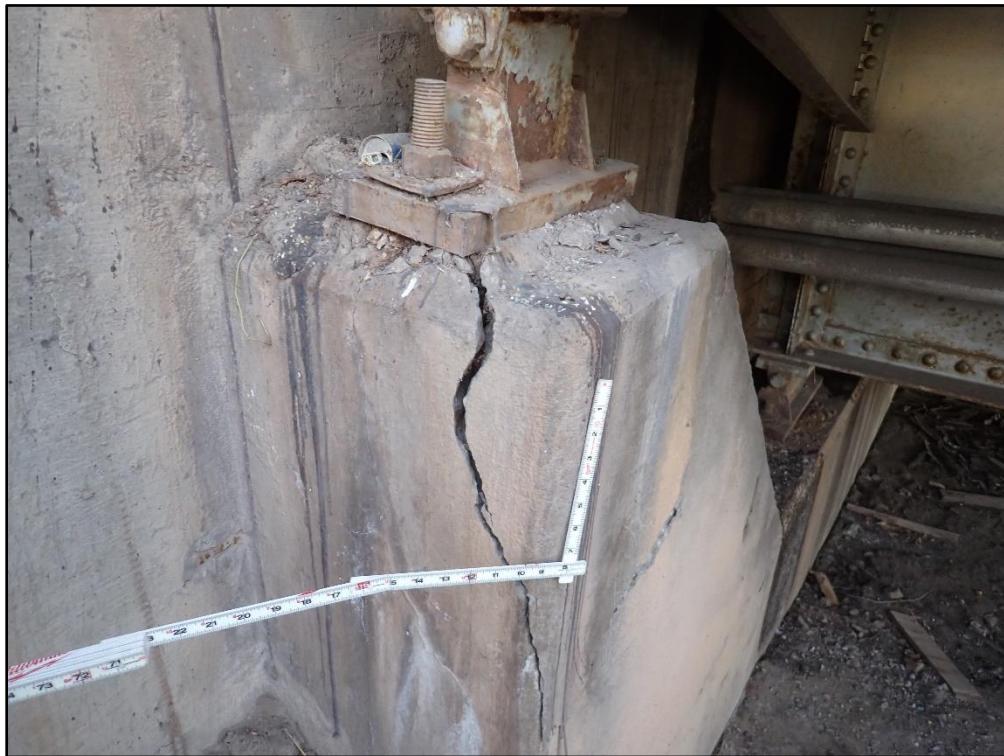
Figure 36: Typical Anchor Bolt Nut Backed Out and Missing Lock Nut – Girder B at Pier 2

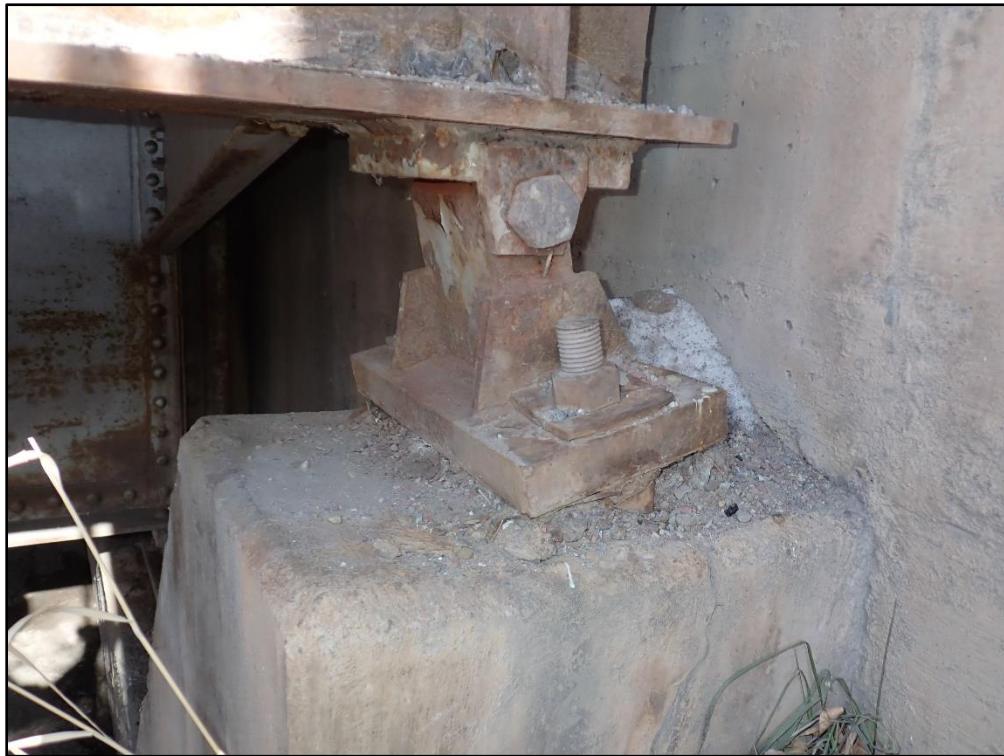
Figure 37: Impending Spall of Bearing Pedestal of Girder A at Abutment 6

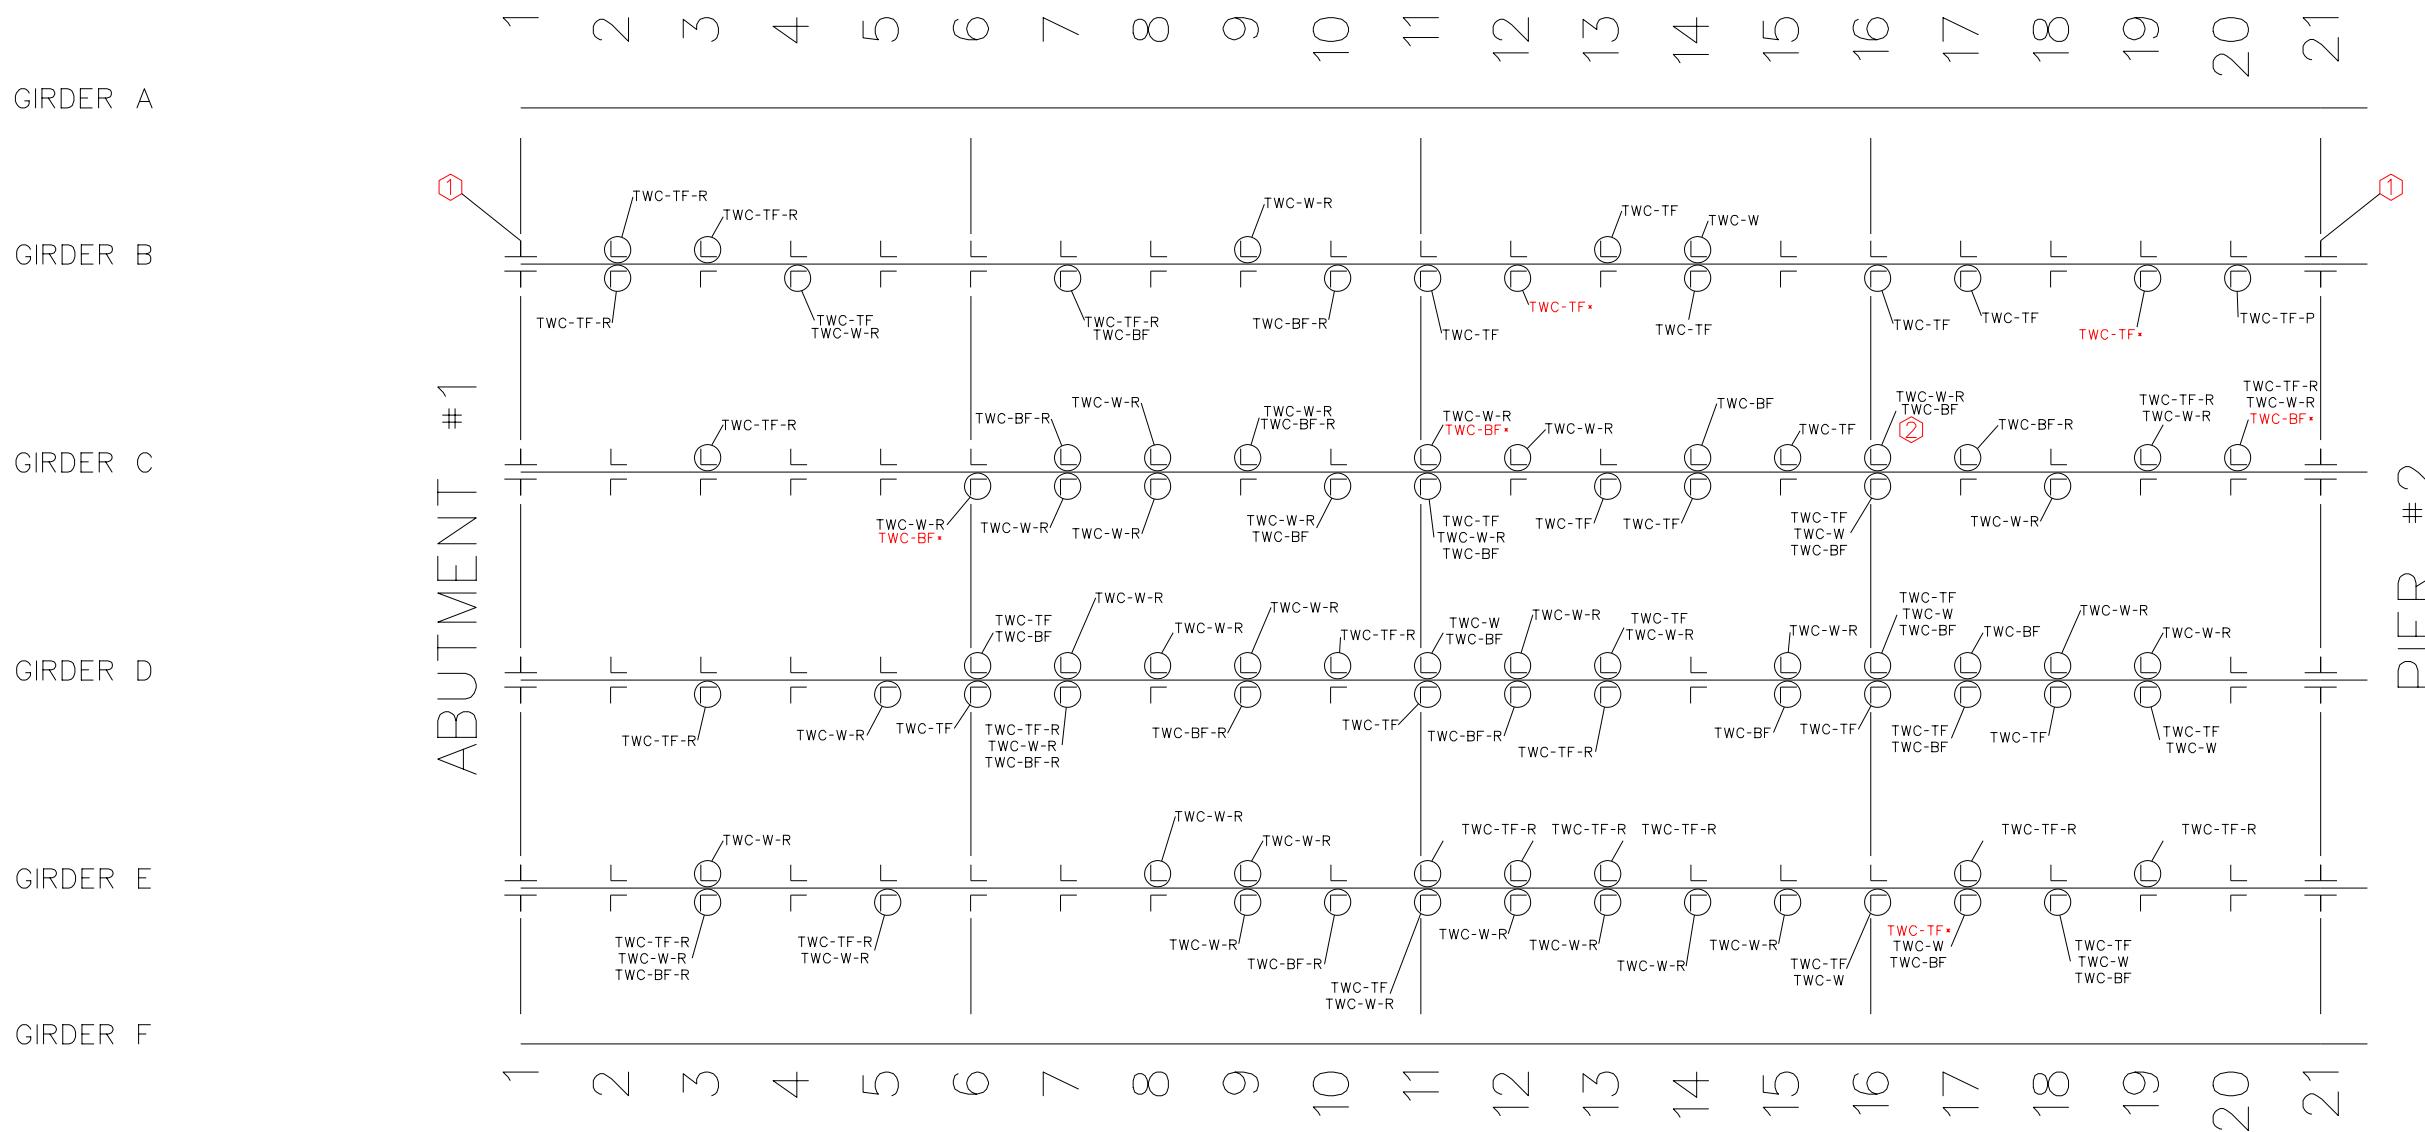
SPAN 1 (75'-0")

- ① PACK RUST BETWEEN FAYING SURFACES OF ANGLE LEGS, UP TO 1/2" THICK, TYP. AT BEARING STIFFENER LOCATIONS.
- ② CRACKED STIFFENER WELD AT BOTTOM
