SH 82 Over Castle Creek Bridge Feasibility Study
Document No: 240207140925_5d9775bf
Version: Draft

City of Aspen
Structure No. H-09-B

Castle Creek Bridge

Prepared by: Beth Tosti, Structures Lead

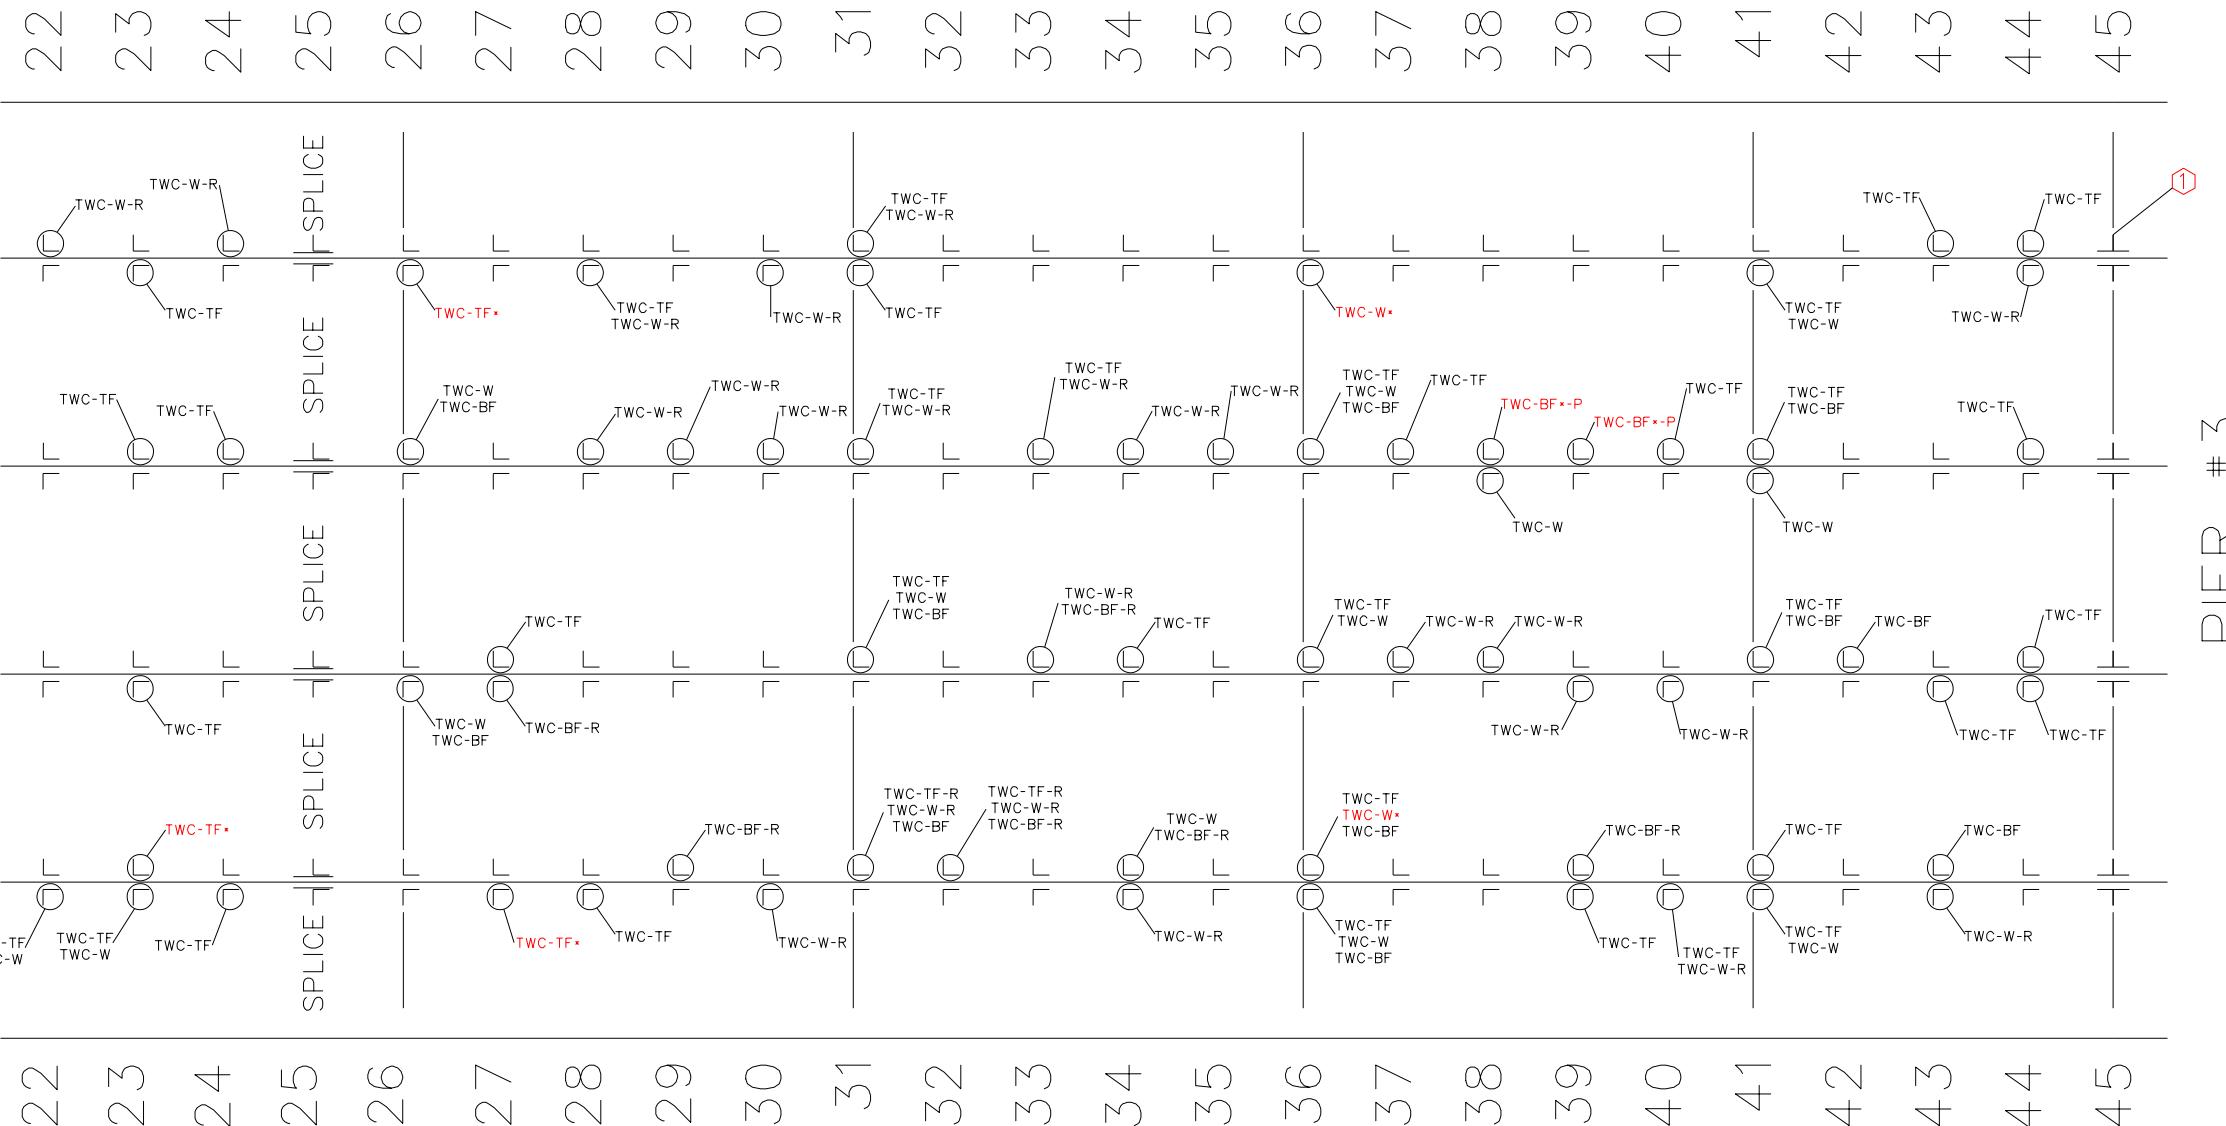
SPAN 2 (90'-0")

① PACK RUST BETWEEN FAYING SURFACES OF ANGLE LEGS, UP TO 1/2" THICK, TYP. AT BEARING STIFFENER LOCATIONS.

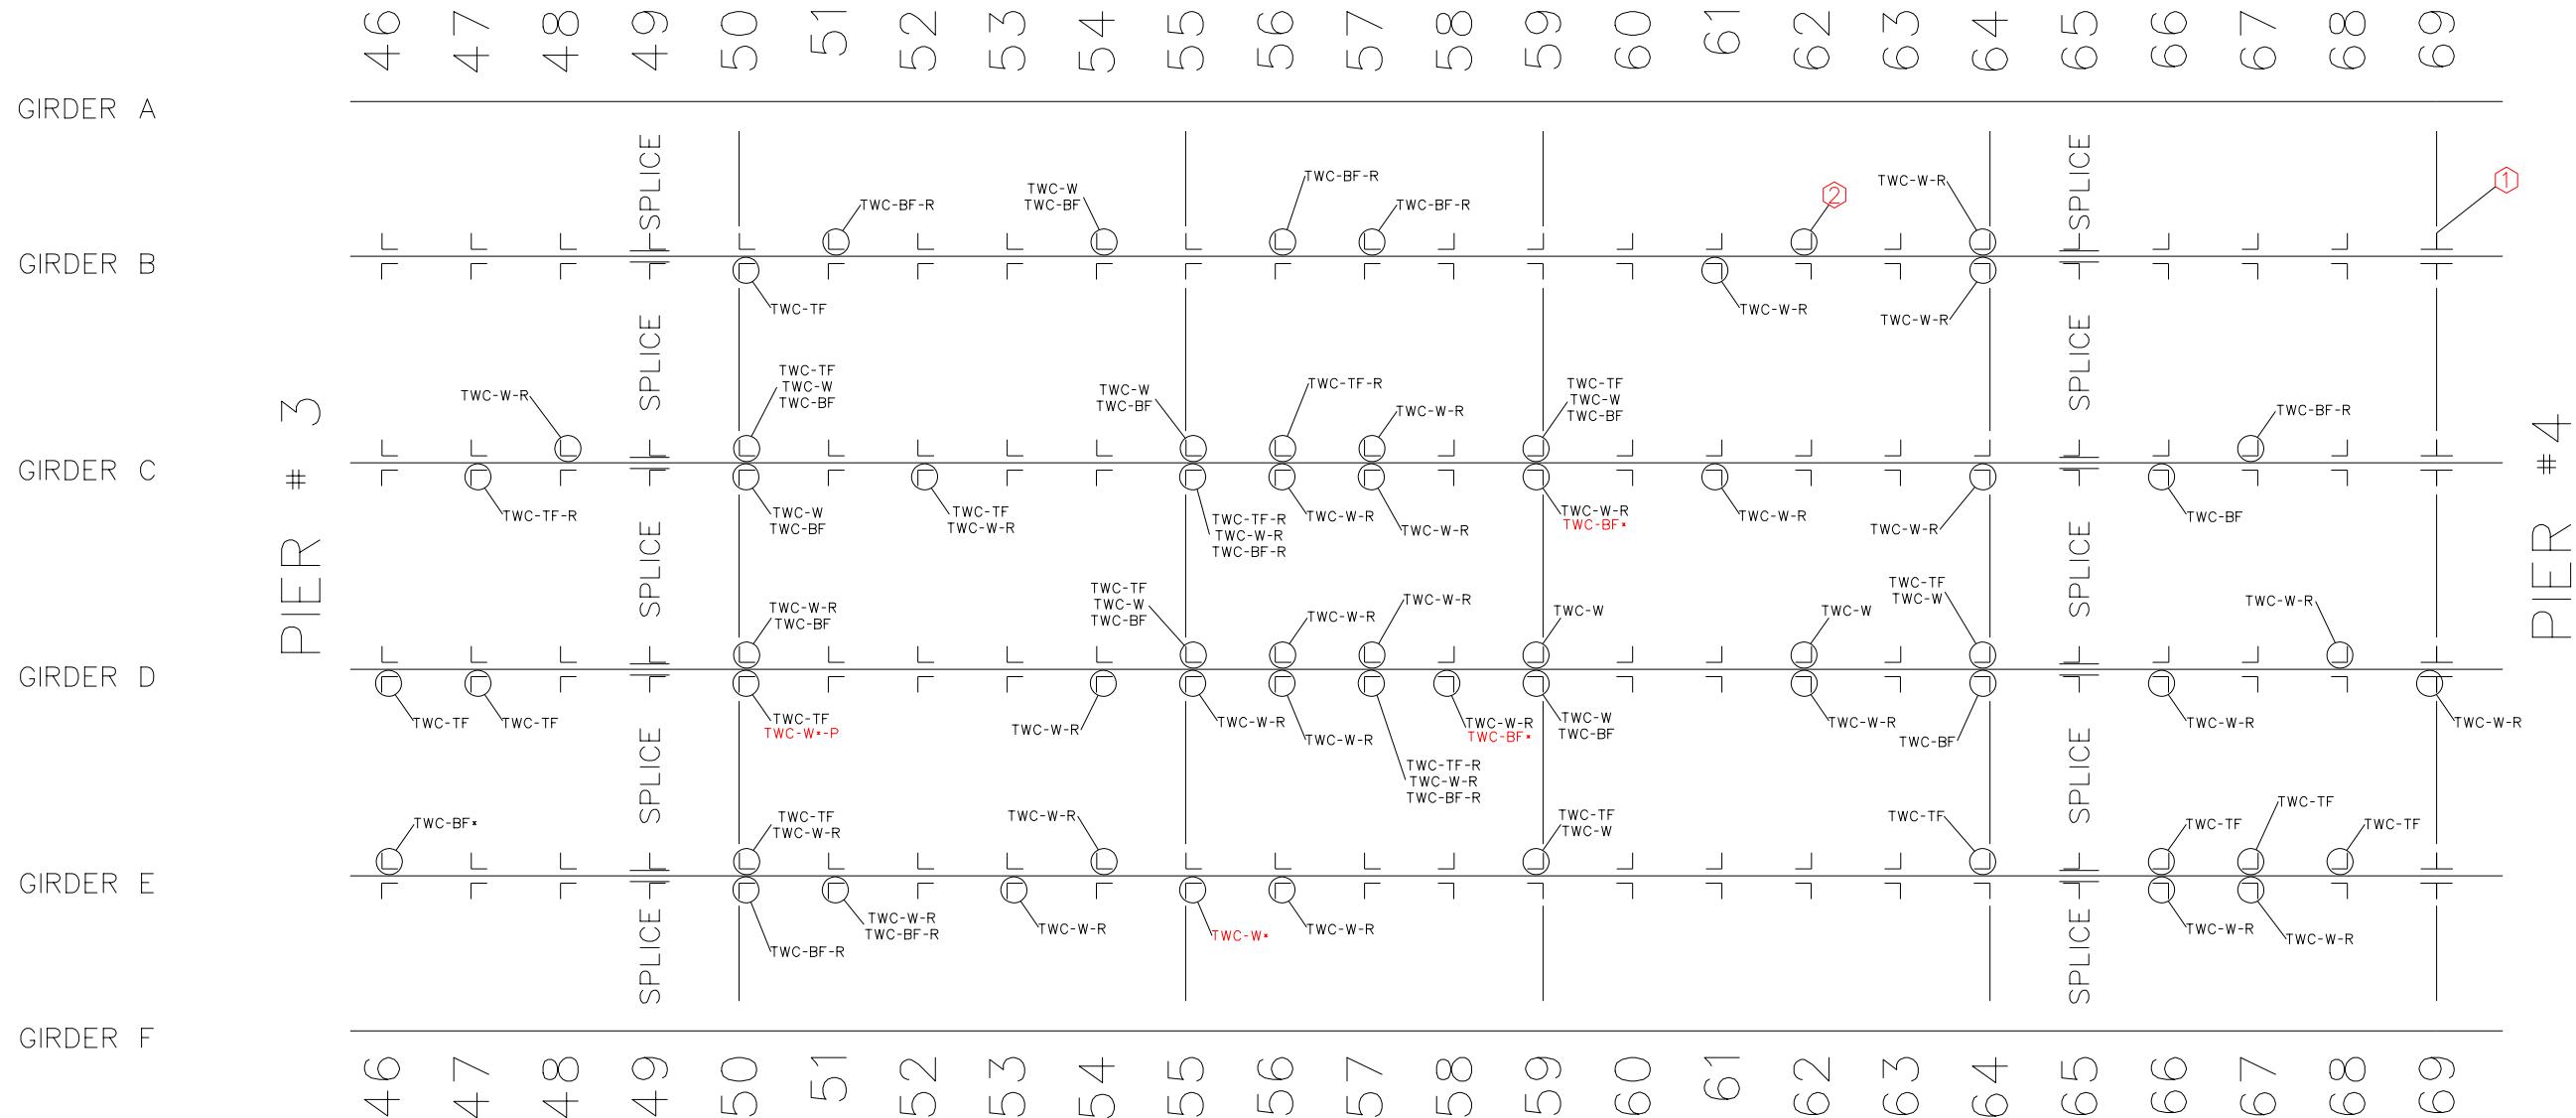
SPAN 3 (90'-0")

- ① PACK RUST BETWEEN FAYING SURFACES OF ANGLE LEGS, UP TO 1/2" THICK, TYP. AT BEARING STIFFENER LOCATIONS.
- ② STIFFENER DEFLECTED, UP TO 1" OUT OF PLANE OVER 6" HEIGHT, NEAR BOTTOM 1/3 POINT

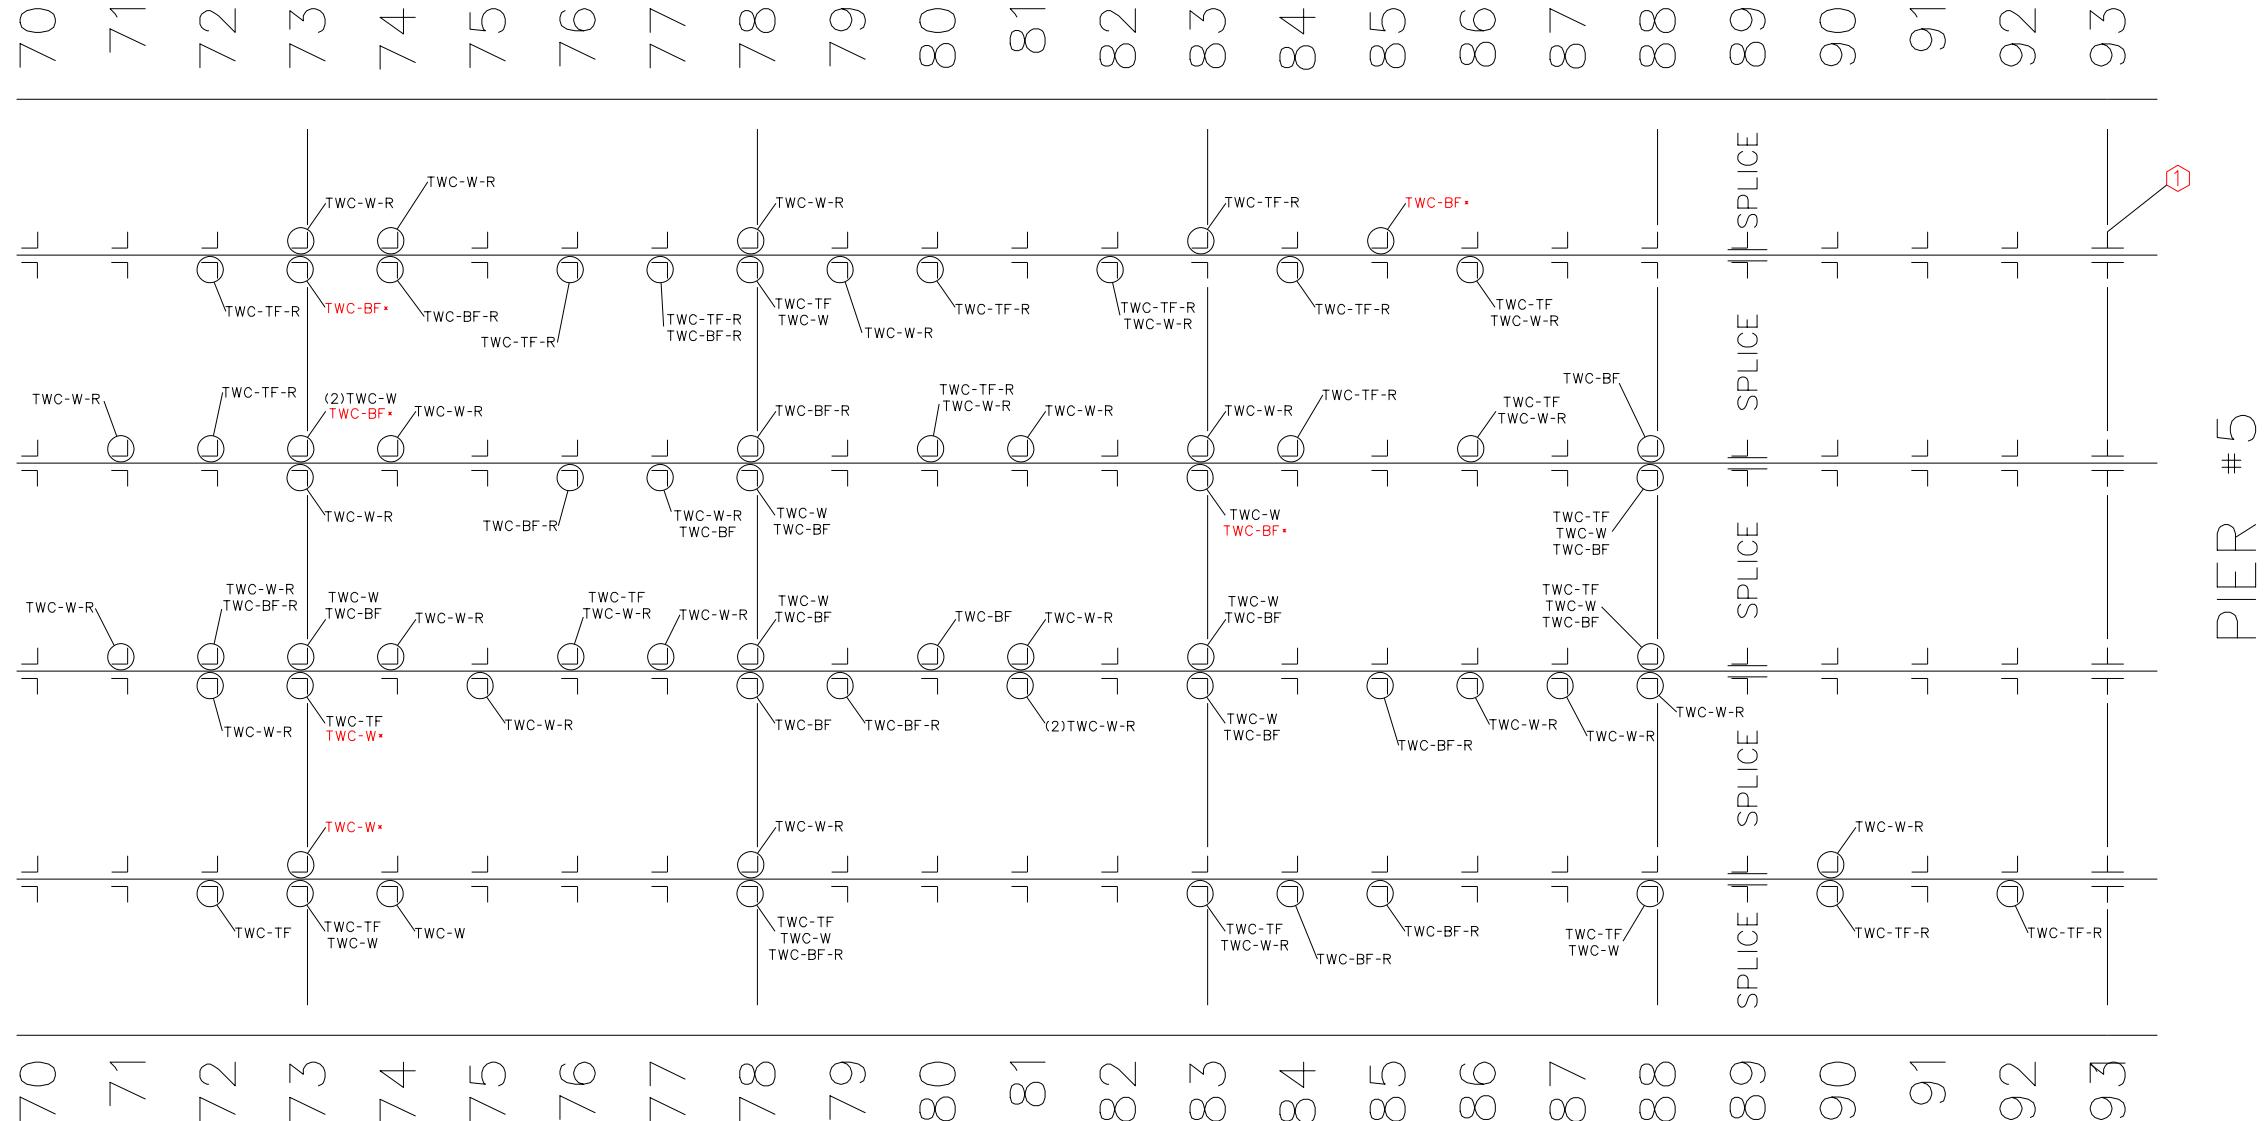
SPAN 4 (90'-0")

① PACK RUST BETWEEN FAYING SURFACES OF ANGLE LEGS, UP TO 1/2" THICK, TYP. AT BEARING STIFFENER LOCATIONS.
