Preservation Plan

ASPEN GROVE CEMETERY

Aspen, Colorado

23 November 2010
SHF Project #08-01-044

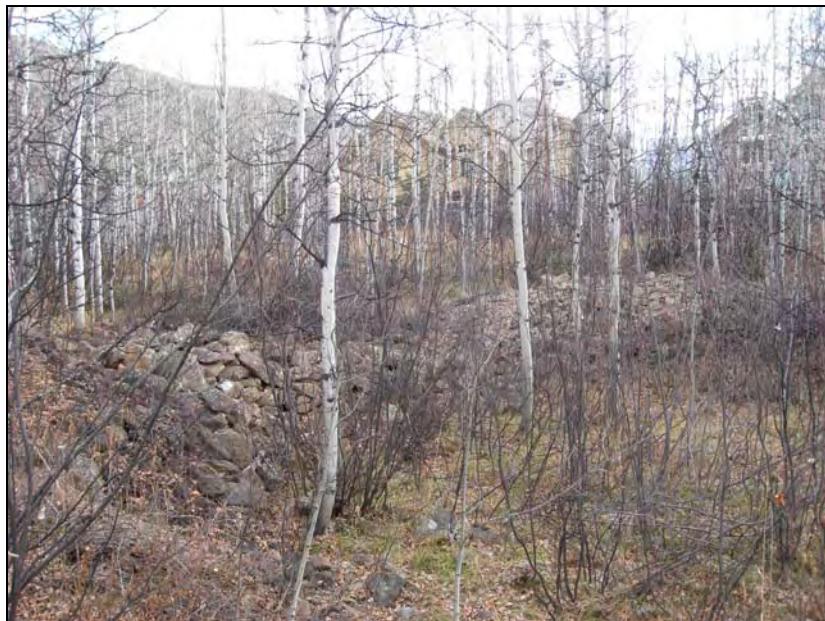
One other historic feature on the site is the small oval-shaped pond located south of the carriage circle and south road. The pond was installed when the site was developed, and it was filled with water during the cemetery's early years. Today it is dry and filled with mature trees and shrubs, indicating that the pond was abandoned long ago, probably for over a century. The center of the pond holds a very large pine tree that contains an old dilapidated treehouse. Dark granite rubble lines the pond's shores.

Granite Rubble Lining the Edge of the Pond

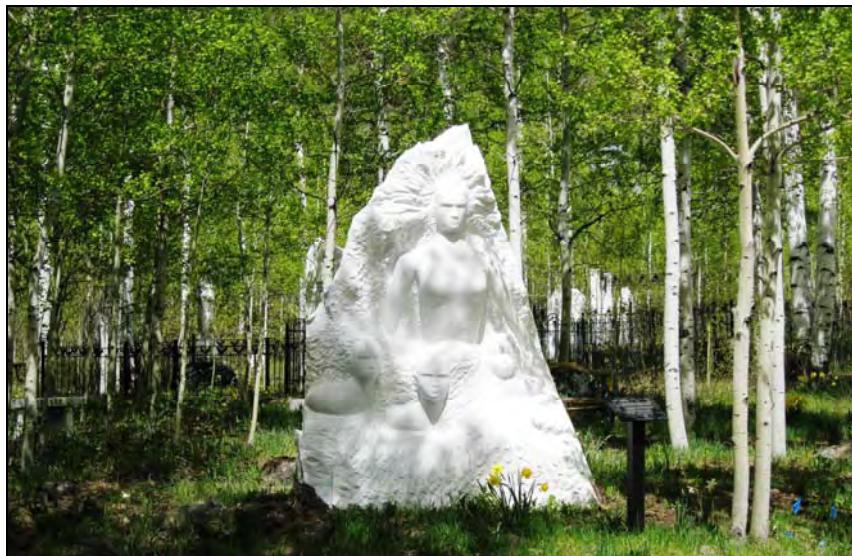
Mothers & Children Monument

The southwest corner of Block 65 contains a monumental marble sculpture that faces to the southwest. It is over eight feet tall and features a mother with three children. Installed in 2006, the sculpture is dedicated to all of the pioneer mothers and children who succumbed to the ravages of disease, the difficulties of childbirth, and the randomness of accidental death. The artwork was commissioned by the Aspen Cemetery Association and created from a block of Yule marble by sculptor Gregory Tonozzi.

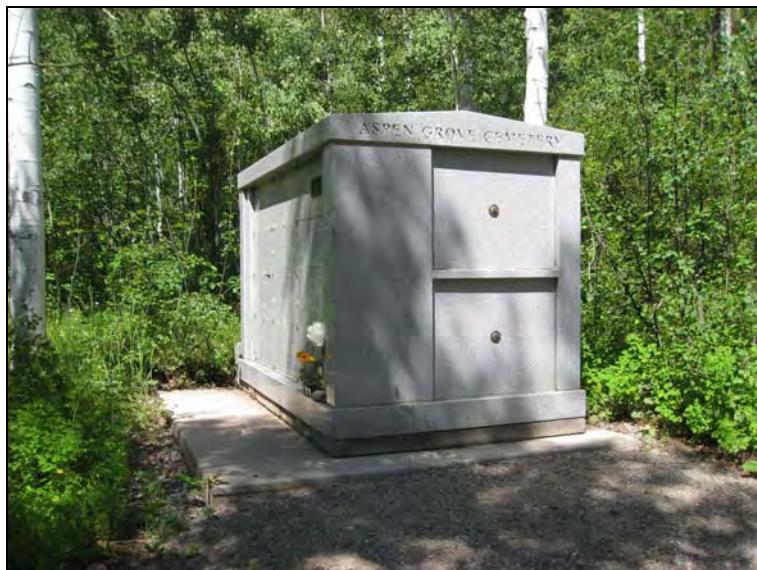
The Modern Columbarium/Mausoleum at the Site Entry

Just inside the main entry gates, along the north side of the road, is a small modern granite mausoleum/columbarium designed to hold two coffins and a number of ashes. The structure measures approximately 5' wide by 8' long by 6' high, rests upon a concrete pad, and has a gabled granite roof. Its south elevation contains two stacked coffin drawers and the west elevation holds twenty-four slots for ashes, all of which are closed with square granite panels.

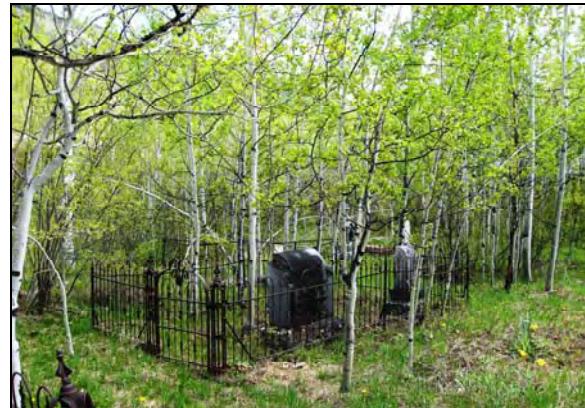
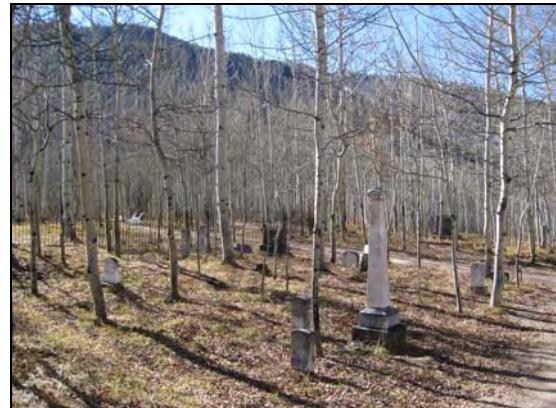
Views of the burial area, showing individual graves and family enclosures.

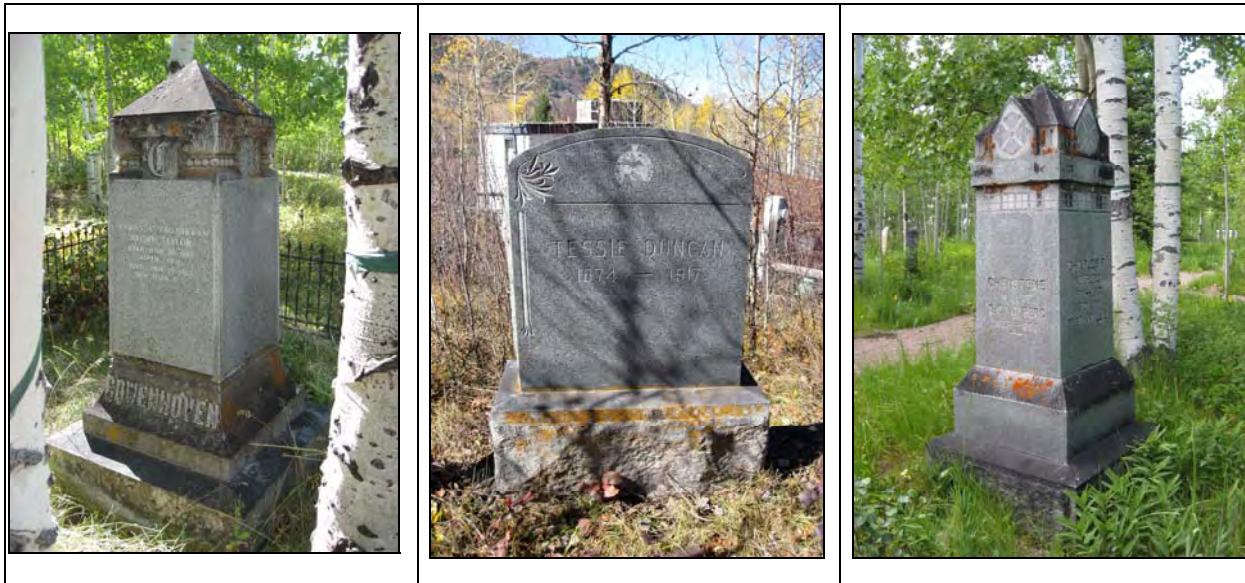
Granite is a very heavy and durable stone, weighing about 172 pounds per square foot, and typically resists many forms of possible damage. These stones, even small ones, can weigh hundreds of pounds and prove to be difficult to move, although repeated frost-thaw cycles can cause them to slide off their bases. Even if toppled, they rarely break although they can suffer from chips and scratches. Most of the scores of granite gravemarkers at Aspen Grove Cemetery are in very good condition. These range in size and complexity from small flat plaques and simple slant markers, to monumental, ornate, multi-part pedestals. All of the granite markers are likely to last for hundreds of years with little wear, and their inscriptions will remain readable for generations to come. Even so, some of these stones are more soiled, scratched or chipped than others. None were noted to be significantly damaged and in need of substantial repair.

Granite Gravemarkers at Aspen Grove Cemetery

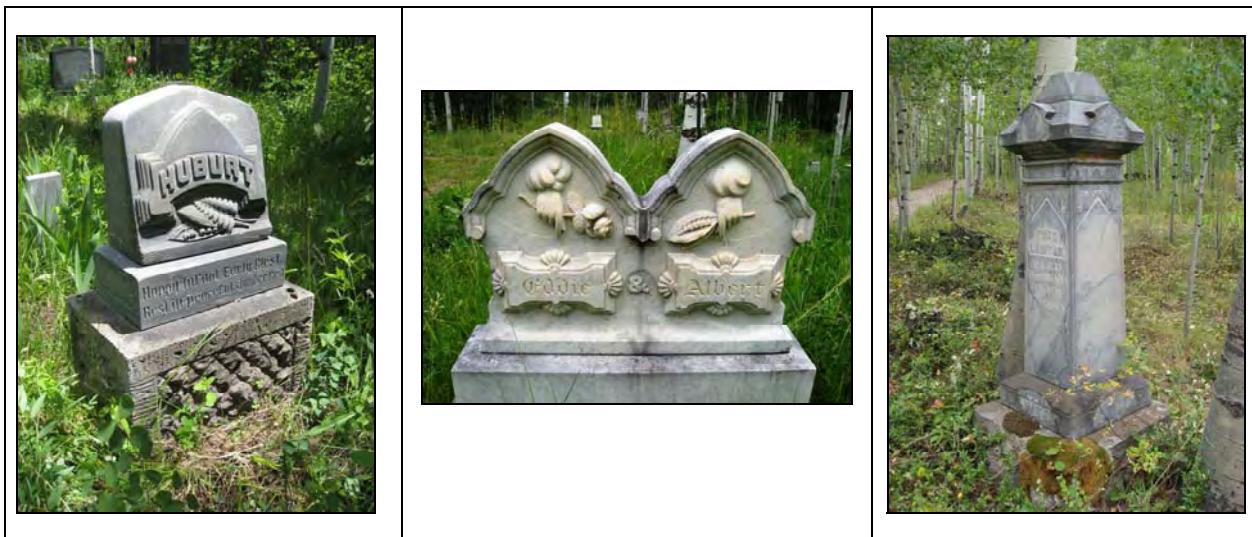
At 160 pounds per square foot, marble is softer and slightly lighter than granite. Many of these stones at Aspen Grove Cemetery exhibit simple, small, inexpensive designs that were affordable for the average family. However, because it is more malleable to the carver's chisel, marble stones can also be shaped to include fine inscriptions, an abundance of ornamental features, and even sculptural designs. Consequently, the site holds a number of more decorative marble pieces, ranging in color from pure white to dark gray. Because of marble's chemical characteristics, these gravemarkers are more susceptible than granite to physical damage from toppling or vandalism, and to environmental damage caused by several factors. Evidence of such damage is found throughout the site.

One ornate marble monument in the cemetery has suffered from a significant form of damage. This is the gravemarker in Block 53 for Minnie Livingston (see *photo on page 3*), which is missing the head from its finely carved statue of a seated woman. The head was present a number of years ago, and whether it came off through vandalism or as a result of a crack in the marble is not known. In any case, it is nowhere to be found and was probably removed from the site by someone who took it as a souvenir.

Marble Gravemarkers at Aspen Grove Cemetery

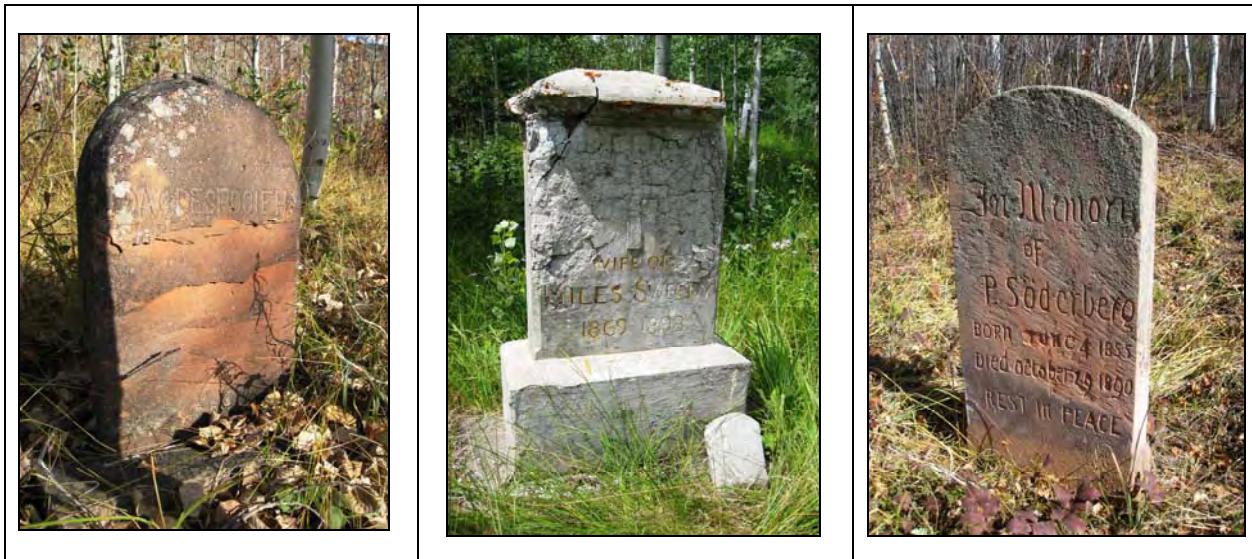
The several sandstone and concrete gravemarkers at Aspen Grove have suffered more extensively due to the nature of these softer materials when exposed to the elements. They are prone to cracking and spalling, with the resulting loss of inscriptions. While chips and scratches are typically the result of toppling, cracks and spalling are often caused by structural failures of the stone and are unavoidable. The sandstone corner blocks marking the Knights of Pythias burial area (Blocks 39 & 40) are all in exceptionally good condition. This may be because they are a different type of sandstone or are thicker than the gravemarkers.

Sandstone & Concrete Gravemarkers at Aspen Grove Cemetery

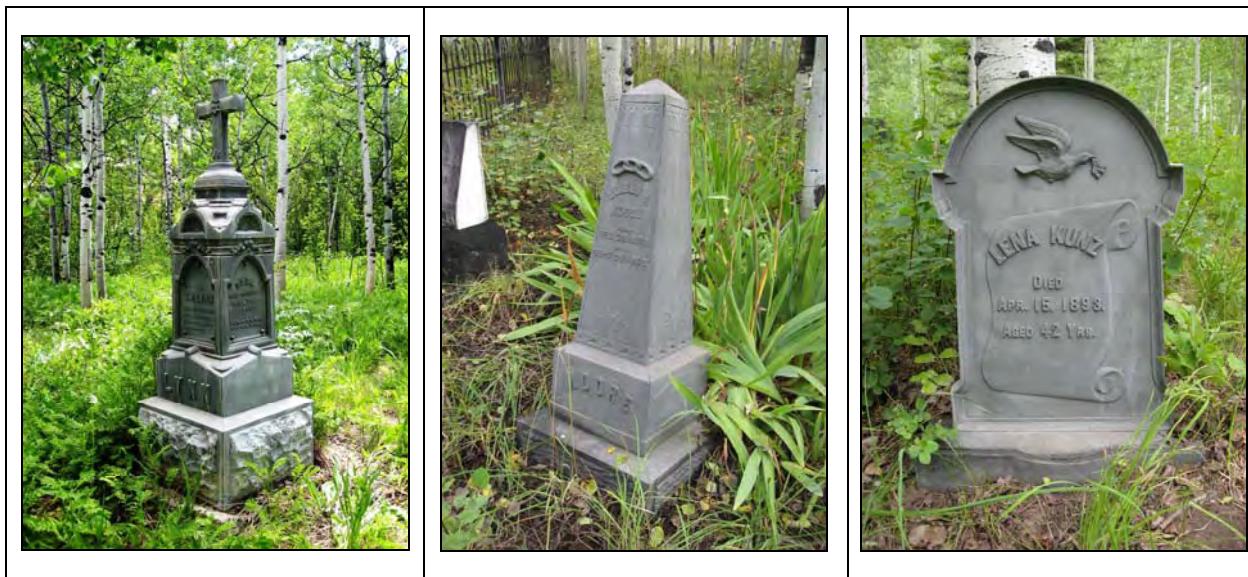
Never widely accepted by the buying public, today zinc markers are present in cemeteries in limited numbers and are seen as something of an oddity. True to their marketing claims, however, the zinc does not rust or stain, and after more than a century of exposure to the elements the monuments in Aspen Grove Cemetery are in remarkably good condition. The only problem noted is that a few of them have slightly split seams. This is unlikely to result in further deterioration that needs to be addressed.

Zinc Gravemarkers at Aspen Grove Cemetery

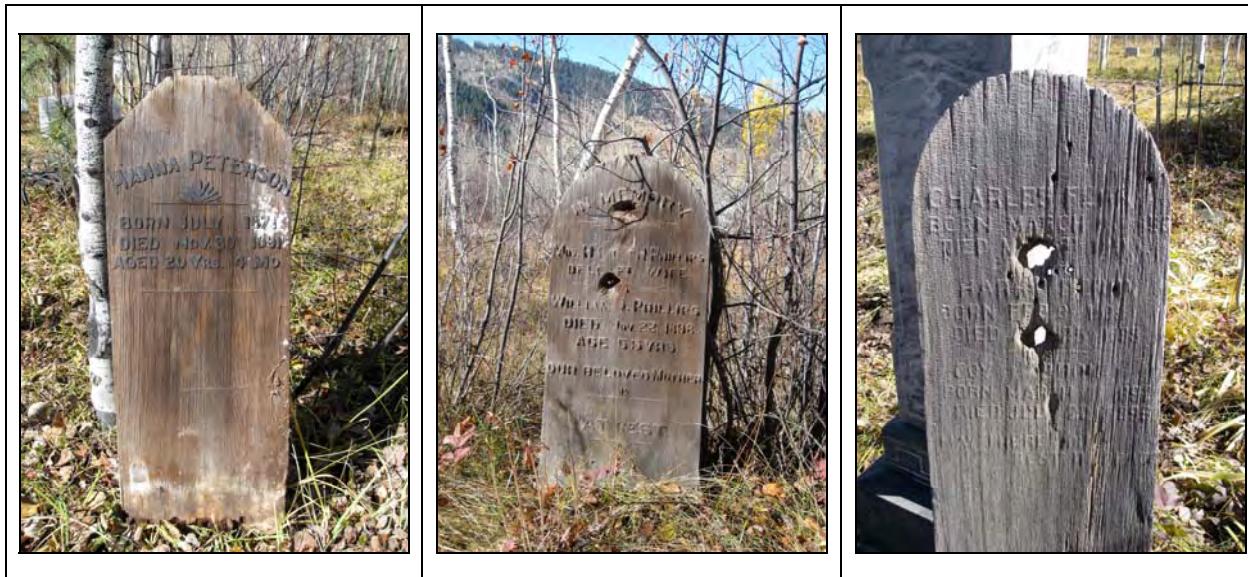
Wood Gravemarkers at Aspen Grove Cemetery

Today the cemetery holds thirty-one wood gravemarkers, all but three of which date to the period before 1900. While a number of these are intact and readable, others are more severely decayed with the inscriptions erased. All but a few are dislodged from the ground, having rotted and fallen over. Every one of the historic wood gravemarkers is in some state of deterioration, the result of moisture, biological activity, and decades of exposure to the elements. Because they are damaged and have become so fragile, these are the most threatened historic resources in the cemetery. Every attempt was made to capture the inscriptions from the wood gravemarkers at the site before they are lost forever. Much of the information was successfully

Decay is the result of fungi that damage the cellular structure of wood. This typically occurs in areas of high moisture, such as joints or connection points, exposed end grains, and where the woodwork comes into contact with the ground. The wood fibers eventually break down, causing a loss of strength and eventual failure. Evidence of this can be seen throughout the site in the form of collapsed fencing and dislodged gravemarkers. Once woodwork has failed and collapsed, it often comes into greater contact with the ground and results in additional deterioration. Lichens are also present on the woodwork, but are not a significant concern.

Among the gravemarkers, it is clear that repeated exposure to moisture has caused the greatest damage. Some of this is natural and unavoidable, resulting from precipitation in the form of rain and snow. However, natural precipitation events alternate with drying episodes. In recent years, a sprinkler irrigation system was installed at Aspen Grove Cemetery, with almost daily spraying of the site during the warmer months. This constant wetting of the site, and its wooden gravemarkers, with sprinklers has caused significant deterioration. Between 2006 and 2008 alone, it was observed that some of the inscriptions had already deteriorated to the point that

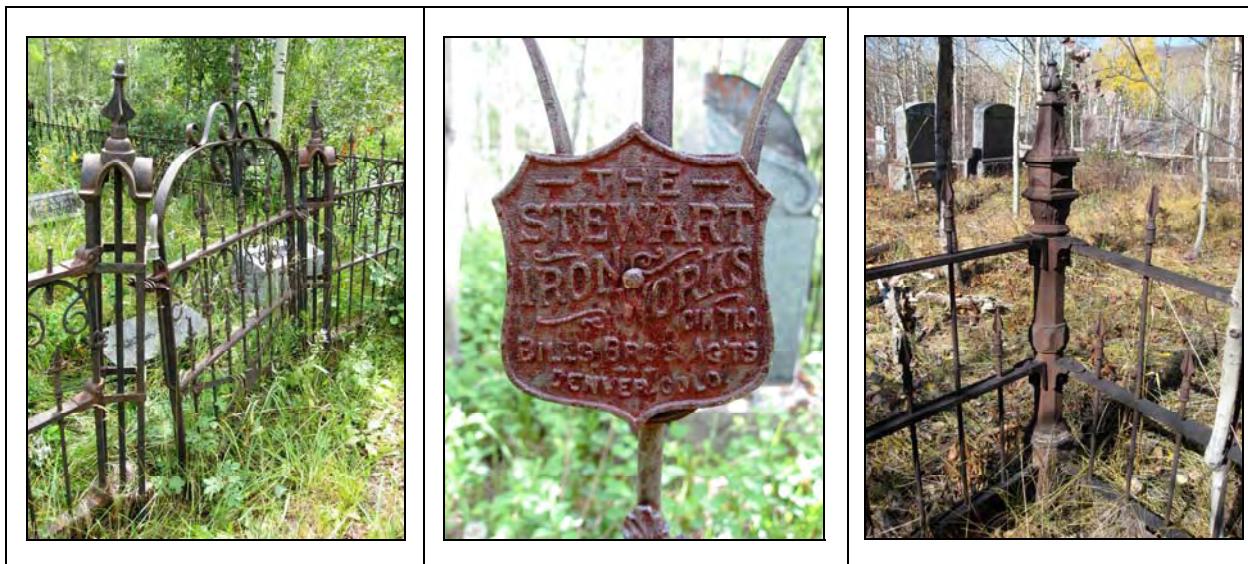
A number of individual and family plots are surrounded by metal fencing or stone coping (sometimes a combination of both). These run along the perimeters of the gravesites, clearly marking their boundaries. The photograph on the cover of this report shows a good example of a combination of these materials applied to the Cowenhoven family plot in Block 25. In the several cases where sandstone coping was employed, masons provided shaped blocks that were often ornamented with scoring and stippling. Some graves, including unidentified ones with no headstones, are lined with rough pieces of granite or even bricks (a few are entirely covered with mounds of granite). Most of the coping stones throughout the cemetery were laid one course high, with just one instance (Cowenhoven) of a low wall being formed by three courses. Due to sinking and the abundant growth of vegetation on the site, many of the coping stones are disappearing from sight.

Metal Fencing at Aspen Grove Cemetery

Ohio, and many examples of their work are found in the cemetery. This company remains in business today, and historic profile fences remain in their current catalog of available products. The metalwork at Aspen Grove Cemetery is predominantly in very good condition, with little rust or damage noted. A few gates are missing, and a small number of fences have bent sections. Most of the bent metalwork appears to have been caused by falling trees. One enclosure, located in the southeast area of the site just east of the intersection of the south and east roads, may have been hit by a vehicle. This appears to be one of the few fences that could use some preservation attention.

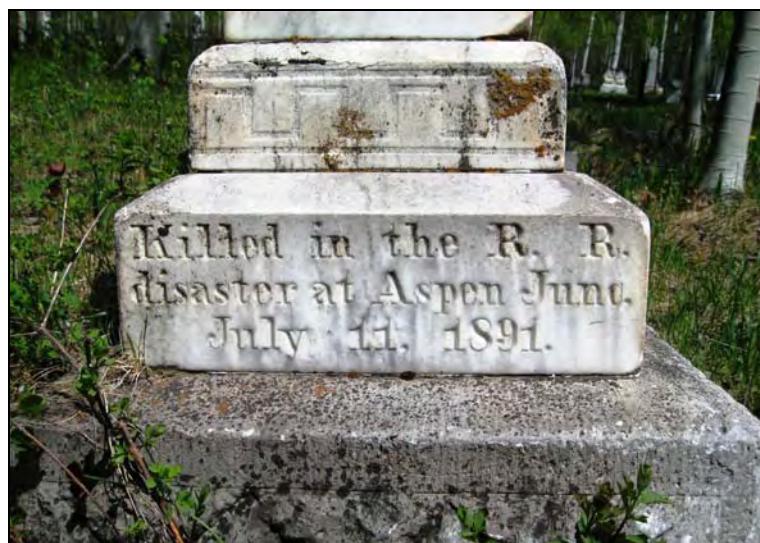
All of the inscriptions but one are in English, with the single exception being a phrase in German. Circumstances of death are absent from almost all of the gravemarkers. The single exception is the monument for the Ellis family in Block 43. In this case, the husband, wife and their infant child all died in a horrific railroad disaster at Aspen Junction on 11 July 1891.

Ellis Family Marker with Reference to the Railroad Disaster.

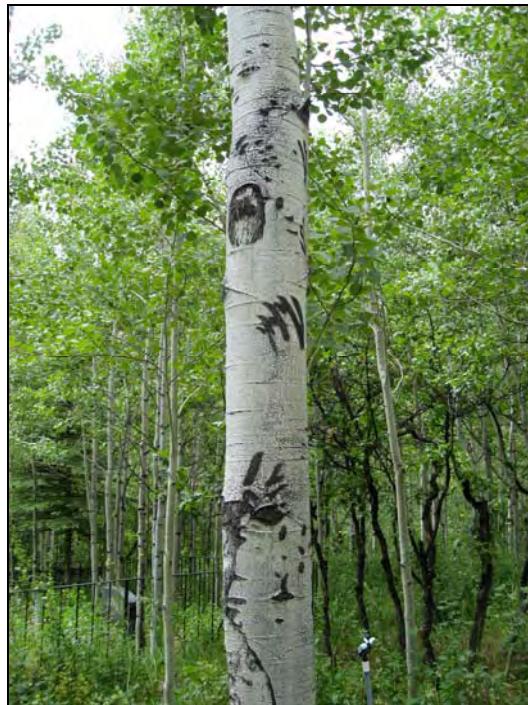
Evidence of environmental impact to cultural resources is found in varied characteristics of the site. For example, woodwork has deteriorated due to exposure to sunlight and moisture. Falling trees have damaged historic fences around some of the graves. Many of the granite and marble stones are darkened by sap and windblown soil. Some gravemarkers are likely to have been toppled by bears using them as scratching posts. Many of the stone and wood

Bear Claw Marks on an Aspen Tree in the Cemetery

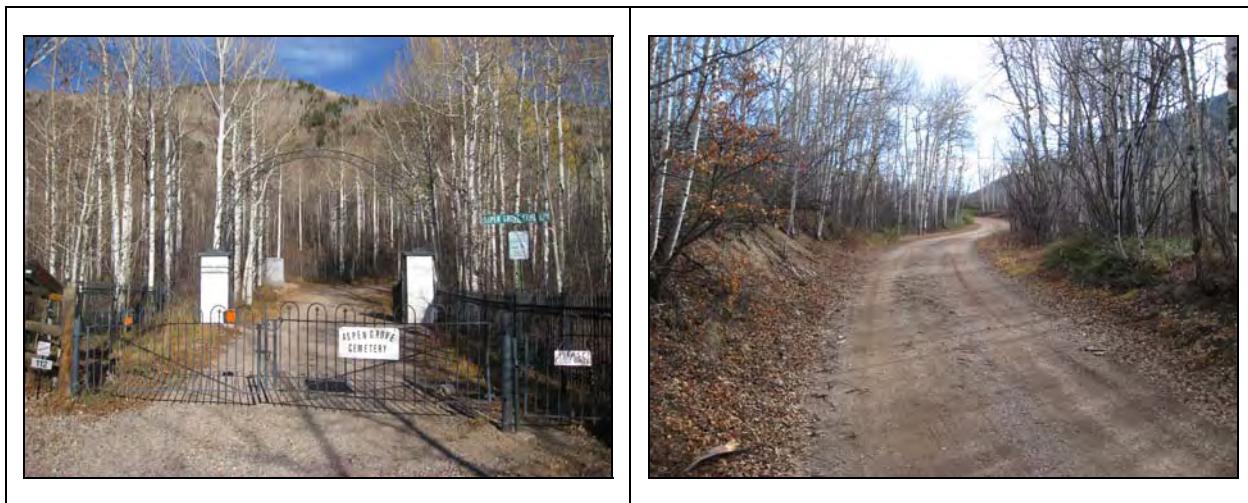
Site Approach & Entry: Aspen Grove Cemetery is accessed from Highway 82 and McSkimming Rd. No signage of any kind identifies the exit off the highway or notifies passers-by that the burial ground is in the vicinity. Those who seek to visit the cemetery will have some difficulty locating it by chance without getting directions. Even if they do find out where the site is located, there is no signage until the cemetery entrance is reached. If the intent is to keep the cemetery relatively secret, the lack of signage is an effective means to do so. Determined travelers with Internet skills and no fear of asking for directions will do their research and find a way to visit the site. Others who might be interested will fly by on Highway 82 and skip the site altogether. It is recommended that a sign pointing visitors to the cemetery be placed at Highway 82 and McSkimming Road. This could be similar to the nearby sign, a short distance to the west, which notifies travelers of the turnoff to the Smuggler Mine.

The Gateway and Entry Road

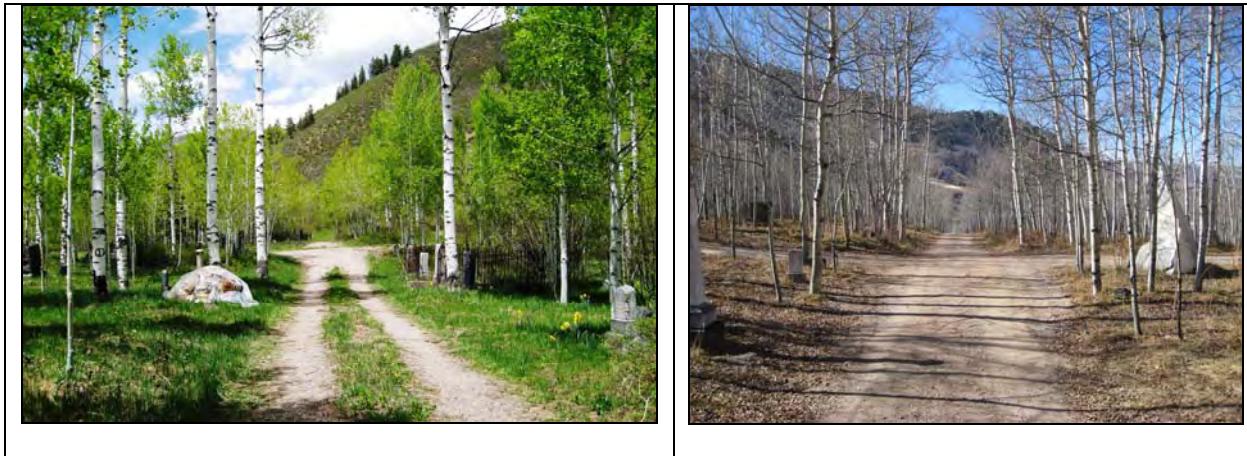
Parking & Circulation: Parking at the cemetery currently takes place along the interior roadways within the burial area. There is no room for parking at the main entry gate or along the entry road. Although the interior roads are unpaved and narrow, the very small number of vehicles that enter the site on any given day can easily be accommodated. Vehicles parked on the central loop road will block circulation through the site. However, they can pull out of the way as needed onto the secondary roads in the northern area of the cemetery. As long as visitation to the site is not greatly increased, this system serves the cemetery adequately and no recommendations are made for additional parking spaces or related improvements.

Interior Roads in the Burial Area

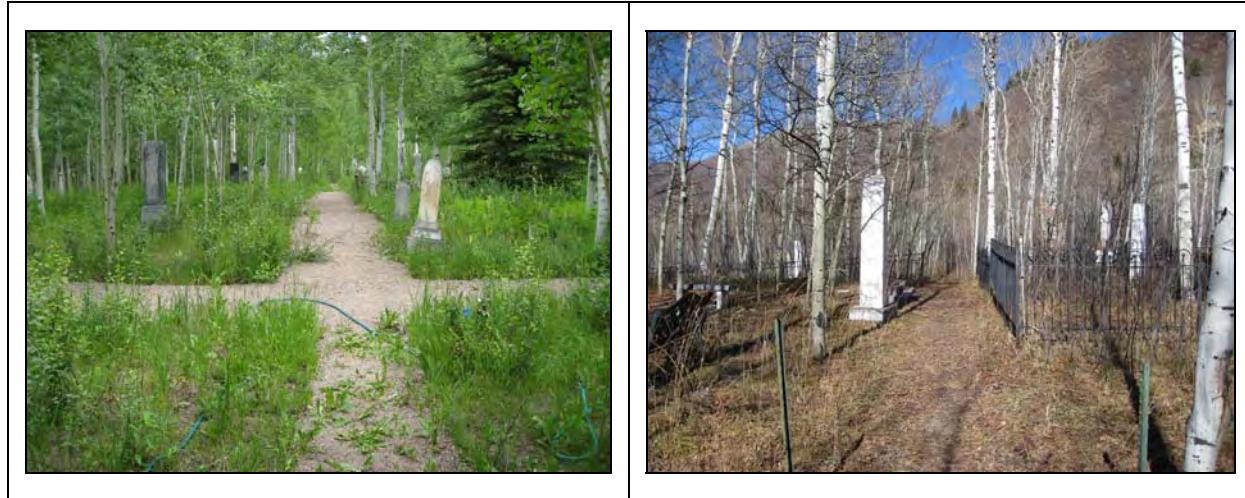
Pedestrian circulation through the site takes place both along the internal roadways as well as along the system of paths that run between the burial blocks. The paths in the south-central area of the site have been improved in recent years with crusher fines. Throughout the rest of the cemetery, the pathways are covered with grasses. Some are difficult to discern in areas where the shrubs have grown in thickets. As described above, some of the paths have also become misaligned over the years. It is recommended that, where possible, the pathways be opened and realigned to match their original locations. This is particularly important in areas where burials are known to be present. However, no realignment should be completed where it will impact graves or other historic cultural resources on the site.

Pedestrian Pathways Between the Burial Blocks

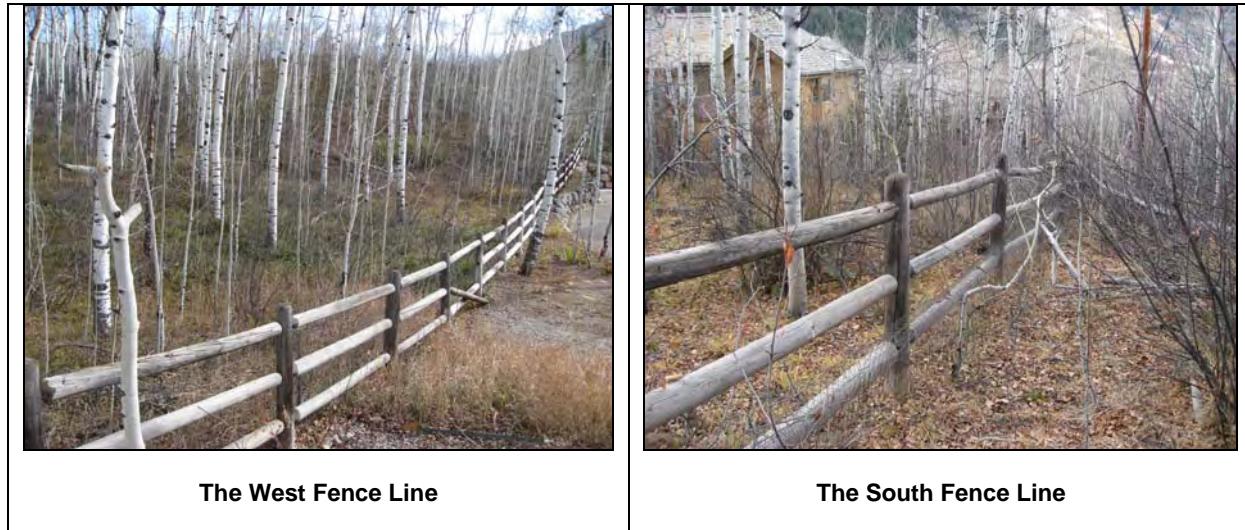
Perimeter Fencing: The cemetery's perimeter is marked by a modern wood post and rail fence that is suffering from some deterioration. While perimeter fencing won't completely stop vandalism or theft, it is an important element in defining boundaries and protecting the spatial integrity of the site from encroachment. This is particularly critical with the cemetery surrounded by residences that could otherwise quietly add ground to their yards. In addition, the simple presence of an intact perimeter fence with limited entry enhances the appearance that the property is being watched over and maintained. The perimeter fence is important for these reasons alone, and its maintenance in the coming years is its only concern. Some effort needs to be made to fix the fence in the near future, as some of its horizontal rails have deteriorated and failed. Although the cemetery is known to have been fenced when it was established, the style of that fence is no longer known. Consequently, the fence that is currently located there is adequate for its purpose, and no attempt to replicate a historic fence is necessary.

Perimeter Fencing at the Site

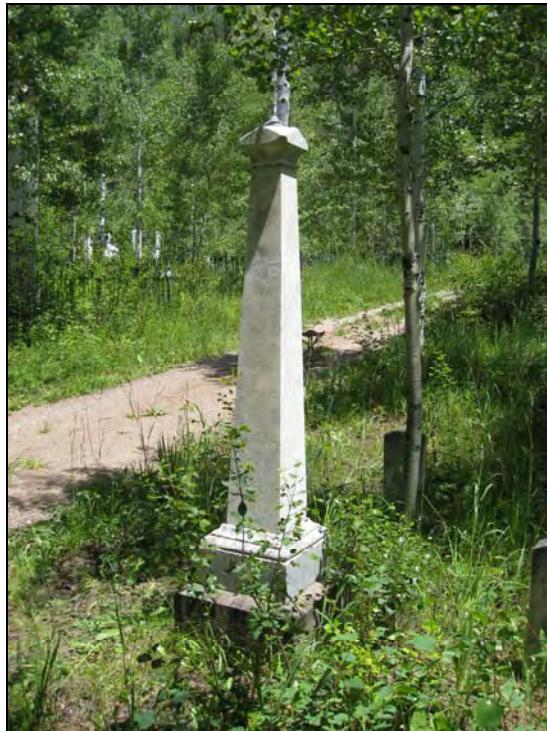
**Recent repair to one of the cemetery's gravemarkers.
(The obelisk's shaft was broken about 1/3 of the way down from the top.)**
