# City of Aspen

## Historic Preservation Design Guidelines

# Historic Preservation Design Guidelines

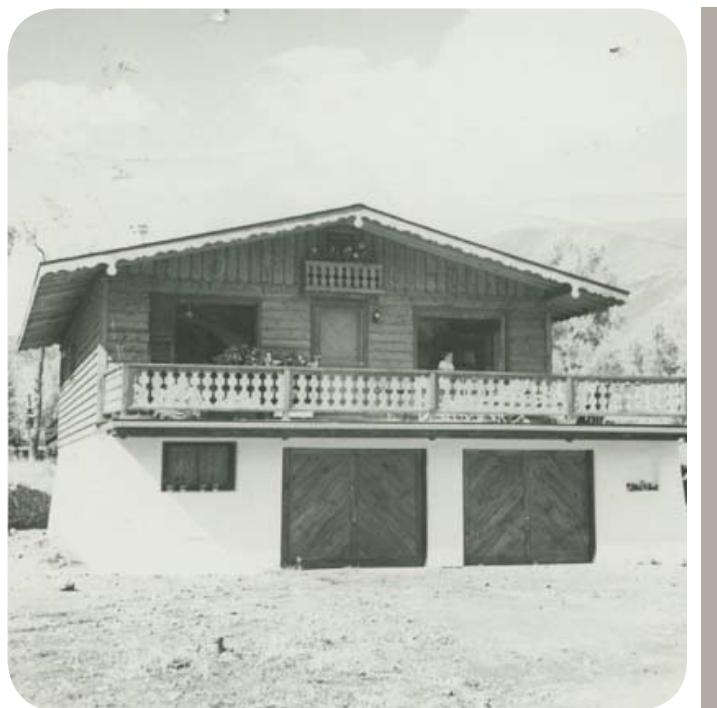
Mountain Chalet Style at 312 W. Hyman, constructed in 1956.

- Large, singular roof form, generally low in slope.
- Deep overhangs with the structure of the roof expressed on the underside.
- Eaves and rakes decorated with cutouts and fretwork bargeboards.
- Continuous porch or balcony running the length of the primary side.
- Decorative elements such as balustrades with cut out shapes (hearts, edelweiss, snowflakes, nature theme).
- Rectangular footprint.
- Stucco ground floor with minimal openings and wood lintels.
- Slider and casement windows, horizontally proportioned and used sparingly.
- Decorative shutters or flowerboxes.
- Colors are restricted to white for the stucco base and dark brown wood walls, eaves, and balustrades. Bright colors are used sparingly for accents and decorative elements.

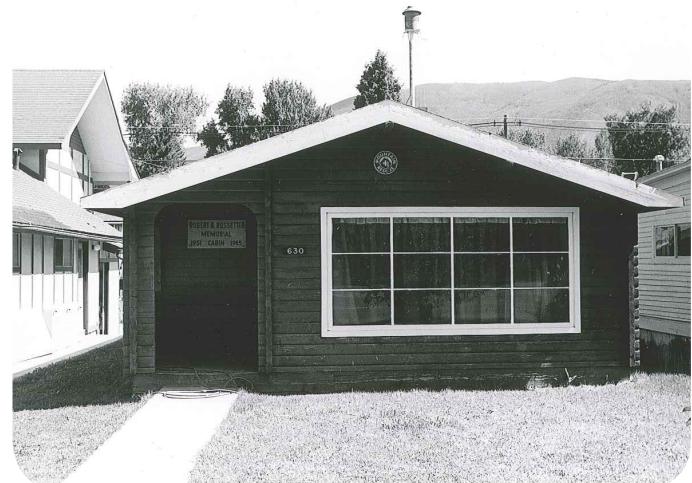
A Pan Abode located at 630 W. Main, constructed 1965.

- Tongue and groove cedar log construction.
- Overlapping notches at corners.
- Wood framed, multi-light picture window.
- Low-pitched roof, usually gabled but occasionally shed.
- Deep overhanging eaves.
- Recessed entrance with rounded or squared corners.
- Natural, stained wood.
- Simple, rectilinear footprint usually one story.

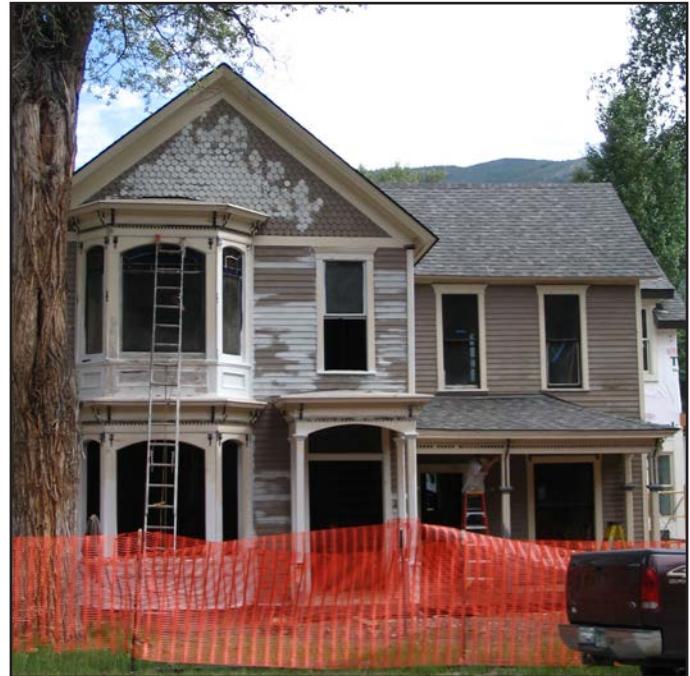
Repair of historic siding in preparation for new paint.

- Once the non-historic siding is removed, repair the original, underlying material.

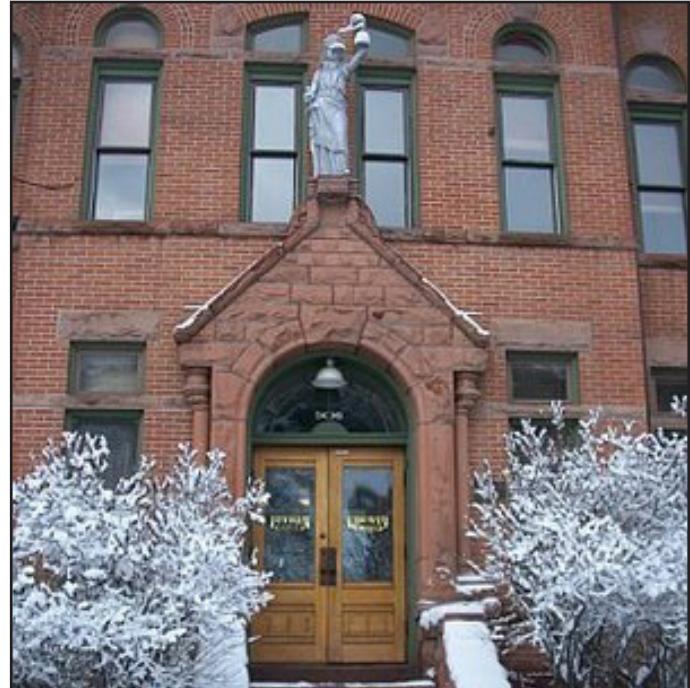
Monitor the condition of horizontal surfaces that collect snow and water.

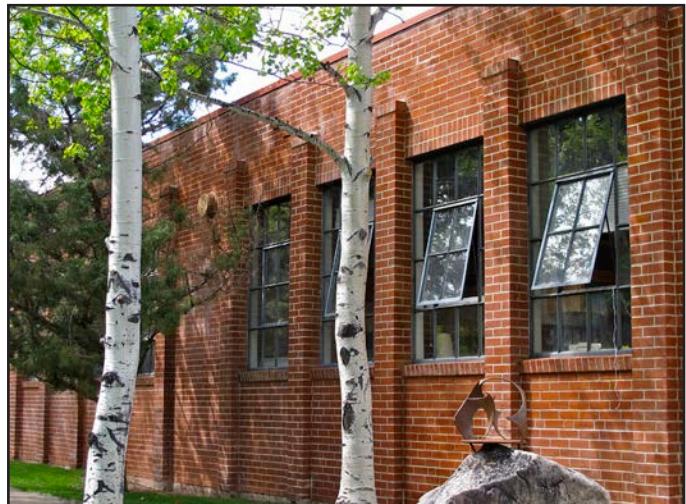
Casement windows.

- Casement - Hinged windows that swing open typically to the outside.
- Double Hung - Two sash elements, one above the other; both upper and lower sashes slide within tracks on the window jambs.
- Single Hung - Two sash elements, one above the other; only the lower sash moves.
- Fixed - The sash does not move.
- Mitered - Also called butt glazed windows, two windows joined together create a 90 degree corner.

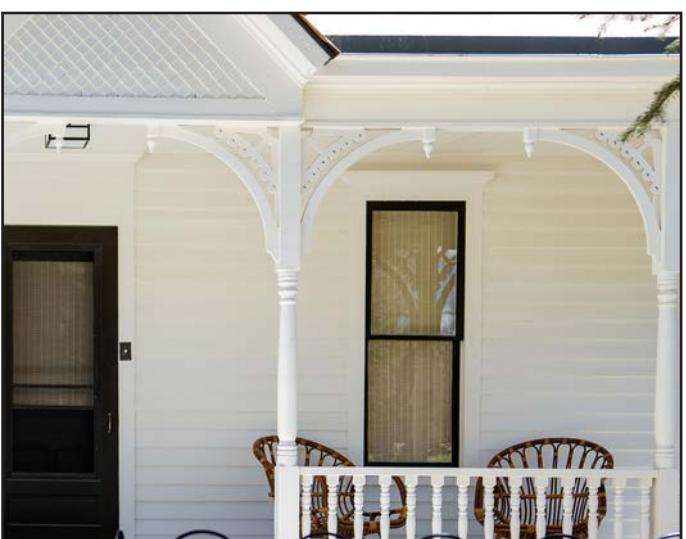
Double hung windows.

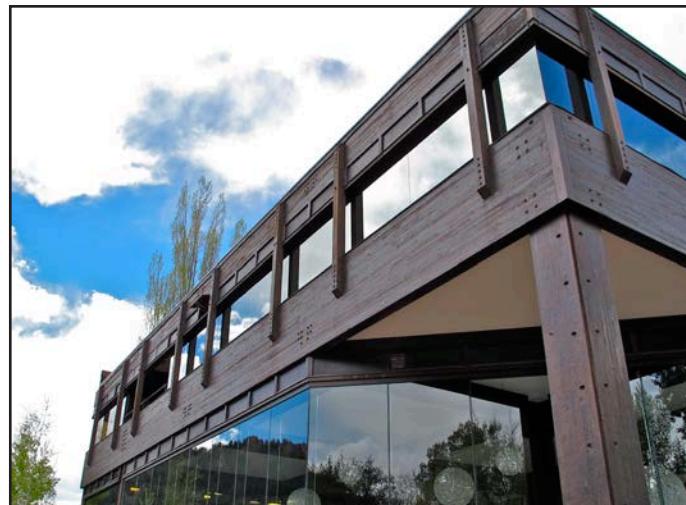
*Mitered windows.*

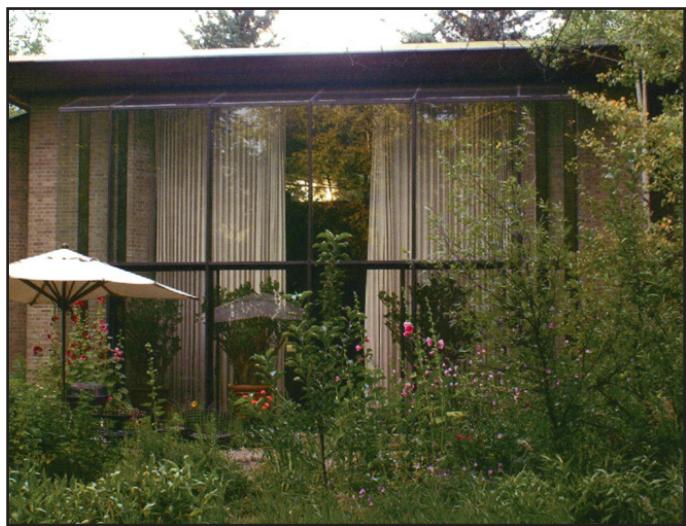
*Fixed windows.*

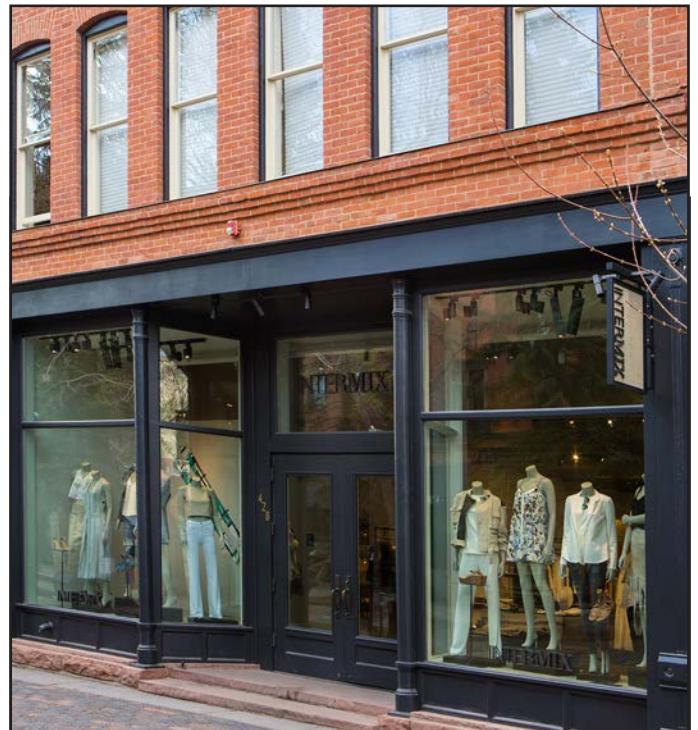
**After:** Restored storefront.

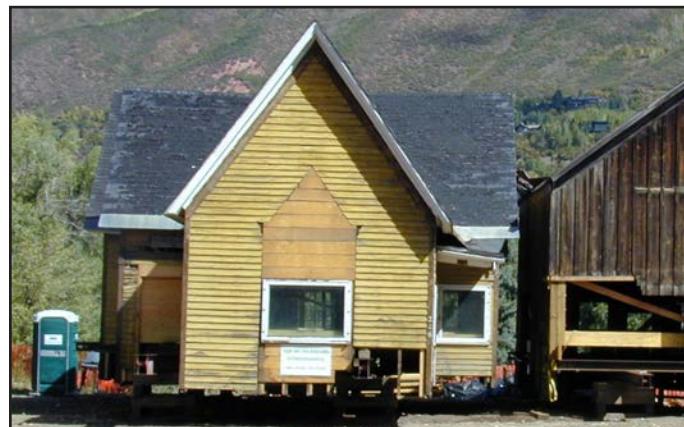
**Before:** Look for evidence of original openings and restore.

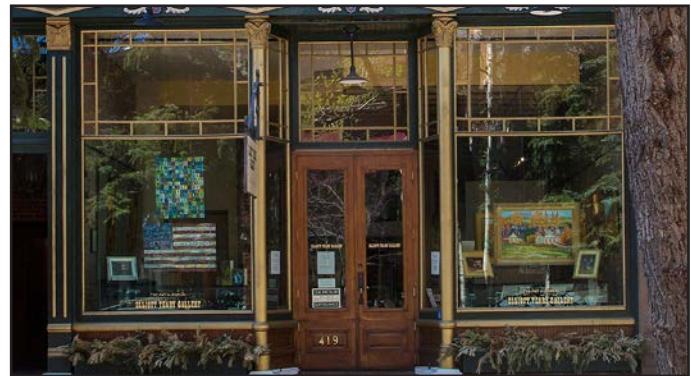
Doorway with transom.

- Doorway with transom - Typically a wooden door topped with a rectangular transom with glass.
- Half-lite door - This type of door has a wide sash of glass in the upper portion of the door. Many early Aspen houses have half-lite doors.
- Full-lite door - This type of door is predominantly glass.
- Paneled door - Wooden door with raised panels.
- Slab door - A door without panels or glass.

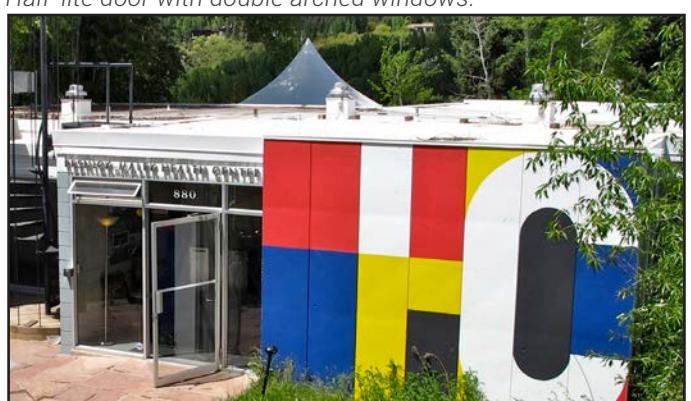
Full-lite door.

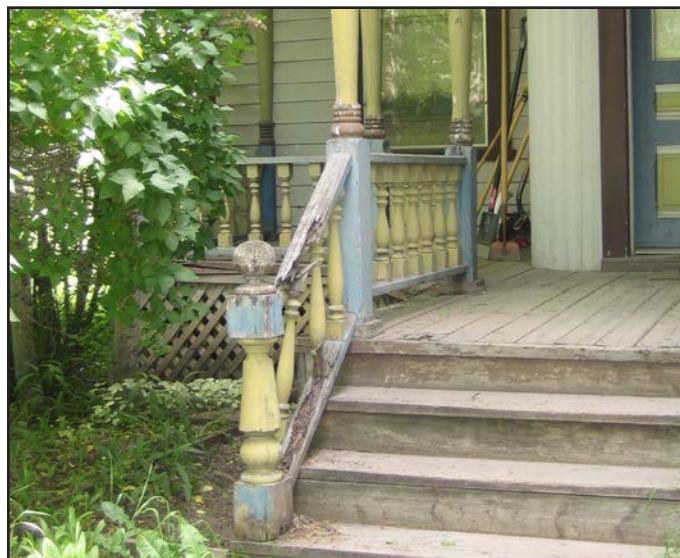
Handrails are susceptible to deterioration.

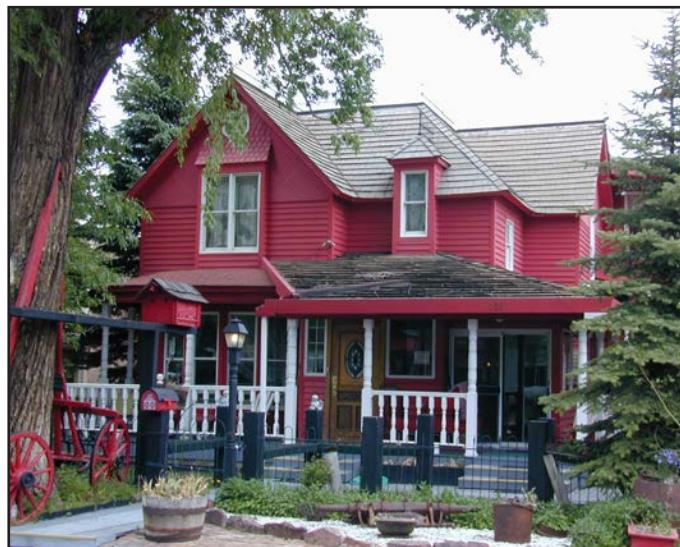
**Before:** A historic porch where the original posts and details were replaced with an inaccurate design.

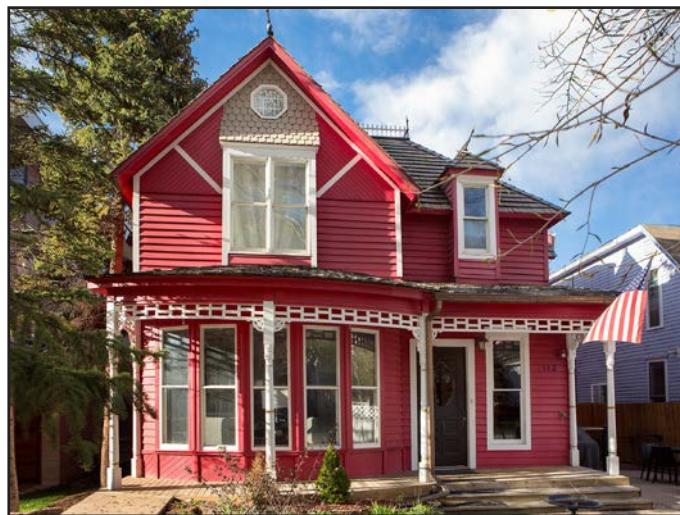
**After:** A restored porch based on historic documentation.

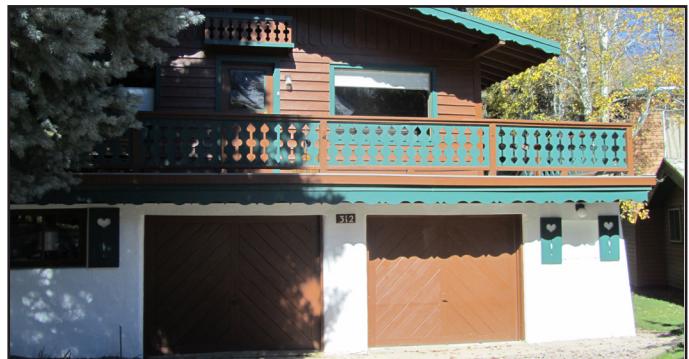
*Broken balusters within this railing were carefully replicated.*

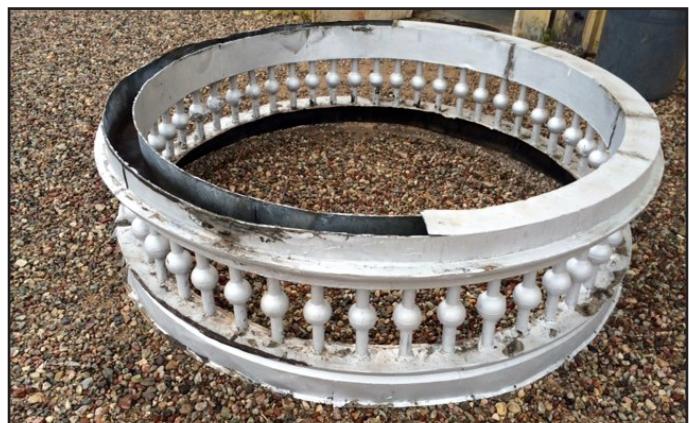
*A portion of the metal crown on the Elks Building was missing and needed to be replicated.*

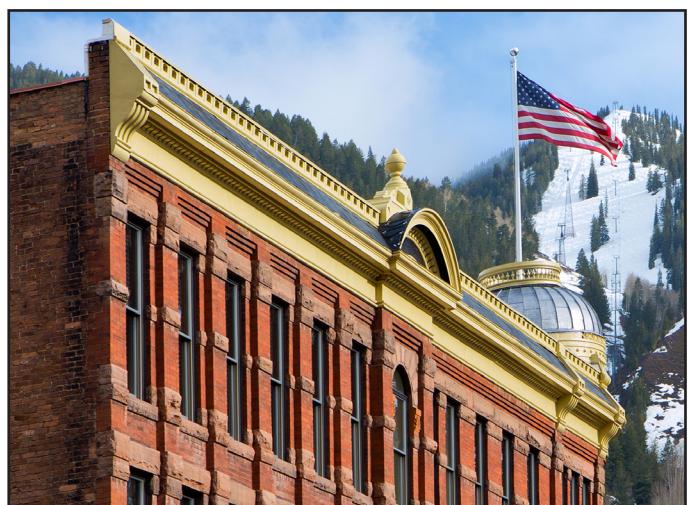
*The restored dome on the Elks Building.*

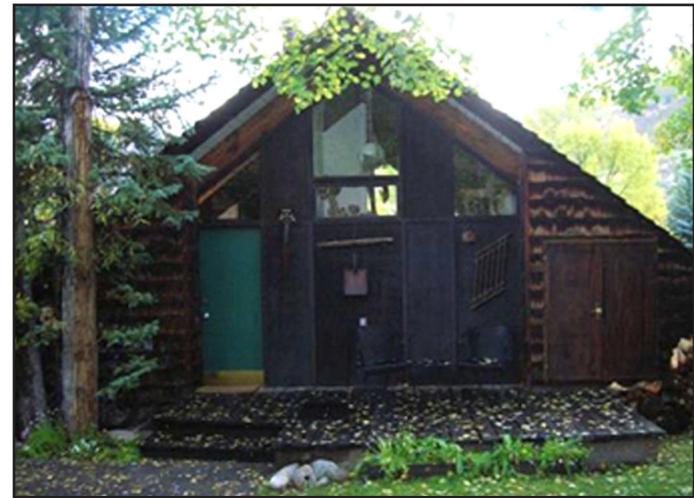
An A-Frame roof form on a Fritz Benedict designed home.

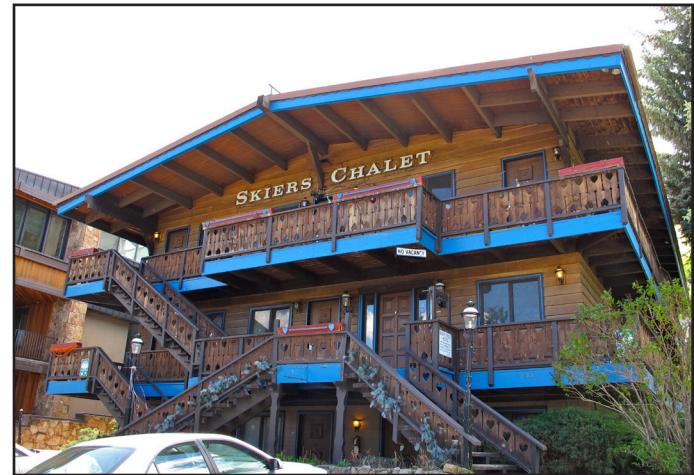
Deep overhangs on a Chalet.

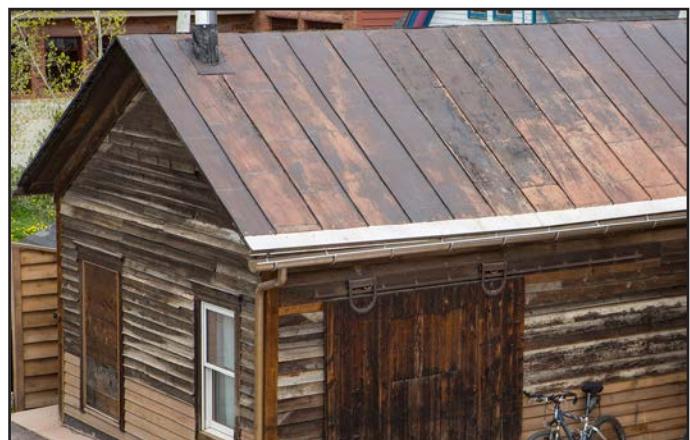
Preserve original roof material when possible.

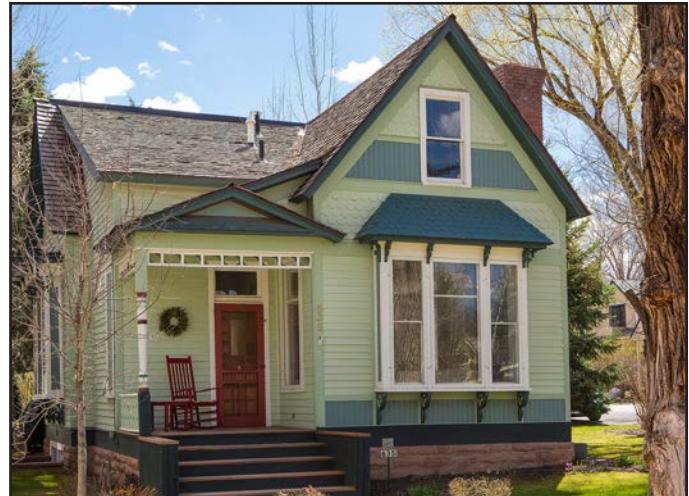
*The original sandstone was used as a veneer on this foundation after a new basement was built.*

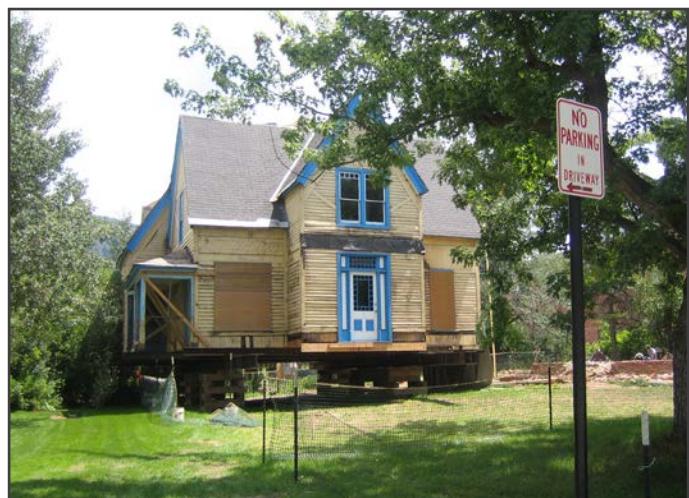
*Storing the historic resource on site during construction of the new foundation is strongly preferred.*

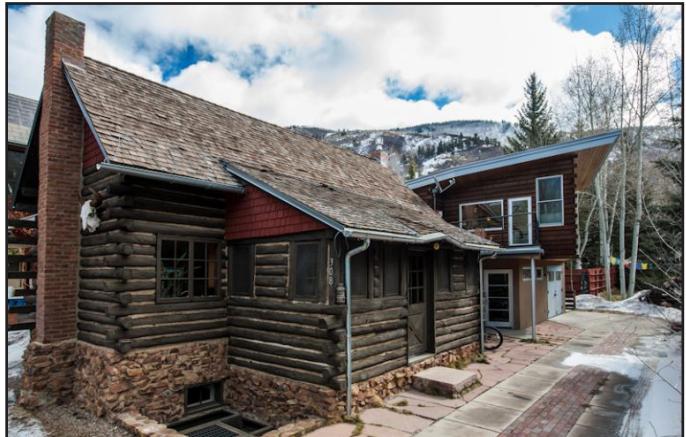
*The rear addition varies from the form of the resource, but addresses the materiality and fenestration.*

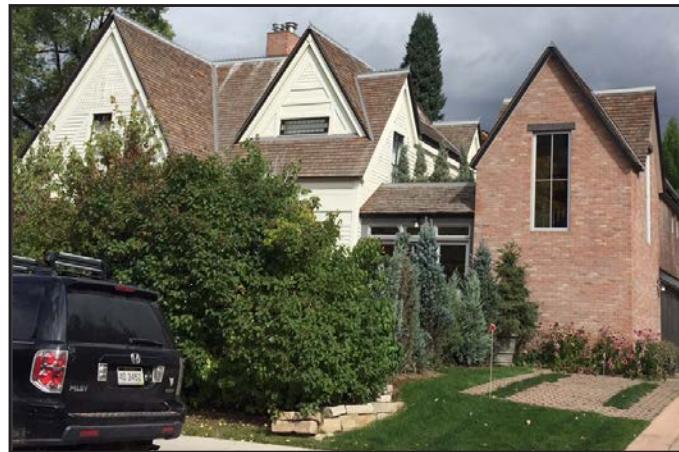
*This addition to this Victorian is clad entirely in brick to distinguish itself from the original clapboard sided Victorian.*
