NEW LIFE FOR AN EARLY DOORWAY

Restoring a Federal Door Surround

— by John Leeke —

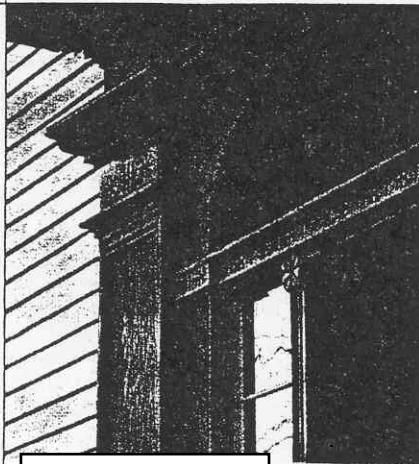
The overall design of this rectangular surround is typical of the period in lower New Hampshire, but the mouldings and the unusual "sunburst" carvings around the louvered fan make it special.

Unique carvings and surprising colors (above) added to the classic Adam-style elliptical fan and sidelights (right).

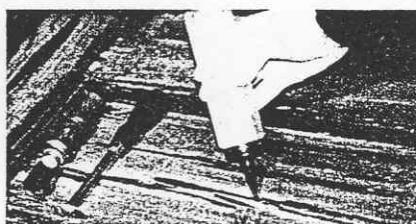
Top: Cracks are cleaned with specially made tools, then primed with epoxy consolidant. Later, forcing in epoxy paste completely fills the cracks. Bottom: Wide gaps where panels meet the bottom stile were filled with backer rod topped with polyurethane caulk.

To begin repairs I removed the mouldings, carefully recording their positions on the door with a number system. After removing all paint I cleaned out cracks in the panels with my special scrapers. Then I soaked the cracks with epoxy consolidant to insure a good bond with the epoxy paste filler that followed. Epoxy filler is formulated to match the strength and flexibility of the surrounding wood. This is an important consideration since

Door frames and panels frequently deteriorate when water seeps in behind the mouldings. Soaking the end grain of the panels and penetrating frame joints causes panels to split and decay within the joints. To prevent this deterioration I seal these joints with polyurethane caulk. Round foam backer rod (available at building supply houses) forms the sealant into an hourglass shape that is thin and flexible. If the gap were completely filled the panel might split because the sealant would act like a stiff adhesive

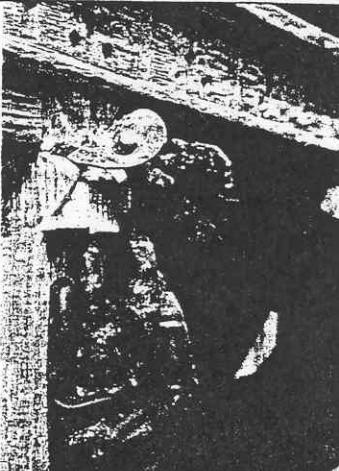
Shaped scrapers pick away softened paint without damaging the wood carvings.

Stripping decorative carvings demands great care. We used wire brushes and shaped scrapers to remove the softened paint. The result was bare wood with only bits of paint left in the deep weather checks. Careful preparation makes wood repairs easier and assures good performance for the new paint coatings.
