City of Aspen Historic Contractor License Training Manual

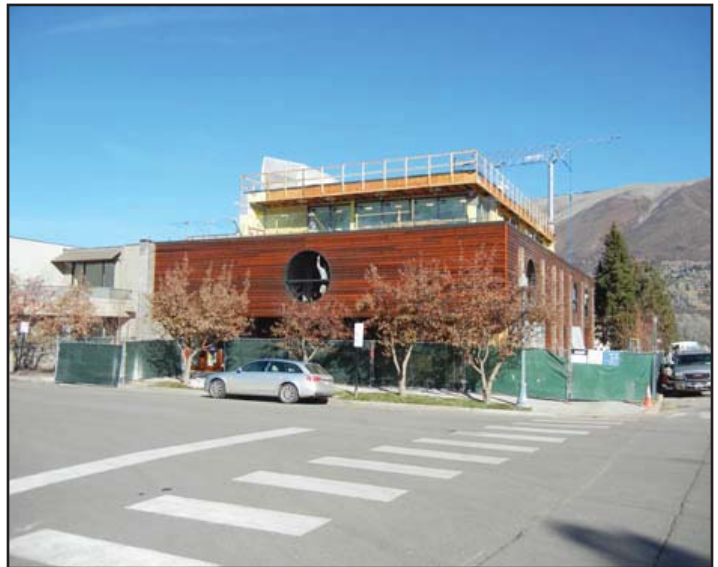
Image 1: The designated Crandall building on Hyman Ave. was approved by HPC to have a penthouse addition, which is an example of not freezing a building in time.

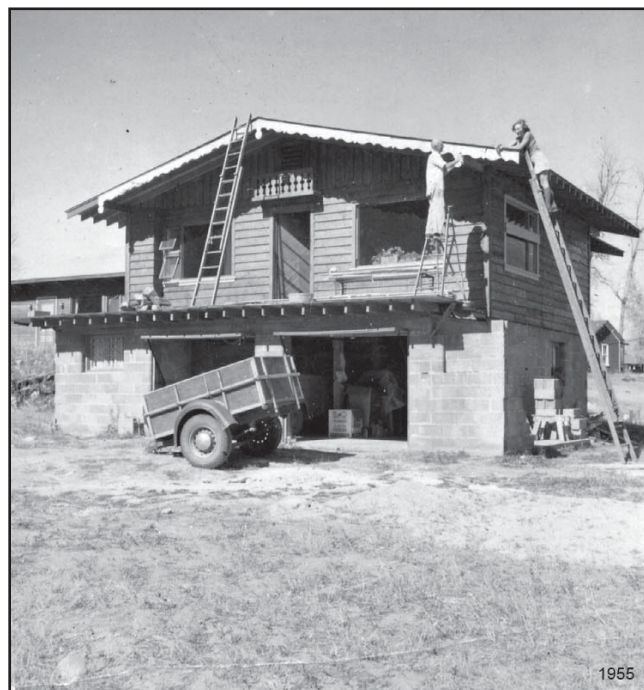
Image 2: Historic photograph of 312 W. Hyman under construction in 1955.

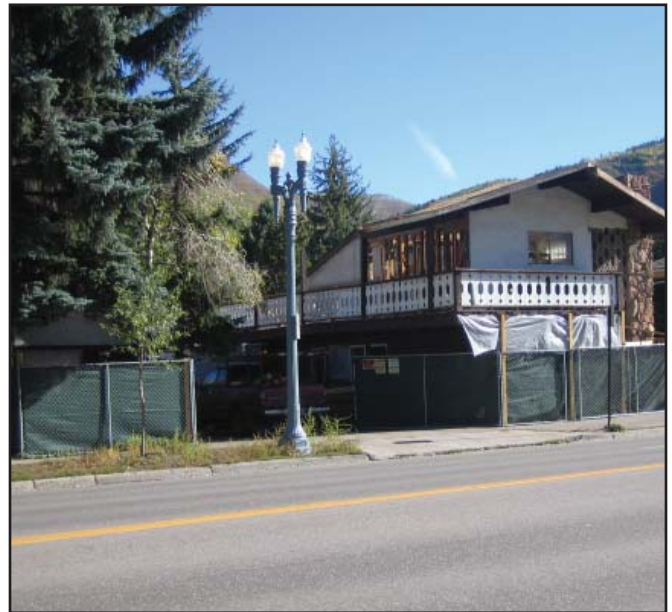
Image 4: The Cortina Lodge with site protection fencing while it is being rehabilitated.

Protection methods should be planned and designed in such a way that they are durable for an extended period of time and do not damage any surfaces in their construction or attachment mechanisms. Documentation prior to commencement of work is critical to this process, as well as good preservation principle.

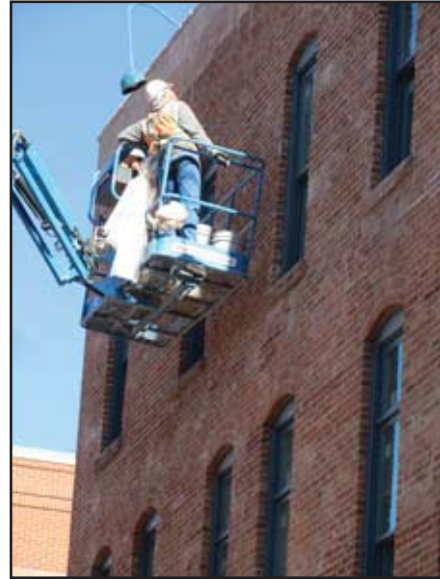
Image 5: Working on the Hotel Jerome brick restoration project. Note the size and color of brick and consistency of the mortar application.

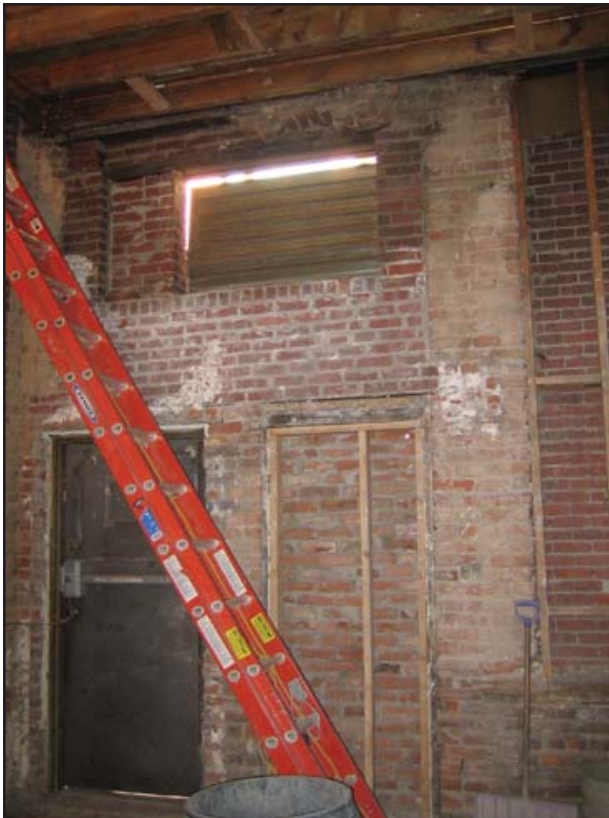
Image 6: Rear brick wall of the Red Onion. Note the different brick and mortar patches.

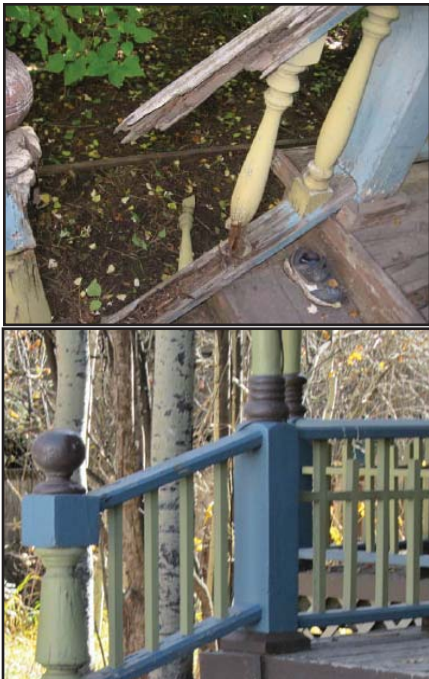
Image 7 & 8: Damaged wood porch railing with missing balustrade (top). Using historic photographs the original balustrade was recreated (bottom).

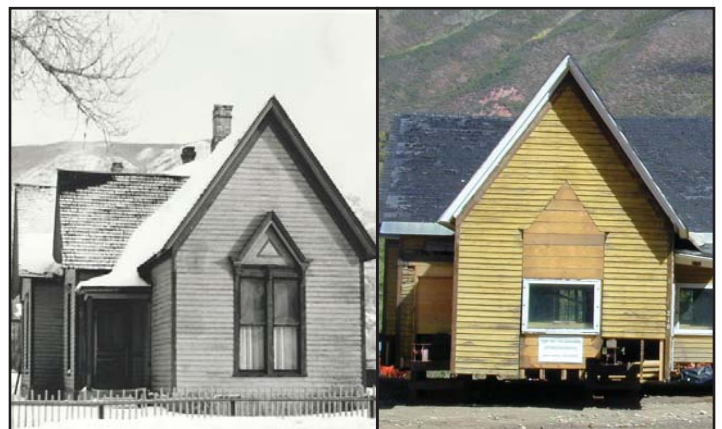
Image 9 & 10: A historic photograph (left) used in conjunction with ghost lines on the residence (right) to restore wood details and openings.

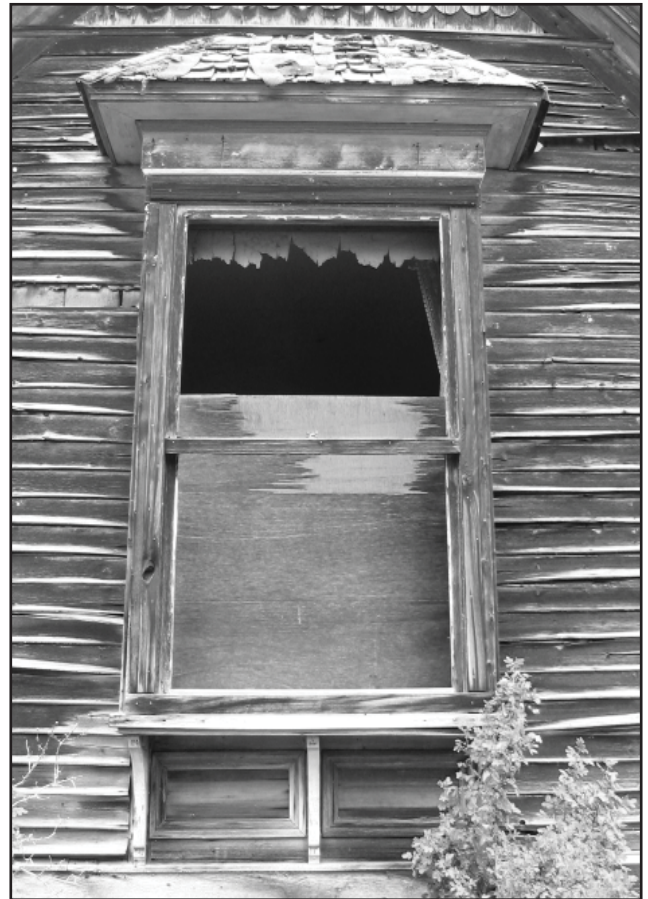
Image 11: Badly damaged historic window in need of new glazing and wood repair.

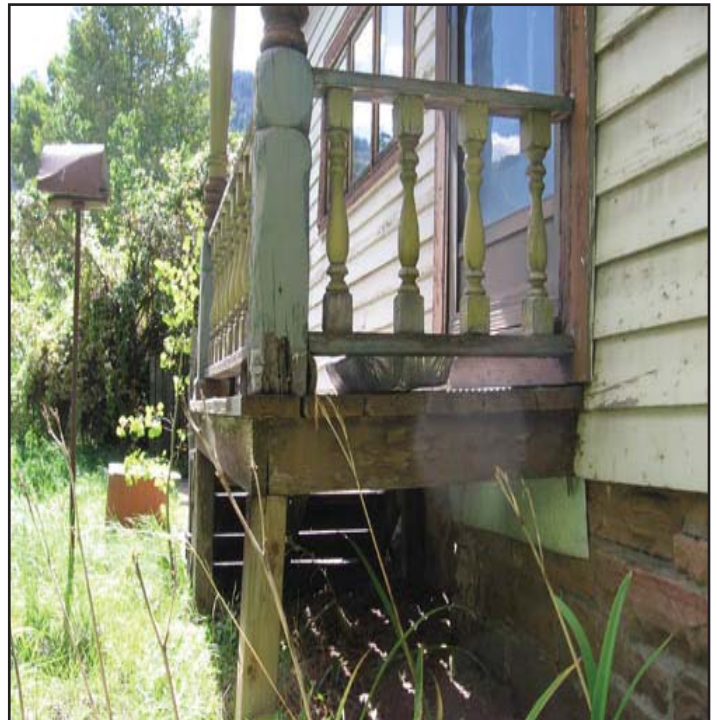
Image 12: Historic side porch with water damage and structural deterioration.

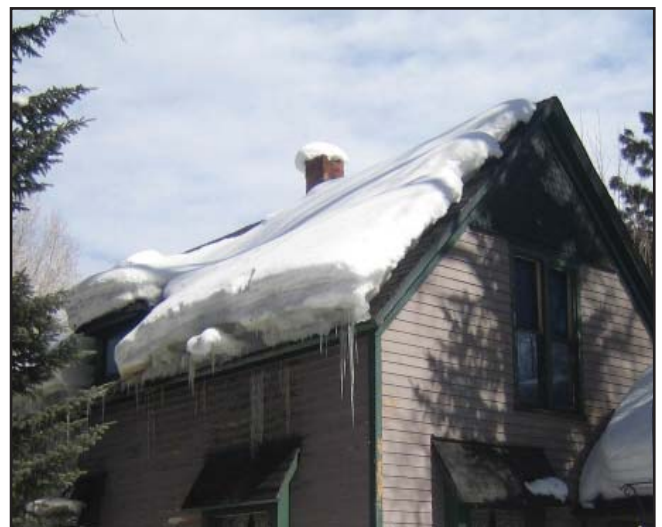
Image 13: Ice damming on a historic roof.

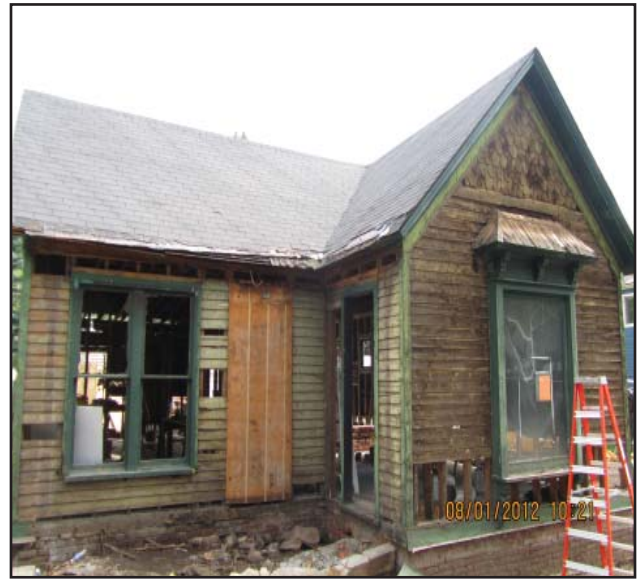
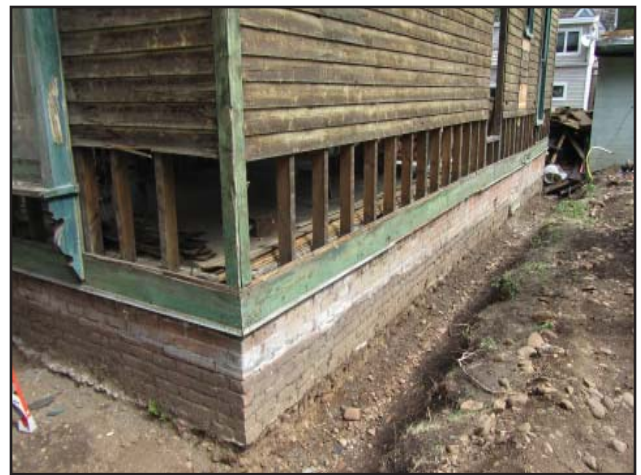
Images 14 &15: Historic home getting prepared to be relocated (top). A detail of the original foundation and documentation of foundation exposure and style (bottom).

Special care must be taken when preparing a building for relocation. In addition to protecting the site and any historic landscape features and trees prior to moving a building, wood panels should be mounted on the exterior of the building to protect existing openings and historic glass. Original door and window frames and sashes should be protected, and not damaged, when covering the openings. Original doors and other architectural features must be either stored safely onsite or secured to the building. All historic material that is removed to prepare for the relocation, siding for example, shall be stored and reused once the building is in its final location. Photographic documentation and dimensional measurements need to be recorded of existing conditions, for example chimney and foundation heights, prior to dismantling and moving the building.
