SH 82 Over Castle Creek Bridge Feasibility Study
Document No: 240207140925_5d9775bf
Version: Draft

City of Aspen
Structure No. H-09-B

Castle Creek Bridge

Prepared by: Beth Tosti, Structures Lead

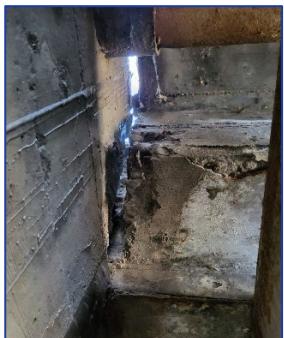
Inadequate joint seal at Abutment 6

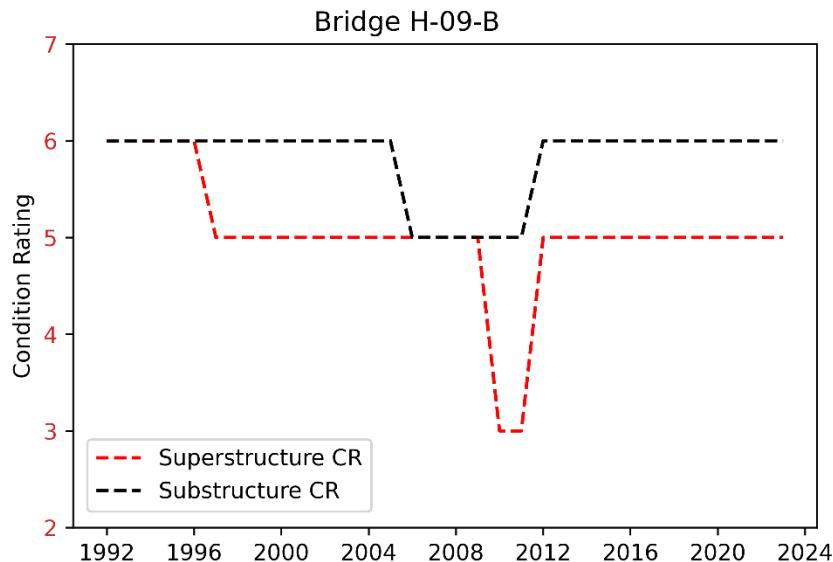
Figure 11 illustrates superstructure and substructure condition code history of the bridge based on the NBI database (NBI 2024). During a 2009 inspection, (CDOT 2009) a decline in the superstructure condition code to 3 ("Poor") was noted, necessitating immediate attention. According to CDOT records, extensive repairs and rehabilitation efforts were implemented on the bridge in 2011 to improve the condition code of the bridge. Despite these substantial rehabilitation efforts, they were only sufficient to elevate the superstructure to a "Fair" code.

Figure 11. Condition Rating History of the Bridge

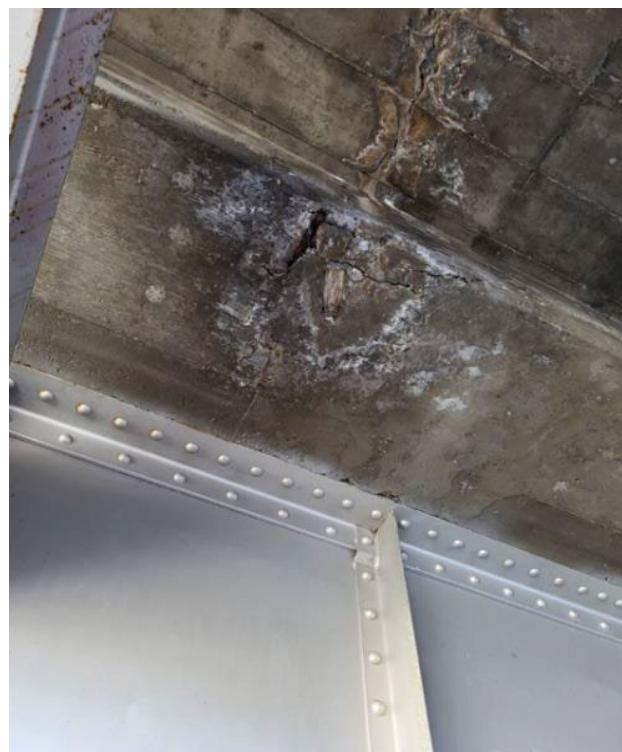
In conjunction with a new asphalt overlay, deck repair was performed on the bridge in 2018, which repaired several inspection and maintenance items. The wheel rutting in the overlay noted during the November 2023 inspection can lead to degradation of the deck over time if not properly maintained. A well-performing overlay system is the best defense for maintaining the integrity of the concrete deck underneath and extending its service life. The type of overlay is also important to enhancing the deck's resistance to corrosion. Cementitious and non-cementitious wearing surfaces are available. The concrete deck issues noted will need to be monitored regularly to confirm the 2018 deck repair effort stopped or significantly slowed down the observed deterioration of the underside of the deck. If it is determined deck repairs need to be performed once again, the deck repairs would follow the typical protocol CDOT uses for this situation.

Figure 12. Deck Concrete Spall with Exposed Rebar

Depending on the chloride testing results of the concrete deck, a new overlay system along with localized deck repairs may be required, or if the contamination is widespread, a full deck replacement may be needed. Full deck replacement would provide the greatest mitigation for corrosion and degradation of the deck. However, it is also the most intrusive activity regarding construction requirements. The bridge would require full closure to replace the deck in its entirety. In the future, if it's determined a full deck replacement is needed, it is recommended a full bridge replacement be considered, given the complicated nature of work involved with a full deck replacement.

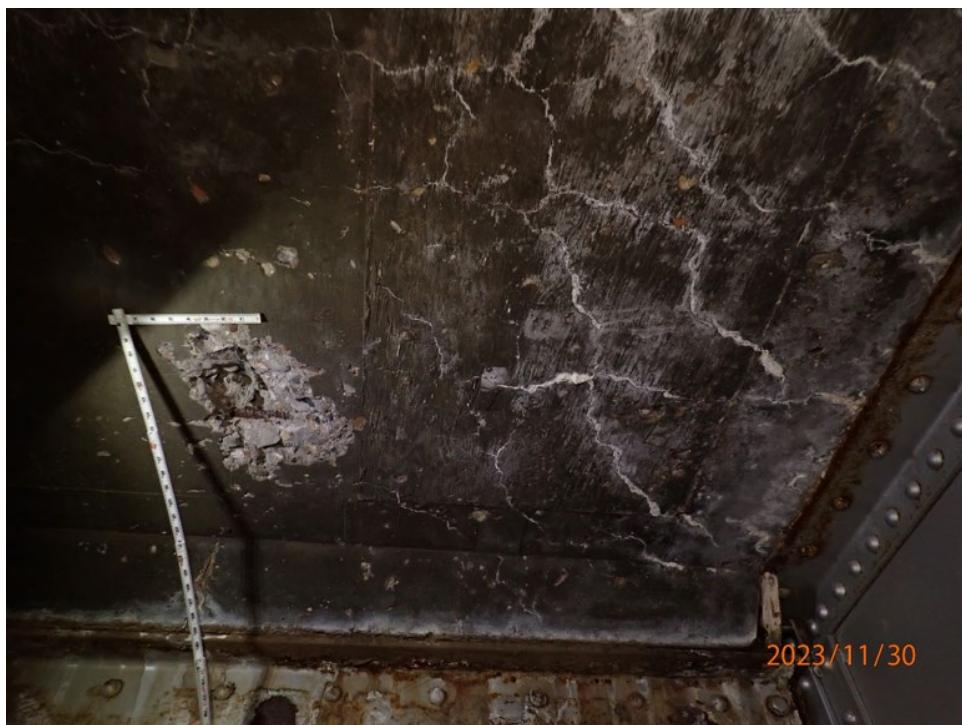
Infiltration of chloride ions into concrete is the most common cause of corrosion initiating in reinforcing steel. Chloride exposure is primarily through the application of deicing salts, such as magnesium chloride. Deck repair and patching or the installation of new membranes and overlays must begin by first identifying the extent of chloride contamination of the deck. Chloride testing consists of taking cores of the concrete deck and analyzing them for chlorides. Depending on the results of the testing, future deck rehabilitation may consist of the replacement of all chloride-contaminated concrete with sound concrete, along with the replacement of the membrane and wearing surface. It may also consist of the installation of a barrier-type overlay on the deck or full replacement of the deck. The test process may significantly impact traffic on the bridge when samples are taken. In addition, the potential deck rehabilitation effort will impact traffic on the bridge and may include full closure of the bridge to complete the repair work.

Figure 13. Deck Concrete Spall with Exposed Rebar

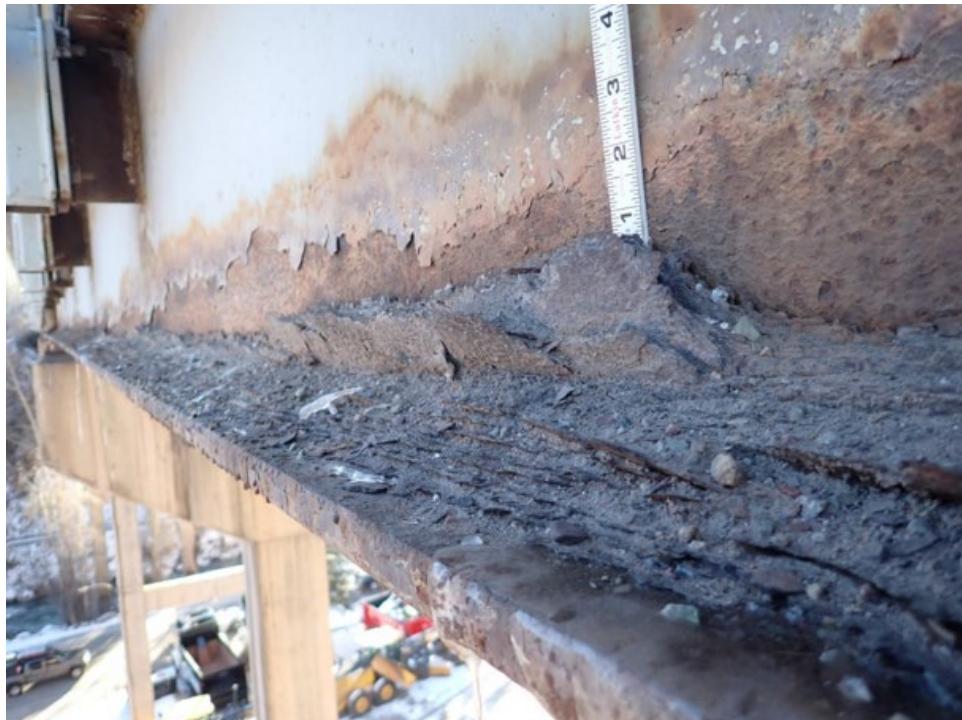
The steel girders show varying degrees of corrosion. Exterior rolled steel wide flange girders (North exterior Girder A and South exterior Girder F) under each sidewalk show significant corrosion on the bottom flanges and lower webs (refer to Figure 14). Several locations along the girder also have severe localized corrosion in the top part of the web. On average, exterior girders show 20% section loss in the web. Some localized areas show up to 40% section loss. Both exterior girders show a visible sag with approximately 3 inches of downward displacement at mid-span locations (refer to Figure 15).

Figure 14. Significant Corrosion in Web and Top of Bottom Flange of North Exterior Girder A

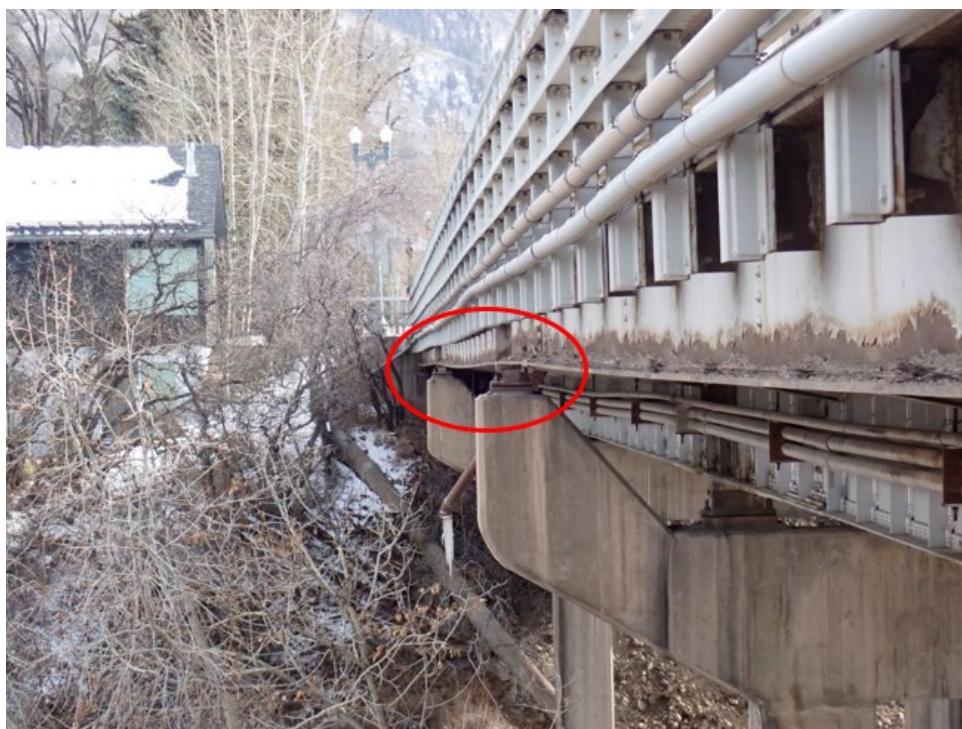
Figure 15. Girder F Sagging Near Mid-span

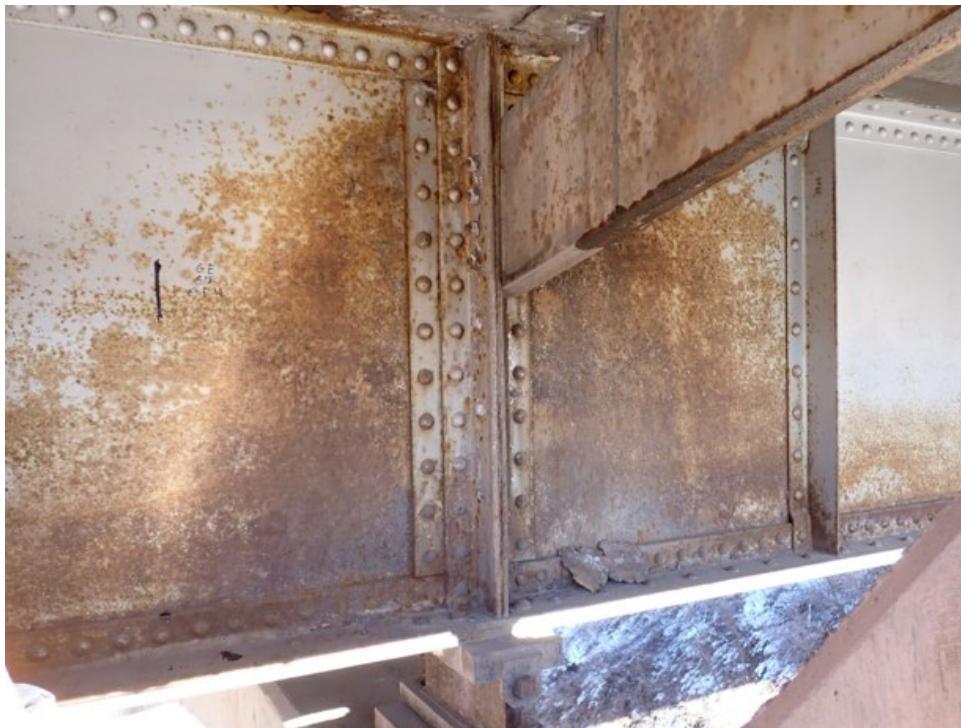
Compared to the exterior girders, the interior girders (B through E) have less corrosion. Surface corrosion and minor pitting are observed at these girders, especially at piers under the deck joints (refer to Figure 16). Girder ends at the abutments exhibited corrosion with negligible section loss.

Figure 16. Typical Surface Corrosion of Interior Girder – Girder E South Face at Pier 4

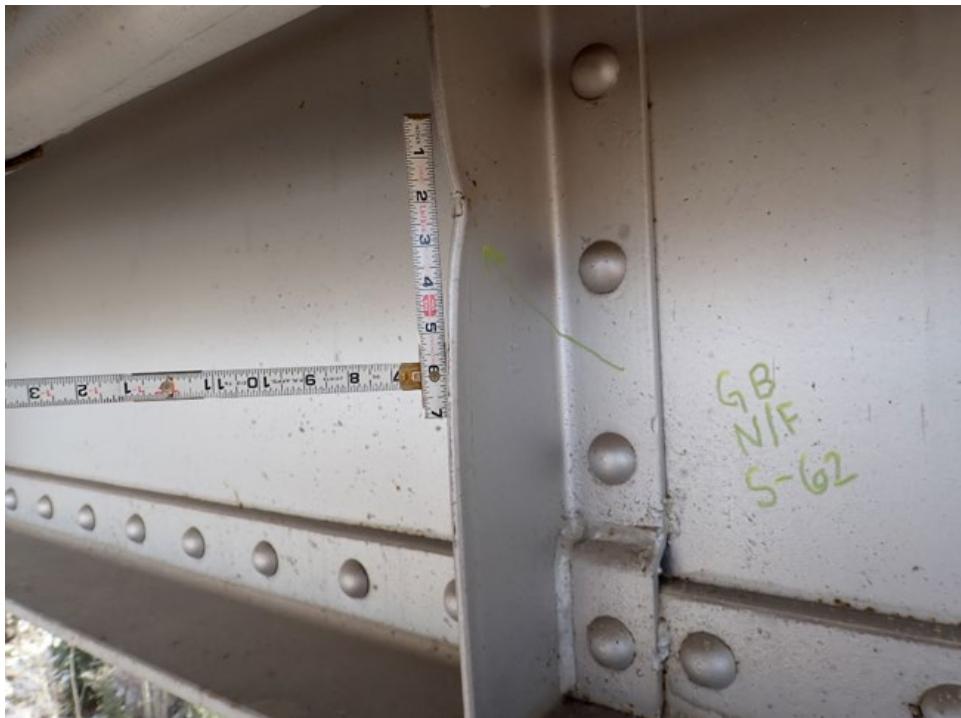
One stiffener in Girder B exhibited a noteworthy 1-inch out of plane deflection, emphasizing the necessity for a more in-depth structural evaluation at this stiffener location (refer to Figure 17). Stiffeners in exterior girders follow the same corrosion pattern as that of exterior girders as described in an earlier section. Notably, the vertical web bearing stiffener of Girder F at Abutment 6 has 100% section loss (2-inch diameter hole) at the bottom of the stiffener (refer to Figure 18). The bearing stiffeners of the interior plate girders, located at both the abutments and piers, are constructed using double back-to-back angles. They exhibit pack rust between the faying surfaces with a thickness of up to 1/2 inch. This rust has caused bowing in the stiffener legs at various points, as illustrated on Figure 19. While section loss in these regions is minimal, the accumulation of pack rust poses a potential concern over time. The continued presence of pack rust can induce separation between the angles, leading to further distortion of the angle shape.

Figure 17. Deflection of Stiffener at North Face of Girder B

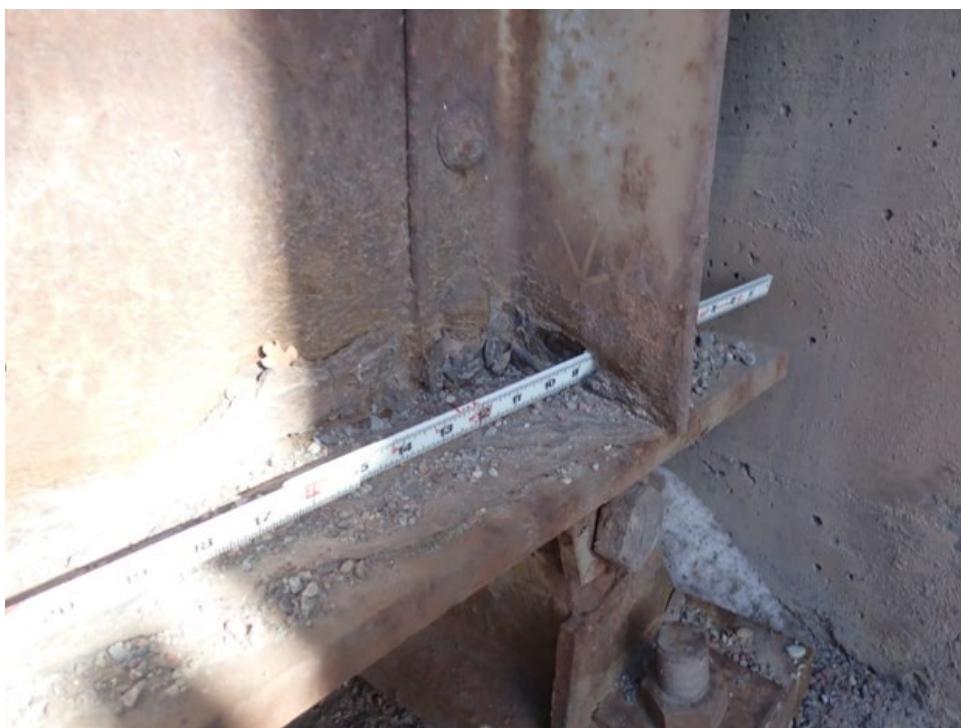
Figure 18. Section Loss in Base of Bearing Stiffener – Girder F at Abutment 6

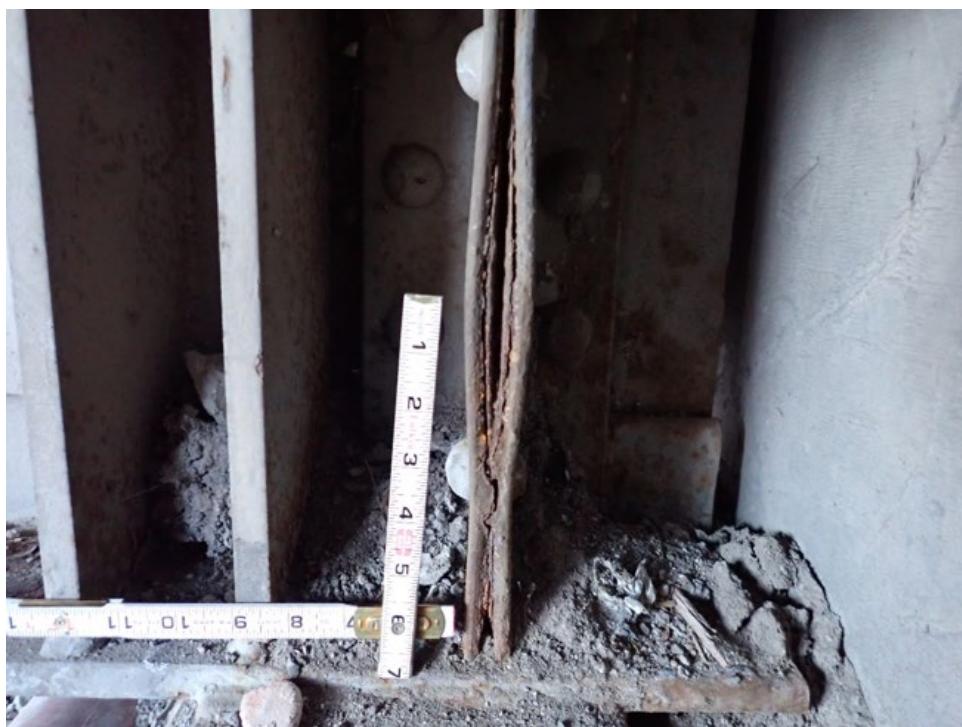
Figure 19. Pack Rust Between Bearing Stiffeners of Interior Girder at Abutment 1

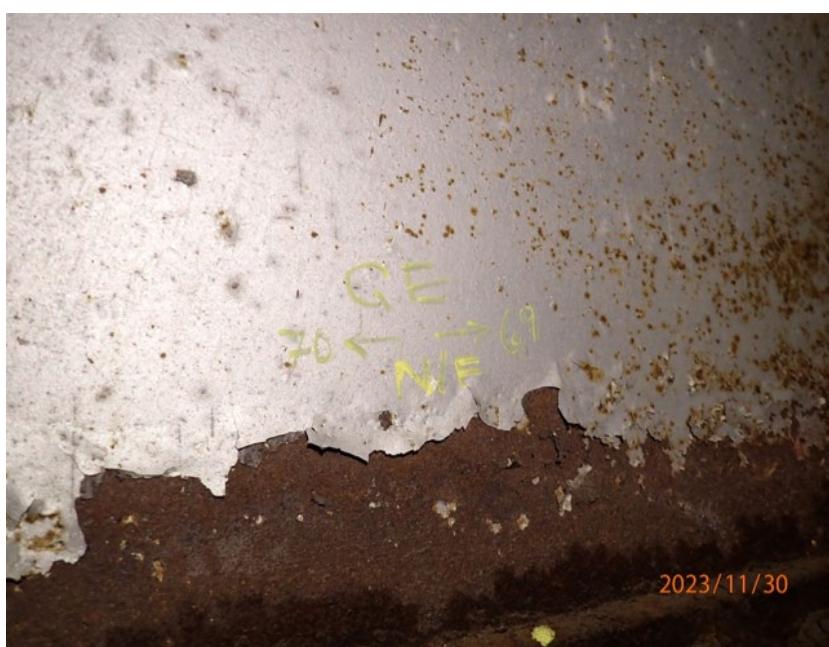
The protective coating on the steel elements has failed in areas because of corrosion, indicating a need for prompt attention. Approximately 80% of coating has deteriorated. This deterioration contributes to the accelerated corrosion of the steel components, emphasizing the urgency of addressing protective coating issues.

Figure 20 Failure of Protective Coating - Typical on All Steel Sections

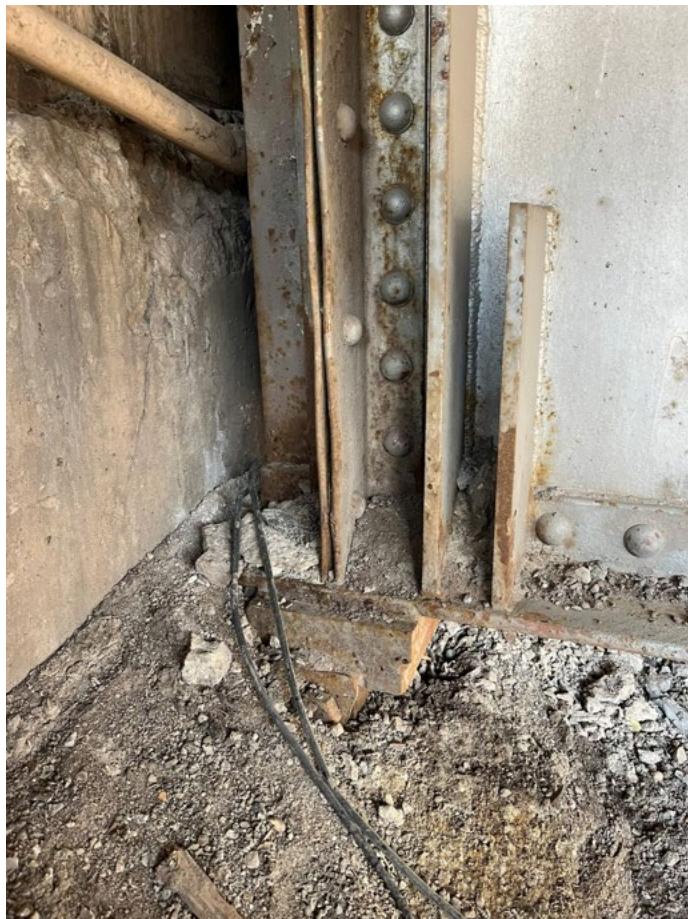
The primary girder bearings display surface corrosion without measurable section loss, with some bearings surrounded by soil and debris specifically at Abutment 1 (refer to Figure 21). Loose anchor bolt nuts are observed at all bearings, and pin bolts are backing out at Bearings 1C, 1D, 3E, and 3F. Furthermore, certain fixed bearings on Abutment 6 exhibit surface corrosion, with the grout pad breaking up under several bearings. It is imperative to address these issues urgently to prevent further deterioration and unintended movement. Overall, the bearing condition is generally fair, with surface corrosion and identified problems with anchor bolts. The interior girder bearings, especially the rocker bearings at Abutment 1, are in the expansion position, which is opposite of what is expected in the colder weather conditions during the inspection in November.

Figure 21. Rocker Bearing Covered in Dirt – Typical at Abutment 1

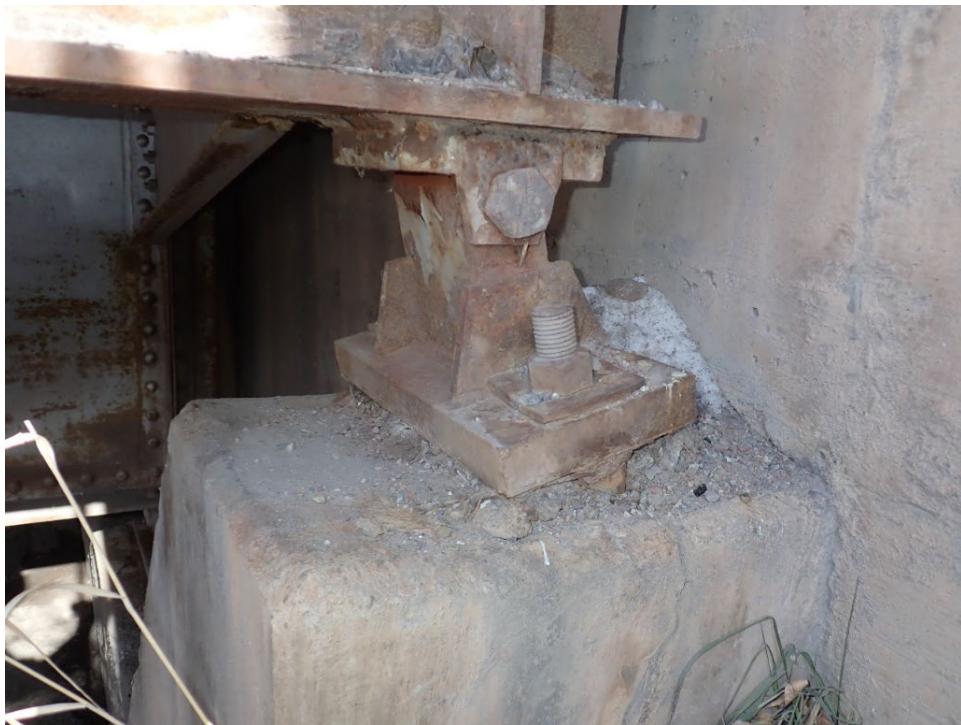
The abutment bearings on both Abutment 1 and Abutment 6 exhibit corrosion-related issues, including flaking and minor section loss. Debris accumulation around the rocker bearings on Abutment 1 is a concern because it can impede movement, trap moisture, and reduce the bearing assembly's lifespan. Abutment 6 experiences surface corrosion on all bearings, with additional problems such as a broken grout pad on Girder 6B and deteriorating grout pads under Bearings 6C to 6E. Despite previous rehabilitation efforts in 2011, the grout pad below Bearing F is broken, with significant bearing loss. The fixed bearing (6F) is beginning to tip longitudinally, as shown on Figure 22. The bearing pedestal for Bearing 6A has a significant vertical crack stemming from the anchor bolts. This crack has propagated through the bearing pedestal and created a large section of delaminated concrete. Immediate attention is necessary to address these structural concerns.

Figure 22. Movement of Bearing 6F at Abutment 6

Observing inadequate joint sealing at Abutment 6 raises concerns about the bridge's structural performance. Despite the presence of fixed bearings at this abutment, notable movement of the bridge has been observed through the existing conditions of the bearings, as shown on Figure 22 (Section 4.2.5). One plausible explanation is the potential impact of the partially buried rocker bearings at Abutment 1. The bearings at Abutment 1 were intended to absorb thermal movements of the bridge, whereas the bearings at Abutment 6 were intended to remain stationary on the abutment seat. It is possible the partially buried bearings at Abutment 1 may be restricting the performance of the rocker bearings, thereby contributing to unintentional movement at the fixed end of Abutment 6. Another factor under consideration is the relocation of the expansion joint from the backwall of Abutment 1 completed in late 2022, which may be contributing to the observed issues. A comprehensive analysis is needed to identify the root cause of the unexpected movement behavior of the bridge bearings and determine the most effective remedial measures.

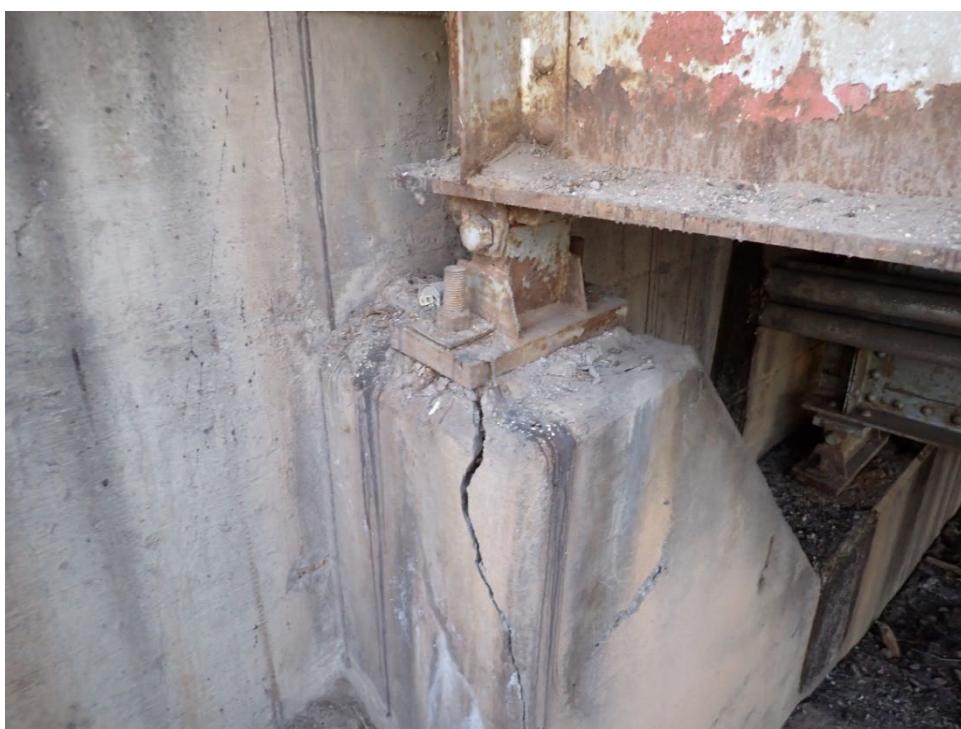
Figure 23. Impending Spall in the Bearing Pedestal at Bearing 6A at Abutment 6

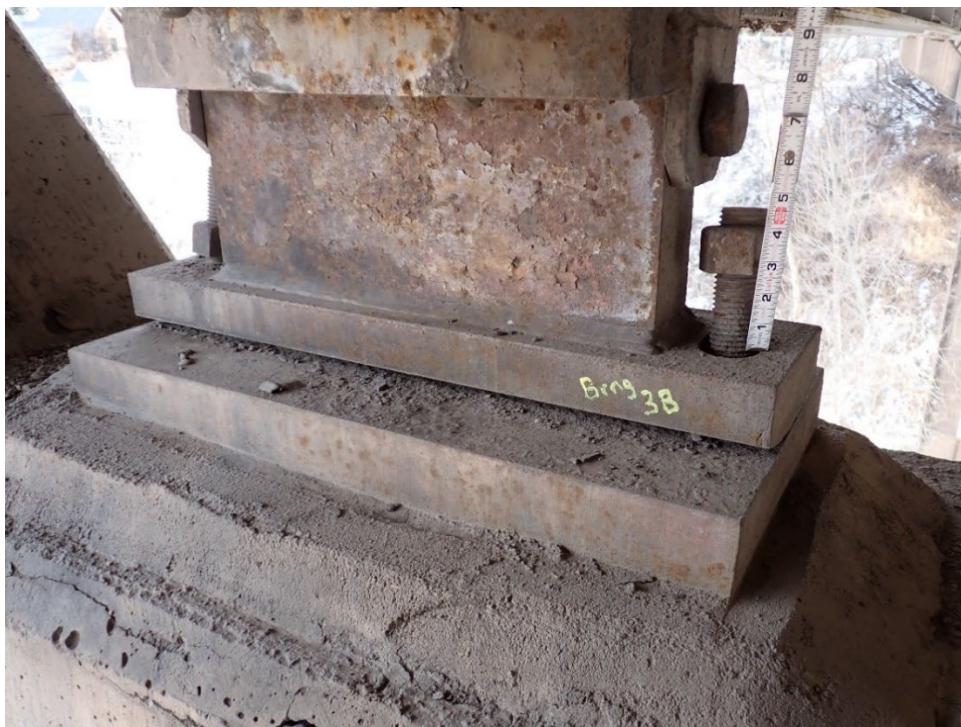
Figure 24. Loose Anchor Bolt Nuts – Typical at All Bearings

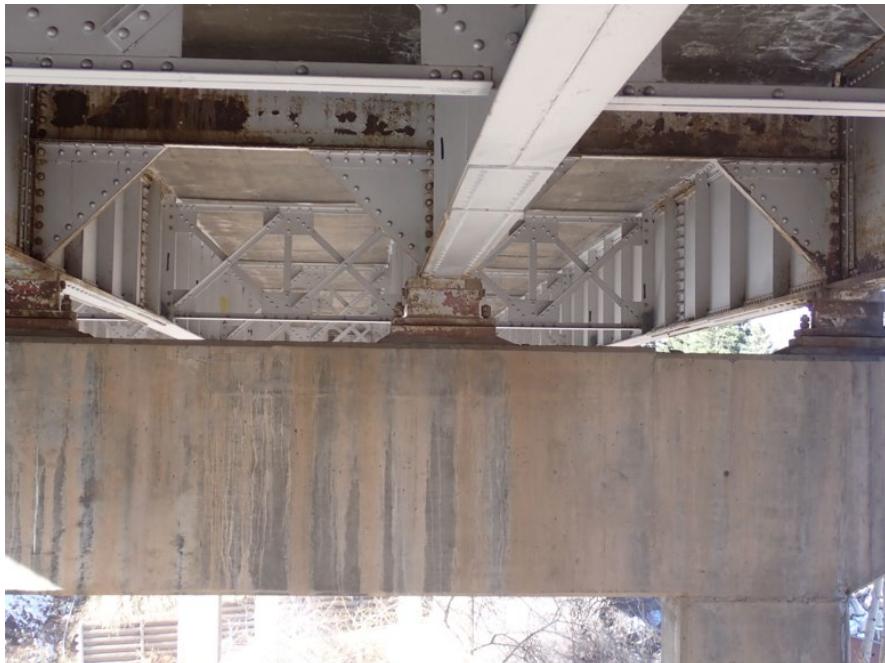
The steel diaphragms exhibit satisfactory overall condition, except for surface corrosion identified in the C-Channel diaphragms at the piers. Notably, the C-Channel diaphragms between the exterior and interior girders at piers show corrosion with 10% to 30% section loss of the webs.

Figure 25. Surface Corrosion of C-Channel Diaphragms – Typical at All Diaphragms

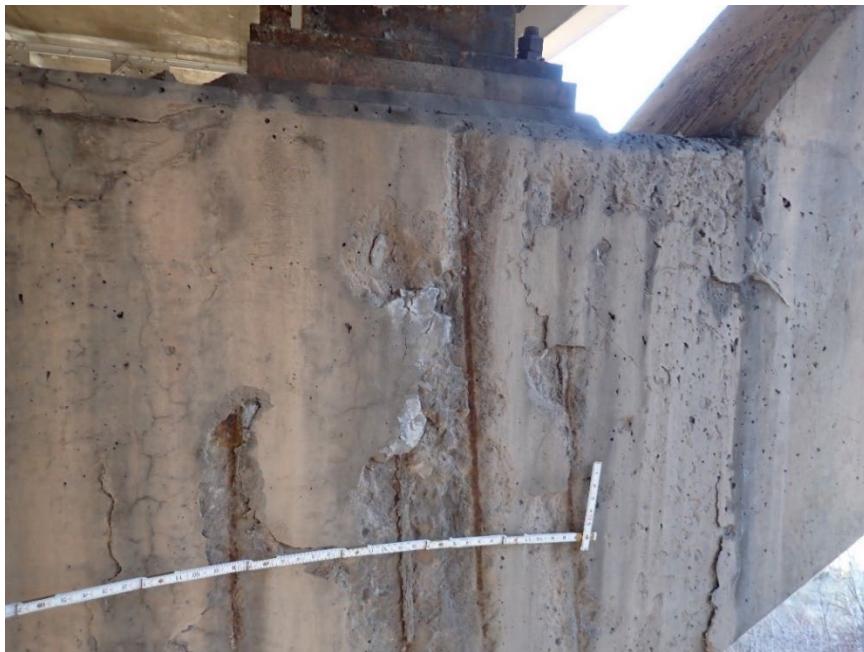
Pier caps exhibit moderate to heavy water staining, light scaling, delamination, and various severity of cracks. Specific issues include a 4-square-foot spall with exposed, corroded rebar on Pier 2, rear face under Girder E. Pier 3 cap shows delamination and cracks with efflorescence, while Pier 4 cap displays delamination, shallow spalls, and horizontal and diagonal cracking below Bay 3C. Pier 5 cap is starting to delaminate on the right side under Bay 4D.

Figure 26. Exposed Corroded Rebar on Pier Cap at Pier 2

7. Pier Cap Repairs:

Repairing the observed spalls and cracks on the pier substructure elements will also prevent further degradation of the components and improve the overall long term durability of the bridge. Leaving

the defects unchecked or repaired increases the potential for water infiltration and subsequent corrosion of the steel reinforcement.

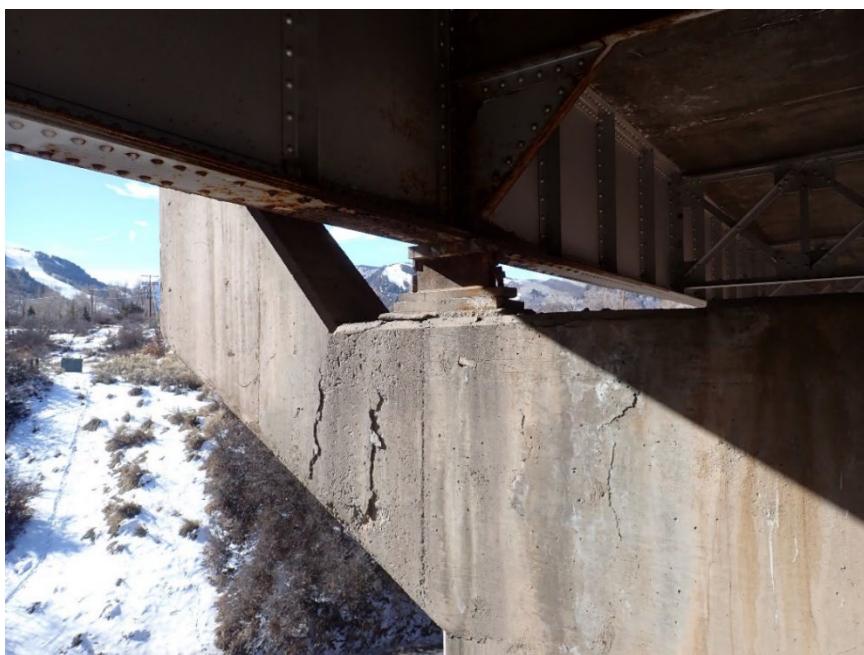
Figure 27. Light Scale Cracking at Pier Cap – Typical at All Pier Caps

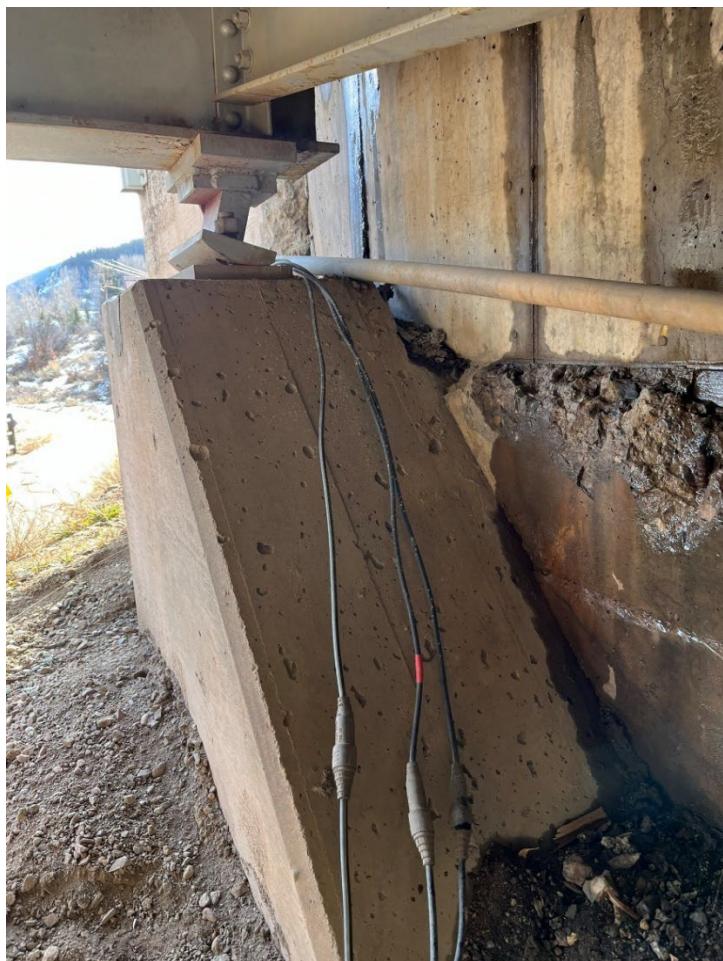
Abutment 1 is covered in debris from previous rehabilitation projects and possibly from an effort to cover the high-pressure gas line. A portion of the backwall appears to have been removed approximately 3 feet from the top during previous construction projects, then recasted to a thinner section thickness. Vertical rebars along the front face of the existing backwall have been cut and are exposed at some locations. Abutment 6 has some light scale, delamination, and water staining.

Figure 28. A Portion of Abutment 1 Backwall Was Removed During Previous Construction

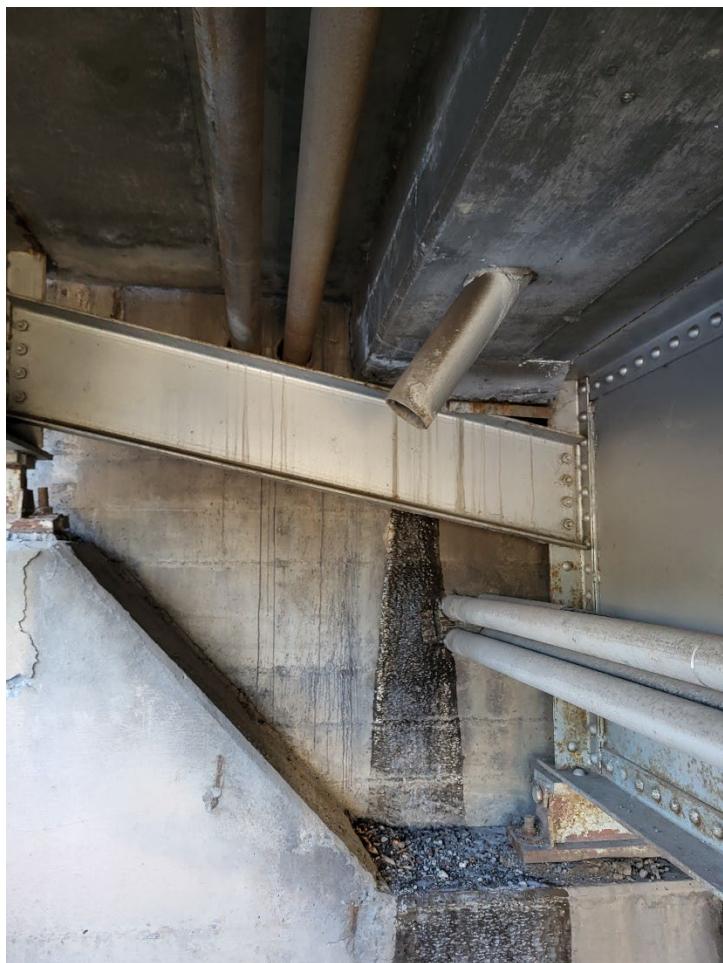
Figure 29. Light Scale, Delamination and Water Staining at Abutment 6

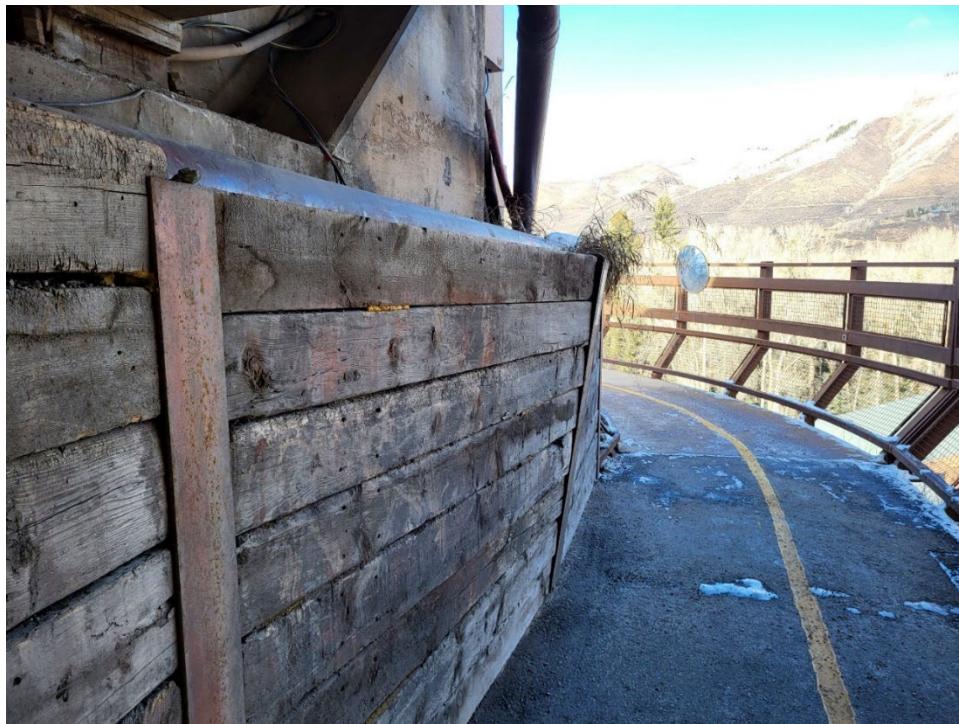
According to the CDOT inspection report for 2022, maintenance personnel in Aspen have reported the need to annually adjust or reposition the timber wall supporting the bike path to a vertical orientation at Abutment 1. This recurring issue has prompted the City to initiate a rehabilitation project aimed at addressing the structural concerns associated with the timber wall. Mitigation of the retaining wall and bike path helps the continued protection of Abutment 1.

Figure 31. Movement of Timber Retaining Wall at Abutment 1

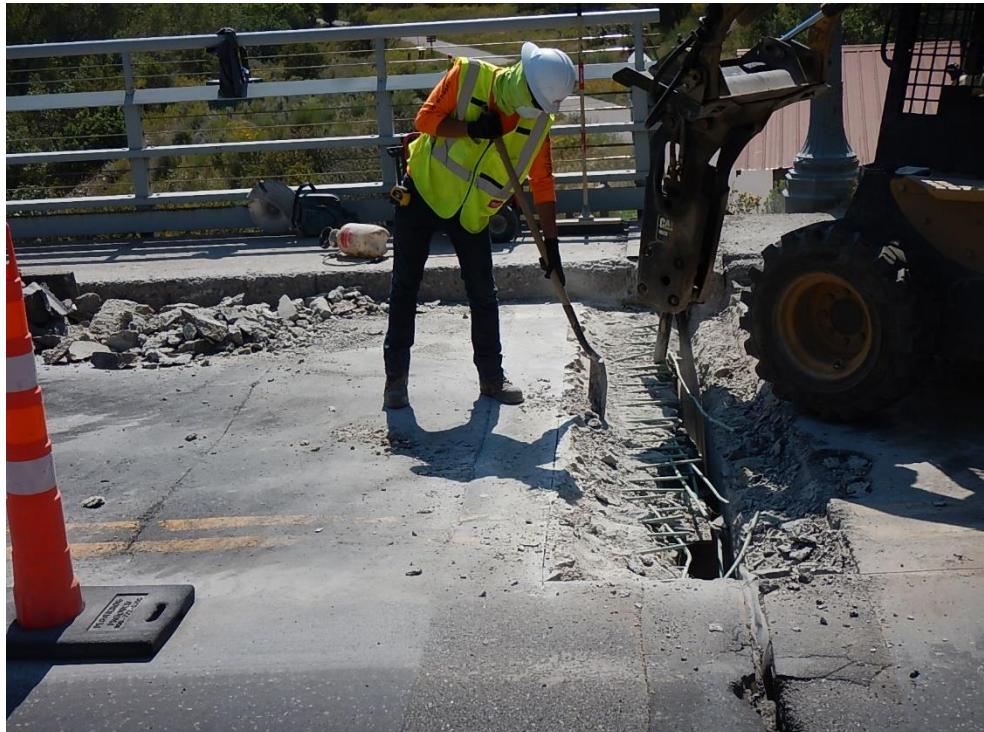
Active Construction at Abutment 1 on Joint

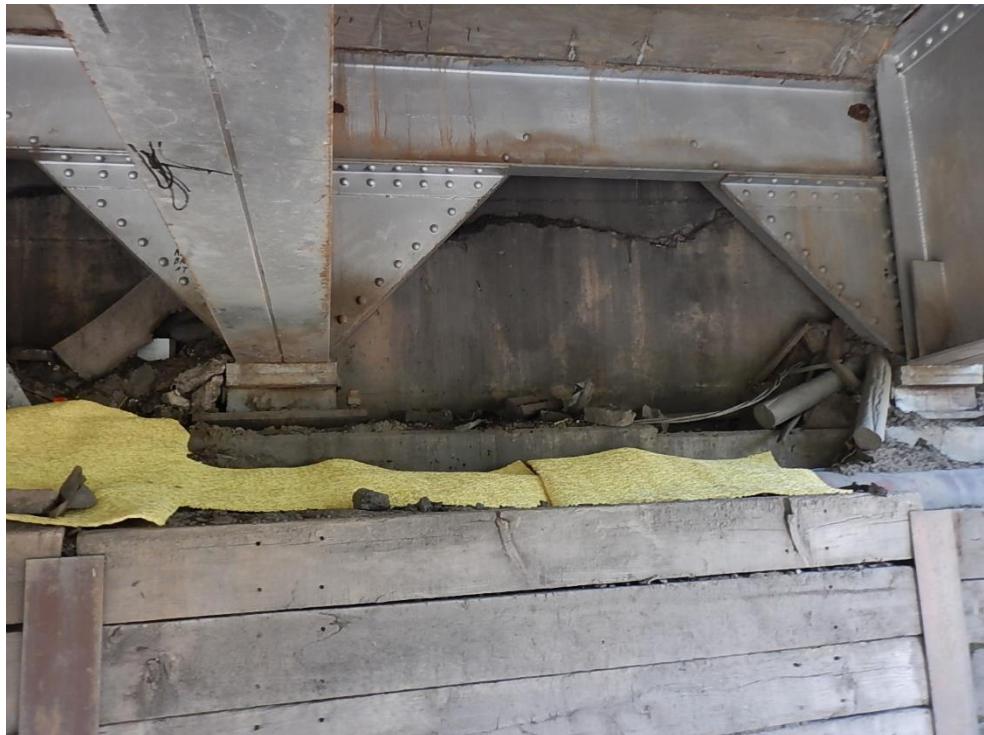
Construction Debris at Abutment 1

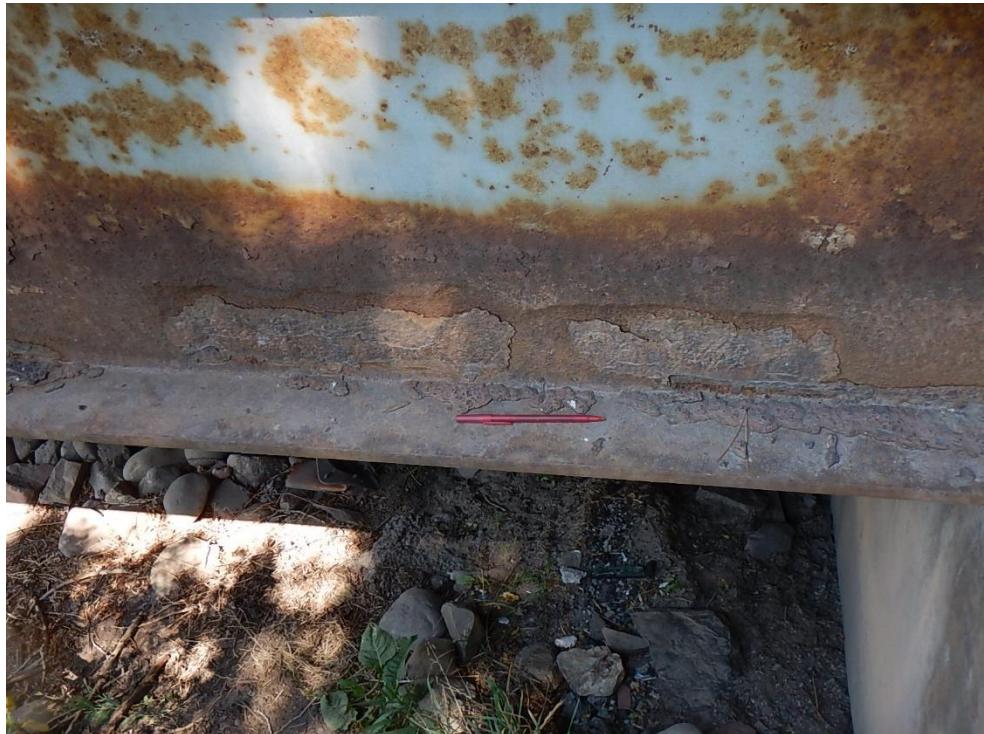
R3 - R4 Corrosion of Girder 5F near Abutment 6

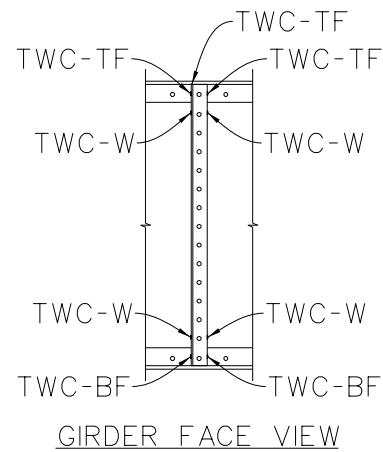
There are numerous tack welds at each stiffener location throughout the lengths of the interior girders. Tack welds were made during construction to fit-up stiffeners to the girders while rivets were being installed. Typically, there are (8) tack welds per stiffener; (2) at the top flange, (4) at the web, and (2) at the bottom flange. In about half of the stiffeners, there is an additional tack weld at the top of the stiffener to the horizontal leg of the top flange angle, and very rarely another tack weld between the vertical leg of the top flange angle and the girder web. See the image to the right for an illustration of tack weld locations, accompanied by a code legend below. See also Figure 9 for an annotated photograph showing a typical stiffener and associated tack welds. The codes that have been used in the legend and graphic shown here have been used throughout the report and drawings in order to more quickly identify the location of a tack weld within the cross section of the girder.

These tack welds are of poor quality as they were only intended to be used for ease of construction and are prone to cracking. At the time of original construction, it was typical for contractors to leave tack welds like the ones found on the Castle Creek Bridge in place after project completion. However, in more recent construction, standards have become more stringent and typically require tack welds used for fit-up to be ground out or incorporated into a full structural weld prior to acceptance.

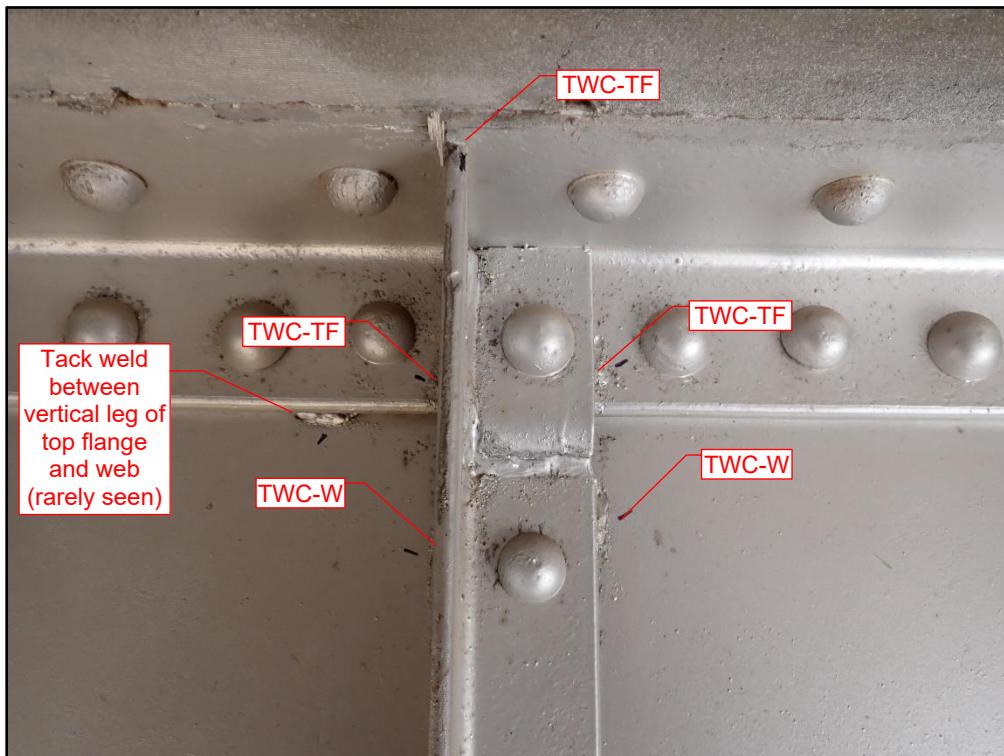
Figure 9 :Typical Stiffener Tack Weld Configuration with Crack Code Call-Outs

Special attention was given to areas where vertical stiffeners were tack welded to either the girder web (steel plate 3/8" x 54") or girder top/bottom flanges (double angles 6" x 4" x 5/8"). Many tack welds are still present on the structure from original construction fit-up and are in-tact. However, many have been found to be cracked and self-arrested (SA) – this condition refers to a completely cracked through tack weld where stress has been relieved and there is no longer potential for crack propagation into the base metal. The remaining tack welds that were cracked but not self-arrested (NSA) were found to be confined to the welds and not propagating into the base metal of the girders. Although there were no locations where cracking was found to enter the girder base metal at NSA tack welds, since the areas are not self-arrested there is a possibility that the crack could make its way into the base metal in the future as it grows. Although it is more likely the crack would make its way through the tack weld and become a self-arrested location, there is always the potential for the crack to migrate into the girder itself.

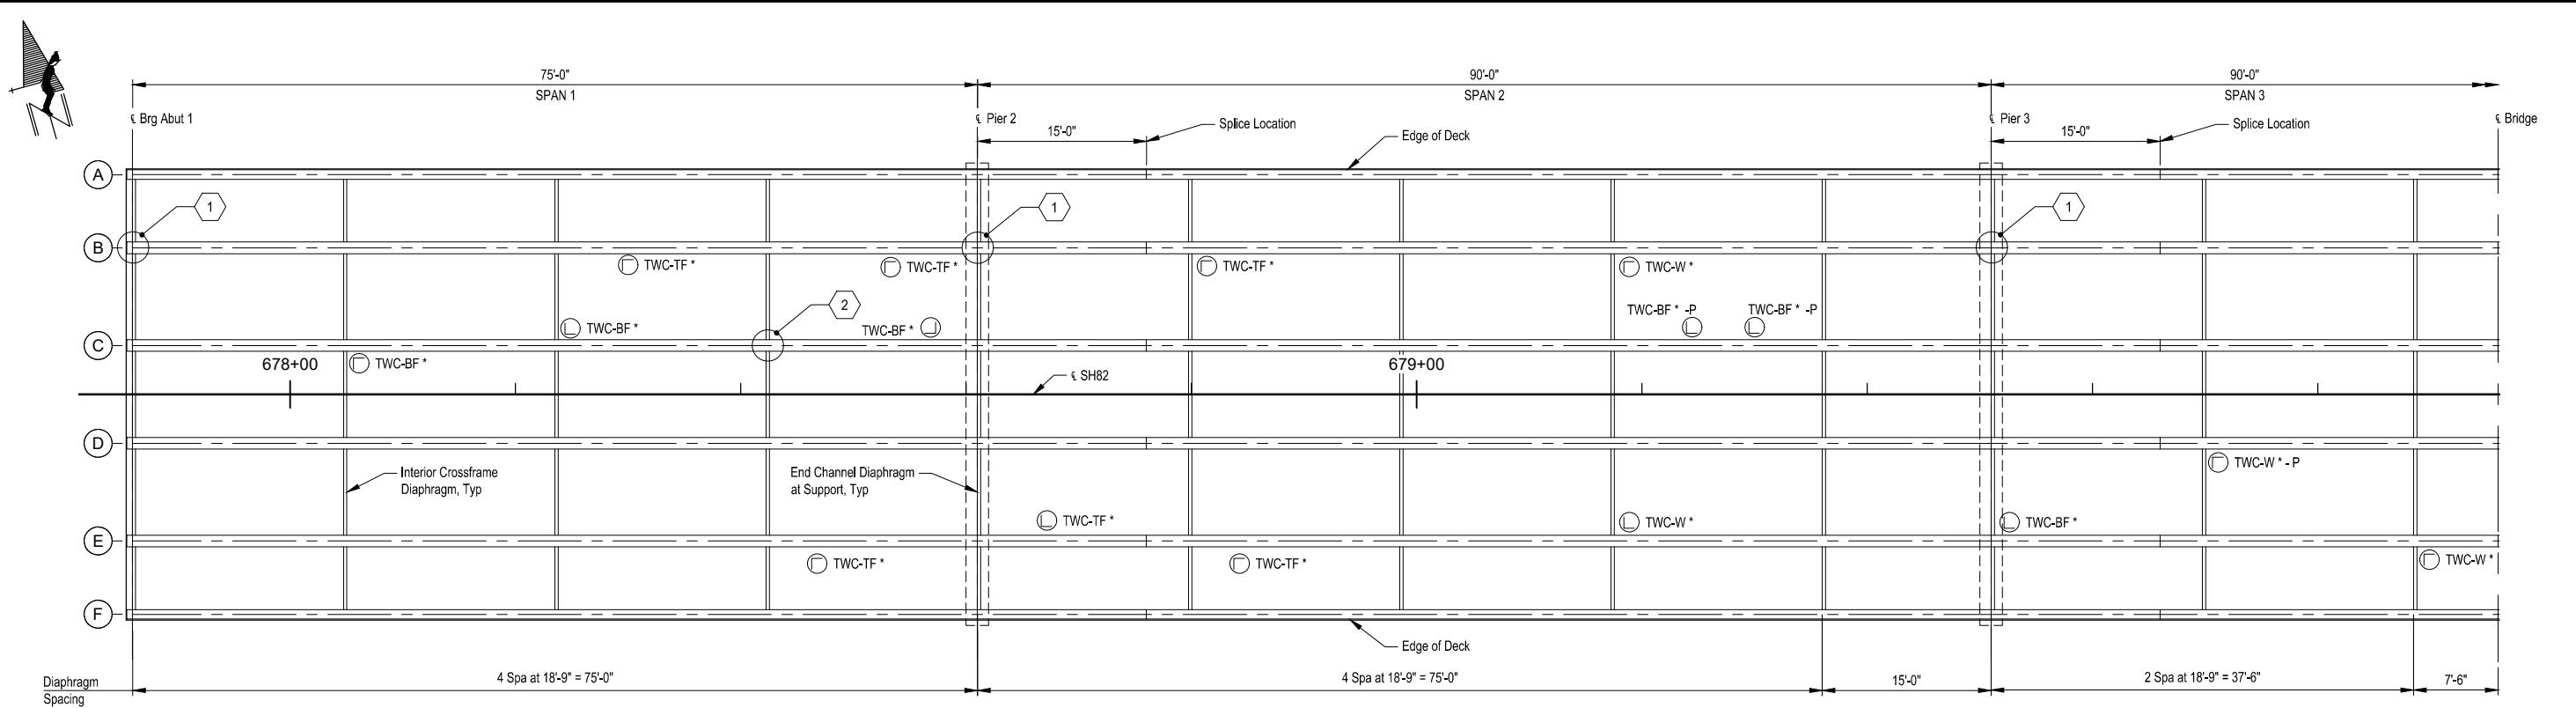
PARTIAL FRAMING PLAN

NOTE: Not all girder defects shown. Only tack weld cracks that are NOT self-arresting (NSA) are noted. All NSA welds shall be repaired at a minimum to improve the service life of the steel plate girders.

- (1) Pack rust between faying surfaces of angle legs, up to $\frac{1}{2}$ " thick, typical at bearing stiffener locations.
- (2) Cracked stiffener weld at bottom.
