SH 82 Over Castle Creek Bridge Feasibility Study
Document No: 240207140925_5d9775bf
Version: Draft

City of Aspen
Structure No. H-09-B

Castle Creek Bridge

Prepared by: Beth Tosti, Structures Lead

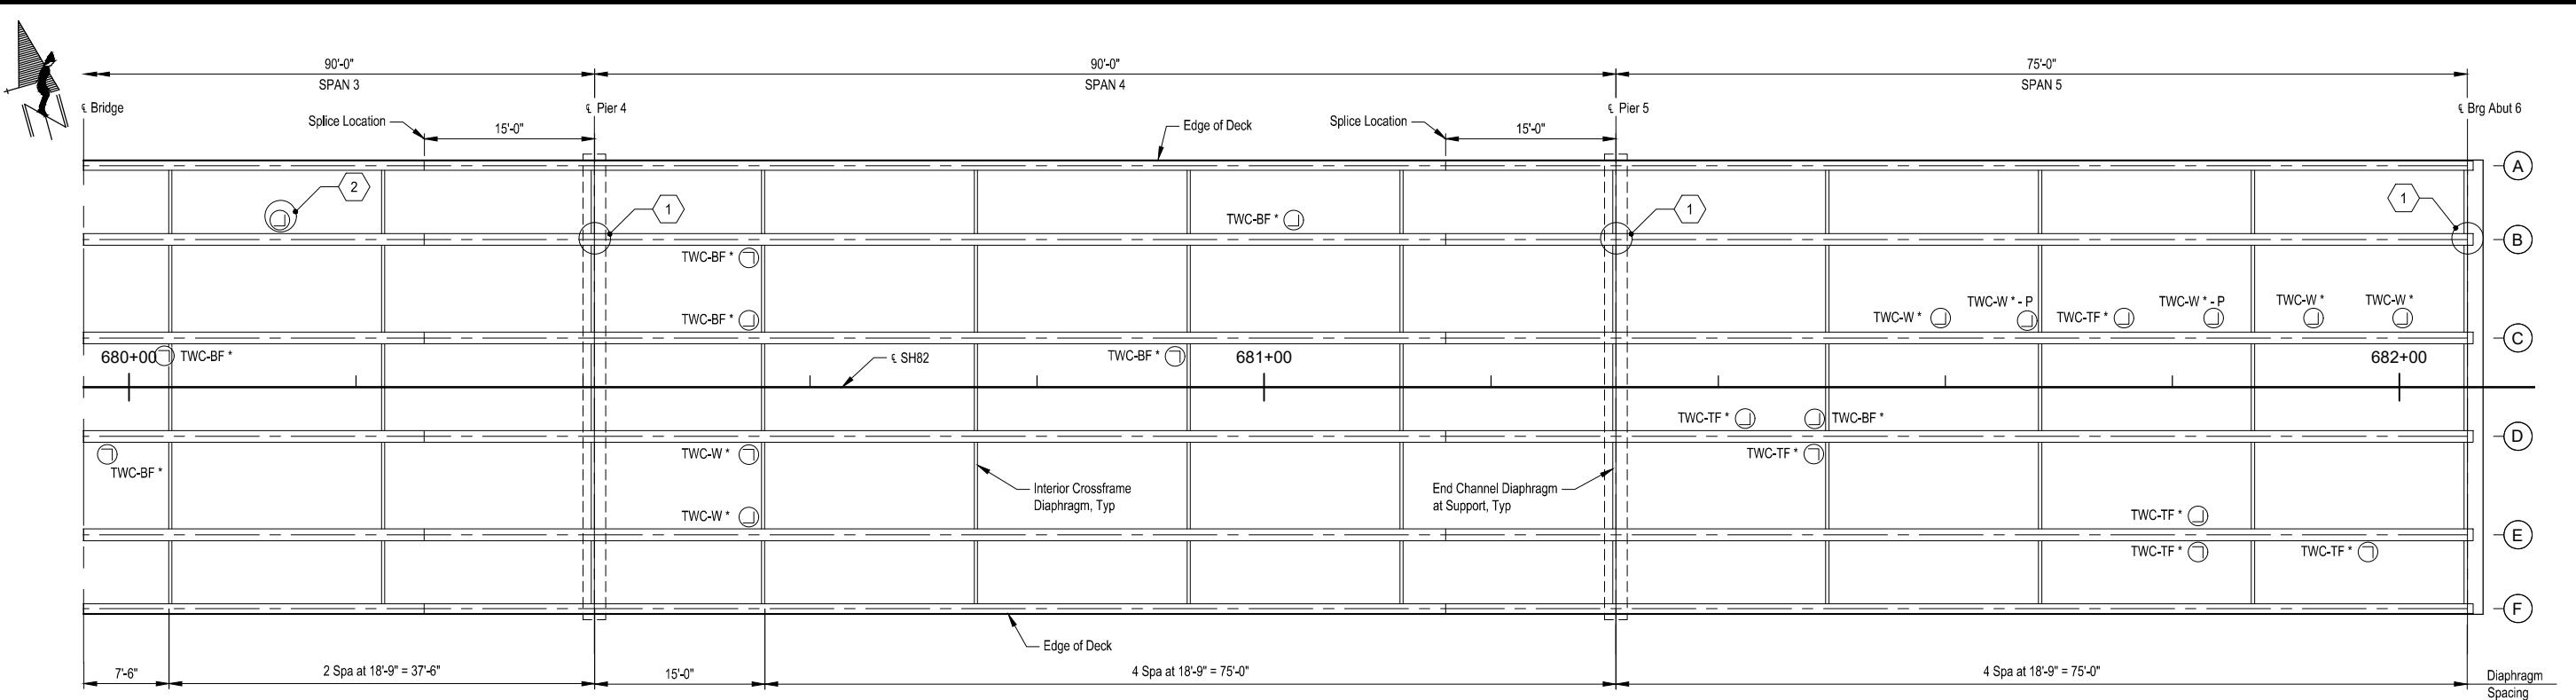
PARTIAL FRAMING PLAN

NOTE: Not all girder defects shown. Only tack weld cracks that are NOT self-arresting (NSA) are noted. All NSA welds shall be repaired at a minimum to improve the service life of the steel plate girders.

- ① Pack rust between faying surfaces of angle legs, up to $\frac{1}{2}$ " thick, Typ at bearing stiffener locations.
- ② Stiffener deflected, up to 1" out of plane over 6" height, near bottom $\frac{1}{3}$ point.
